Final Project Report

Fire Safe implementation of visible mass timber in tall buildings – compartment fire testing

RISE Report 2021:40

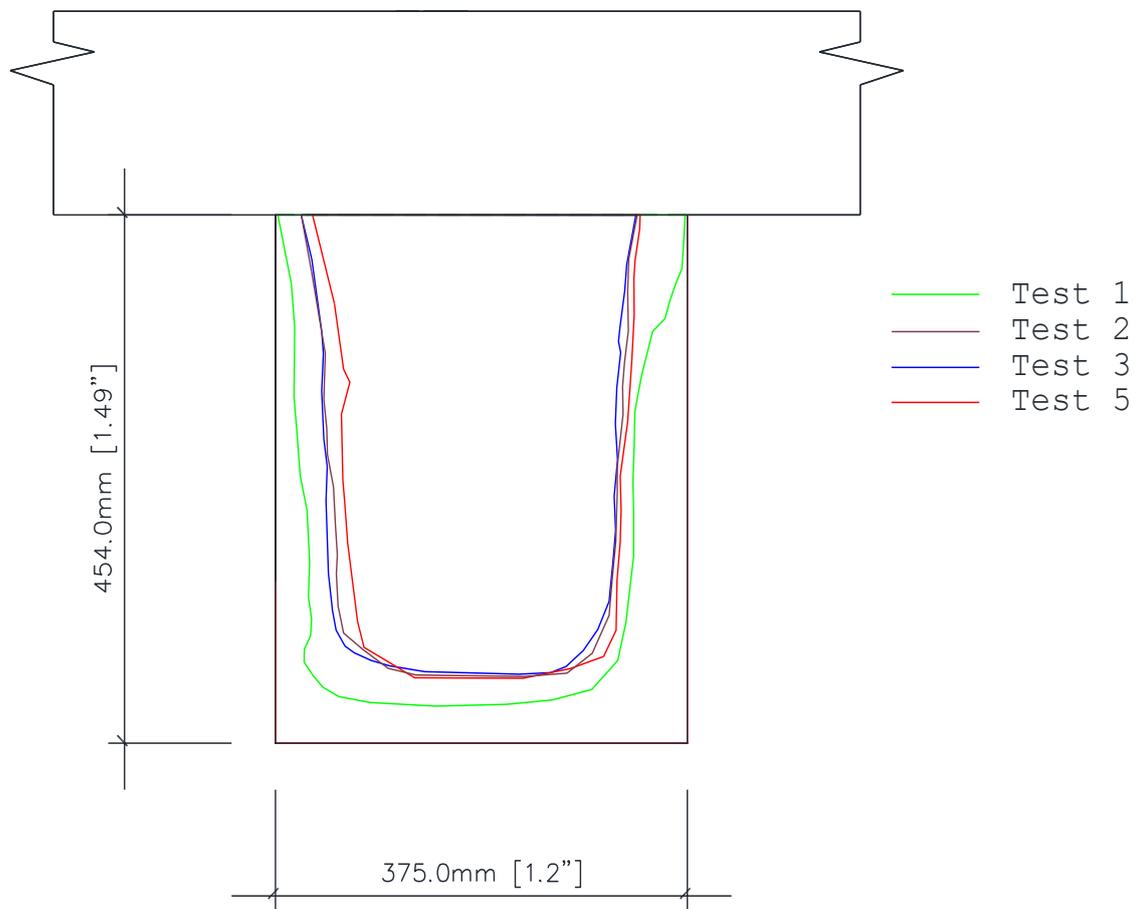
Figure 80: Post-test beam char shapes.

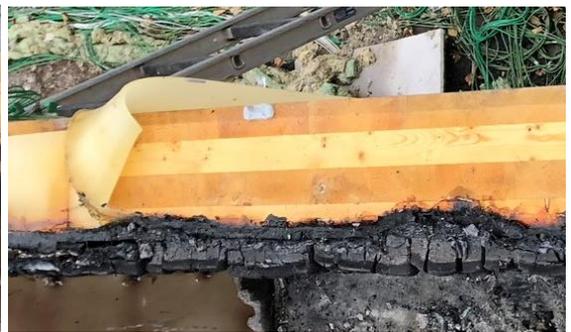
Figure 89: Top of the wall after removal of the ceiling. Typical location. Sealing method: construction tape and resilient profile (Test 2).

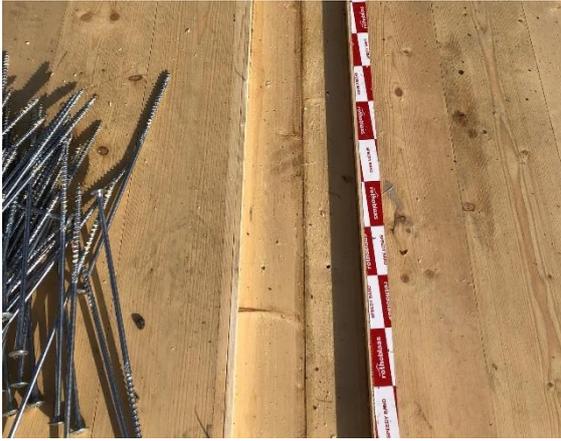
Figure 90: Photo after removal of spline board. Sealing method: 2x construction tape on top of spline boards (Test 1)

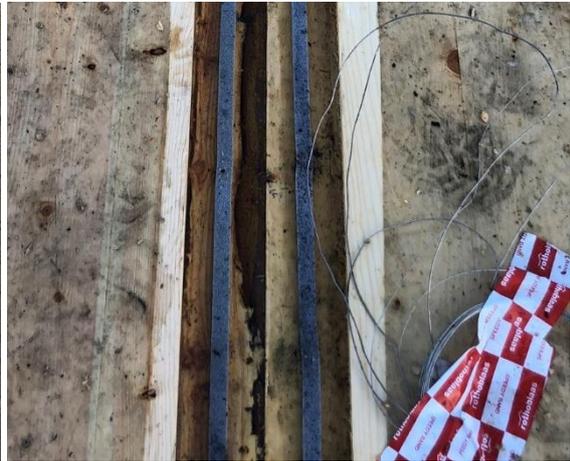
Figure 93: Photo after removal of spline board. Sealing method: 2x expanding tape at center of lap (Test 3). Note: the rain after the test cause additional discoloration

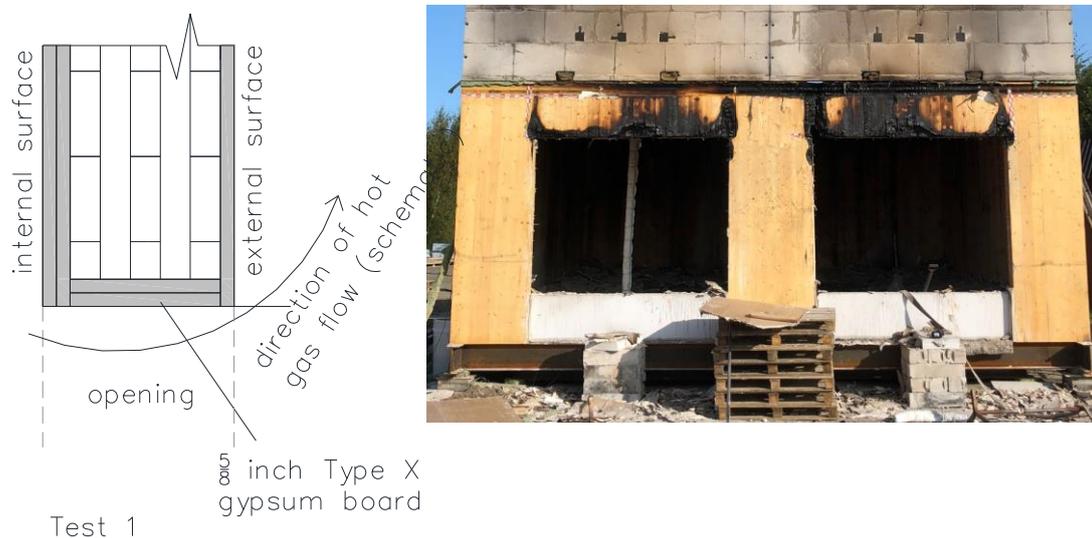
Figure 96: Test 1 - Detail above opening (left) and front façade after removal of gypsum boards (right)

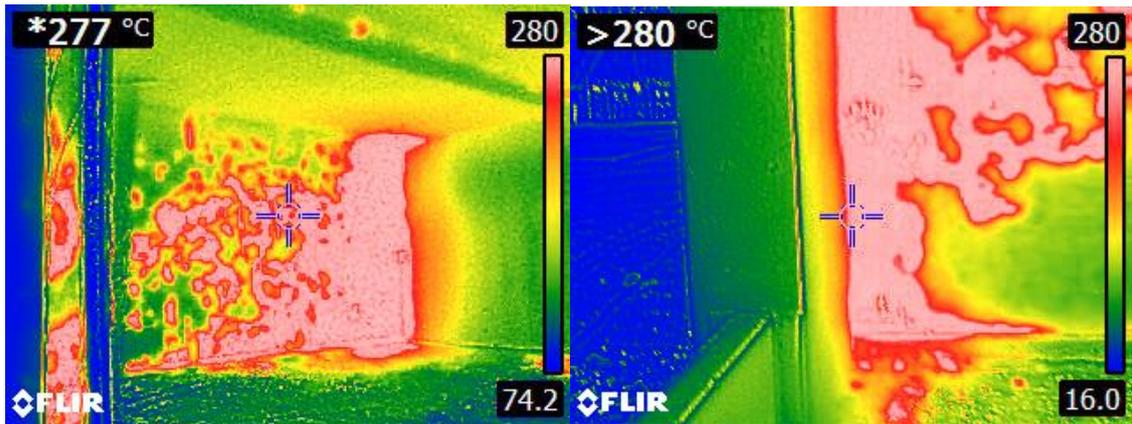
Figure 103: Thermal camera photo of hot spots in the back right and front left corner of exposed walls after the test. Multiple IR cameras have been used, colours used in the here have been altered to match those of the other thermal camera. The original output uses a purple to orange scale.

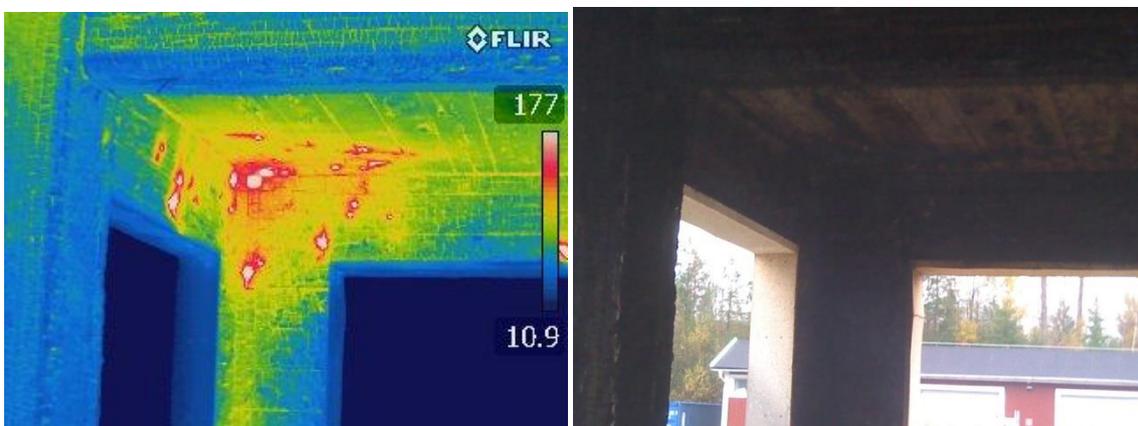
Figure 105: A typical hot spot after Test 4 (left thermal camera, right regular camera)

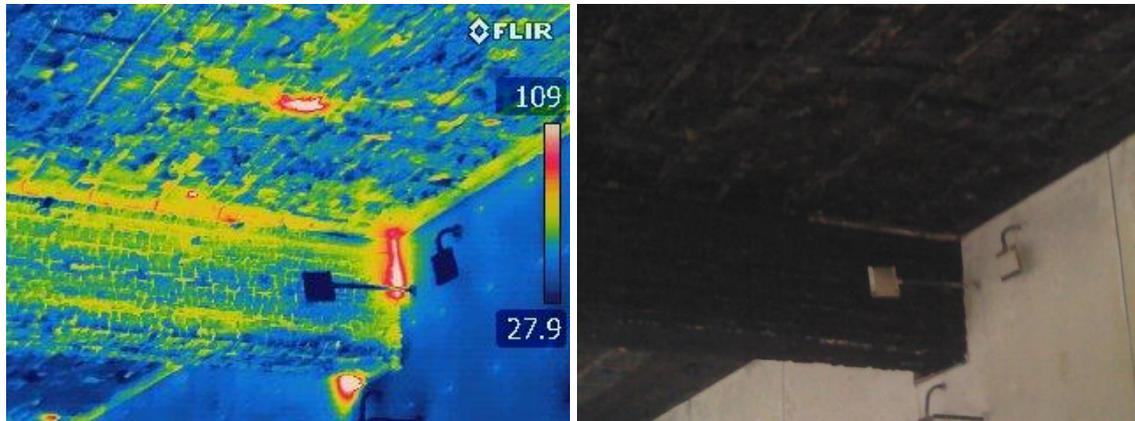
Figure 106: connection between beam and back wall after Test 4 (left thermal camera, right regular camera)

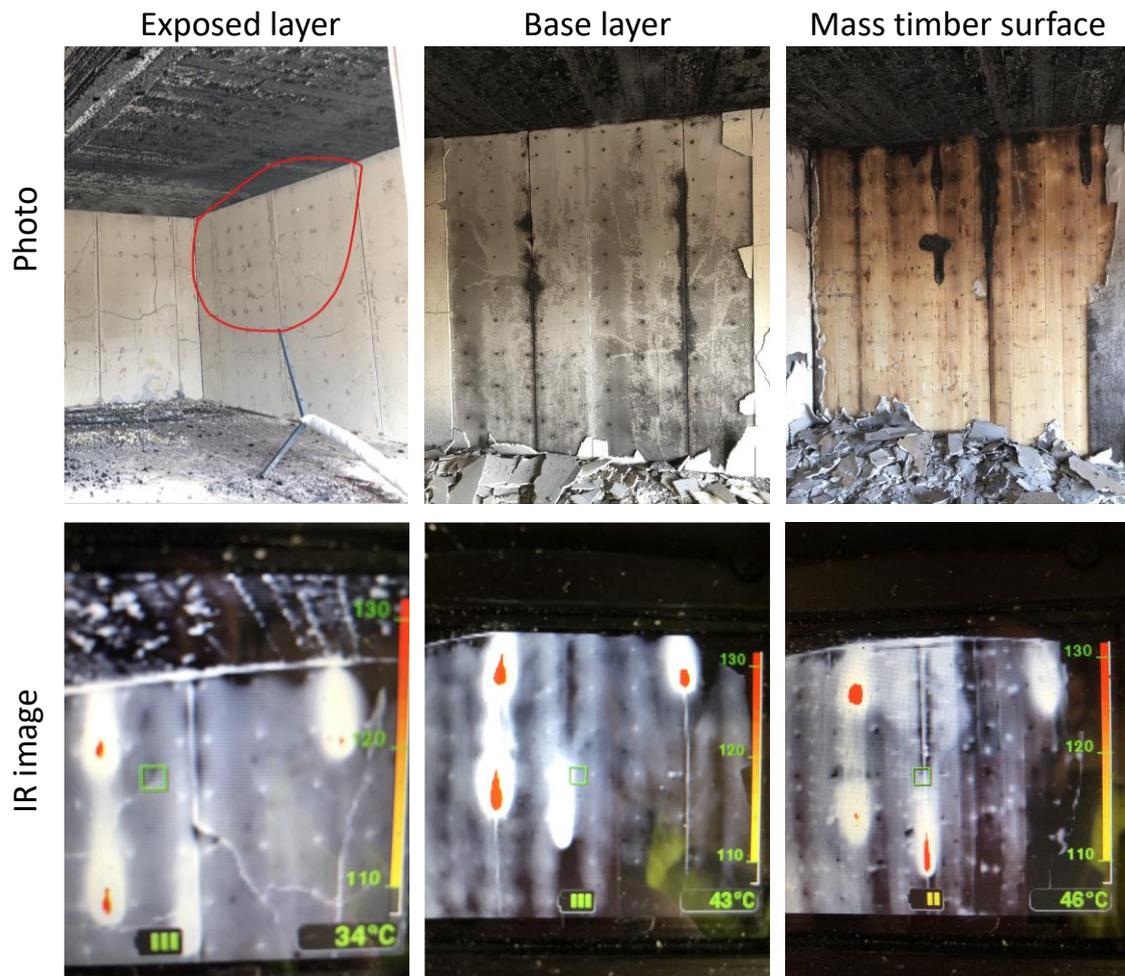
Figure 107: Thermal camera photo of hot spots in the left wall (at the joint between plaster boards and the back wall (at a lap joint, exactly where thermocouples are located in the CLT).

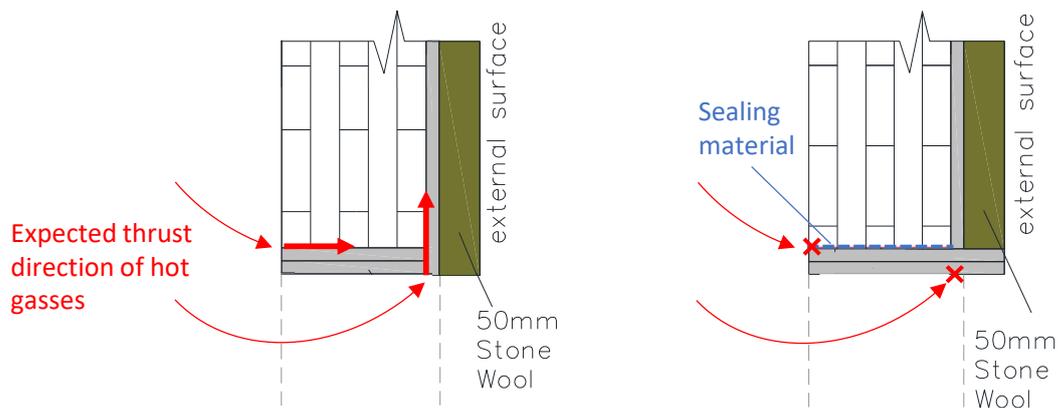
Figure 112: Example of a sensitive detail (left) and a variant with improved fire performance (right)

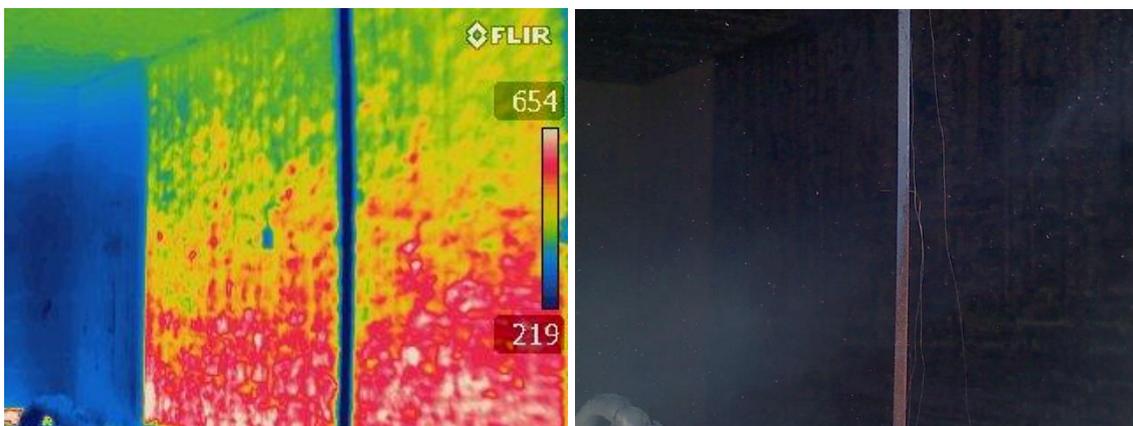
Figure 113: Infrared camera picture and corresponding photo of right wall at 2 hours after ignition in Test 3.

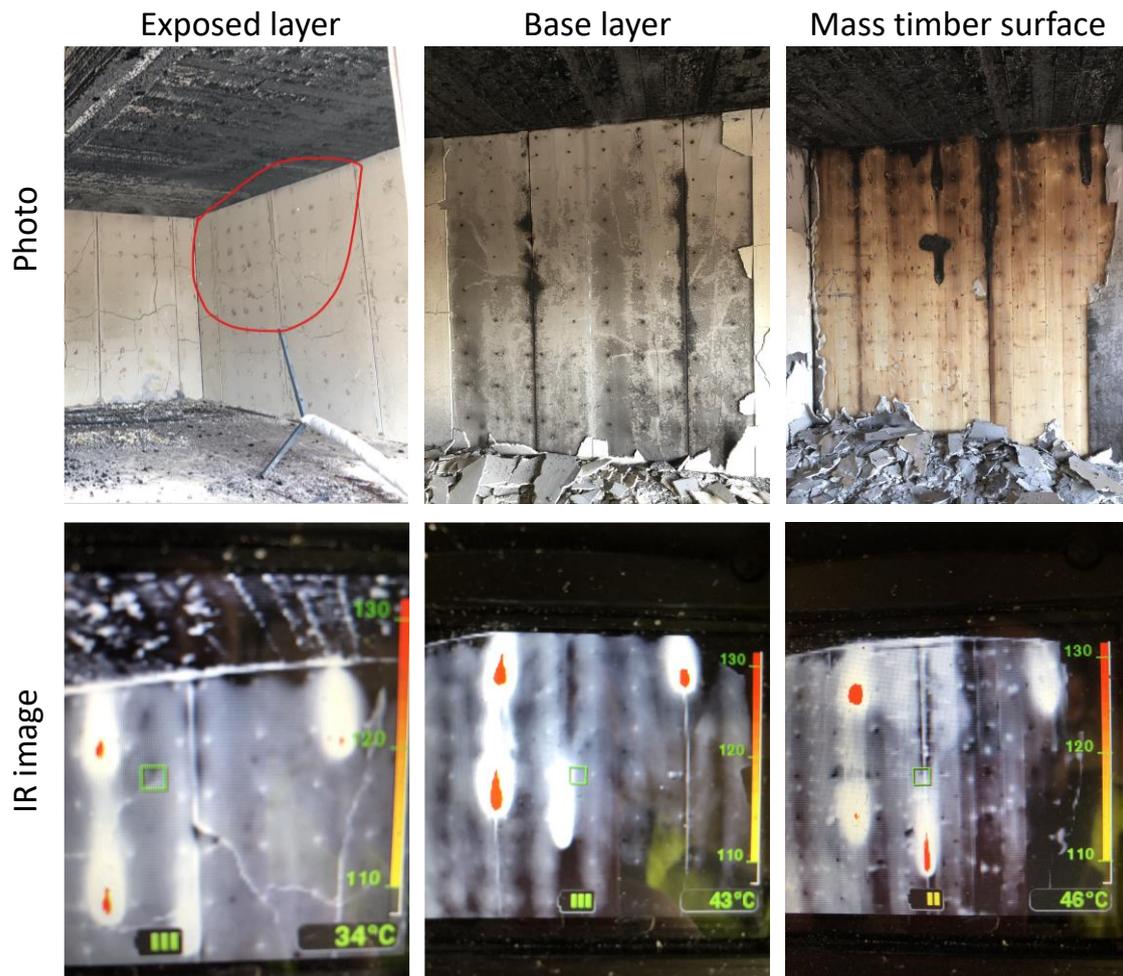
Figure L.4: Three identified spots of smoldering behind gypsum in the left wall of Test 1. Upper panels show visual images and the lower panels show IR images of the exposed layer (left), base layer (middle) and CLT surface (right)

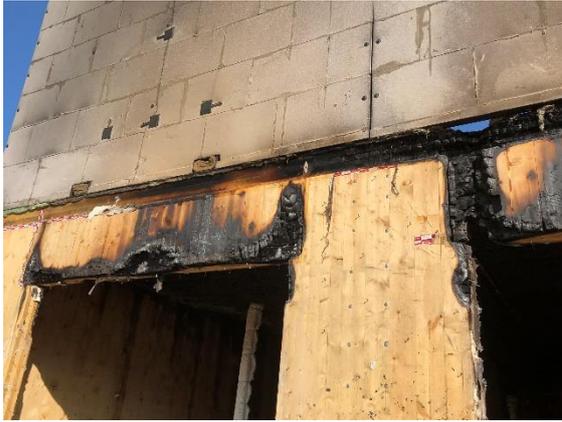
25 Test 1. Damage above the openings after Test 1. Highest damage occurred above the left corner of the right opening. The lap joints above the corners were not sealed in Test 1.

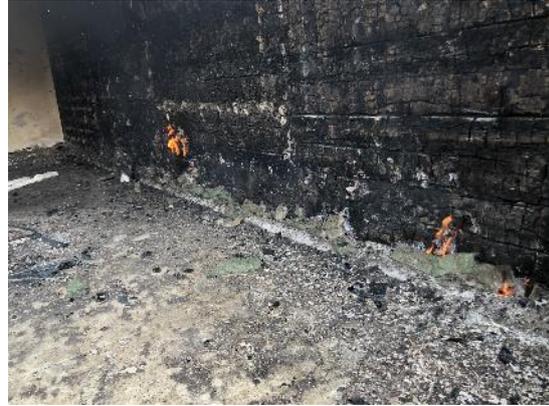
50 - Test 2. Small smoldering areas at end of fire.

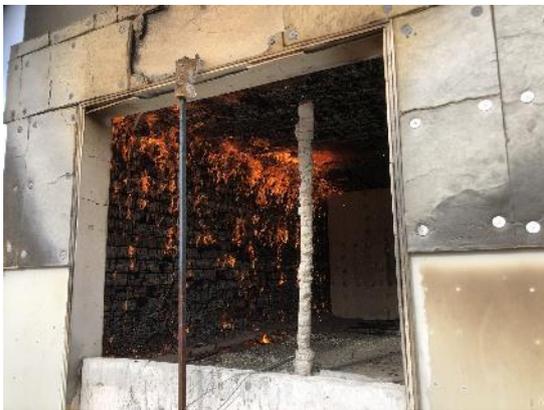
74 - Test 3. Flaming on the left wall late in the decay

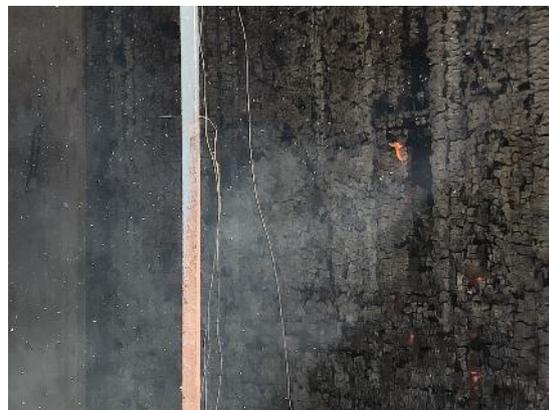
75 - Test 3. Small area of smoldering on an exposed wall

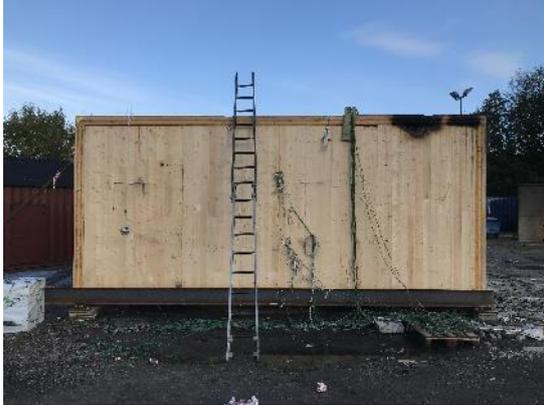
84 - Test 3. Area of charring visible from outside post test.

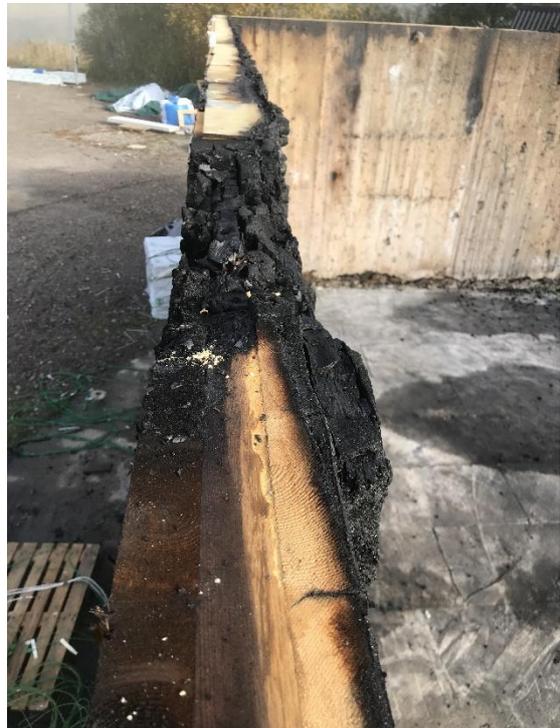
87 - Test 3. Area where resilient profile failed (likely due to lack of airtight seal) to provide protection at wall top.

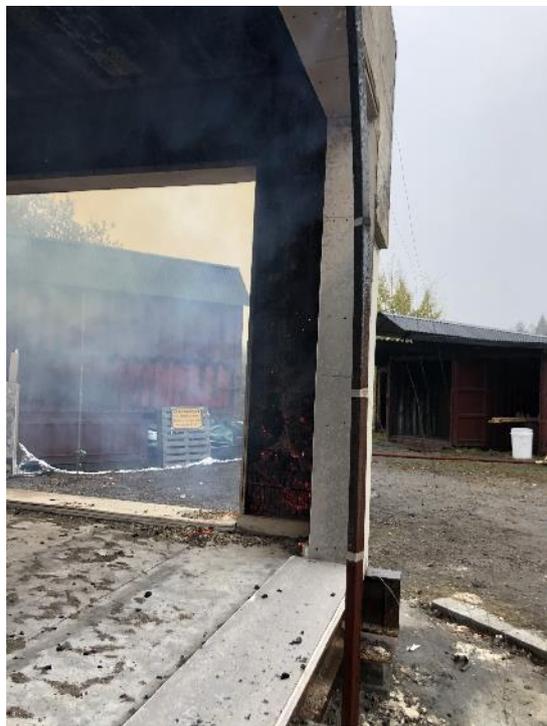
98 - Test 4. Smoldering ongoing in corner after fire stopped elsewhere.
