## Post-Fire Rehabilitation of CLT

Daniel Brandon  
Johan Sjöström  
Fredrik Kahl

RISE Report 2021:67

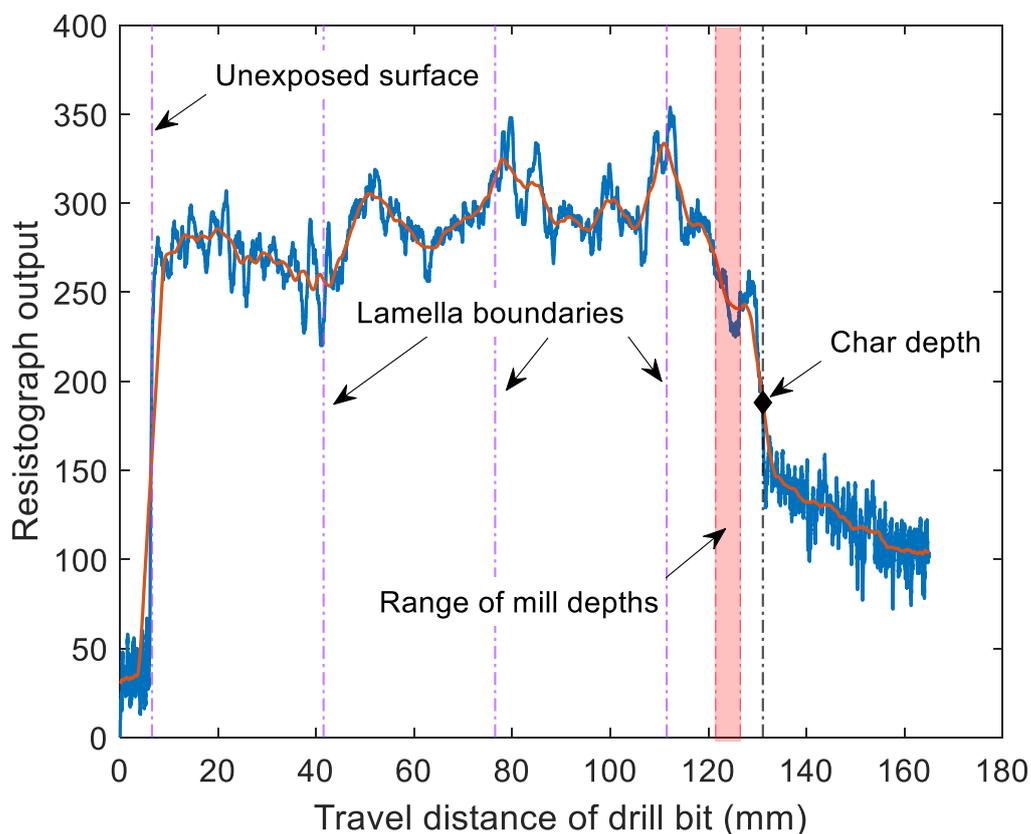
Figure 4 shows a resistograph measurements taken in the to be repaired section of the ceiling, giving an indication of the char depth and a rough indication of a heat affected layer. The average char depth in the ceiling was 50 mm (~2 in). However, it should be noted that there was some variability of char depth measured in the ceiling, as reported by Brandon *et al.* (2021), introducing some uncertainties.

Figure 4: Resistance measured by the resistograph and an indication of the char depth and the milled depth. Note, the resistograph drill travels approximately 7 mm (0.28 in) before it reaches the unexposed surface. To calculate the depth from the exposed side, the drill bit travel distance minus 7 mm (0.28 in) should be subtracted from the original thickness of 175 mm (6.89 in).

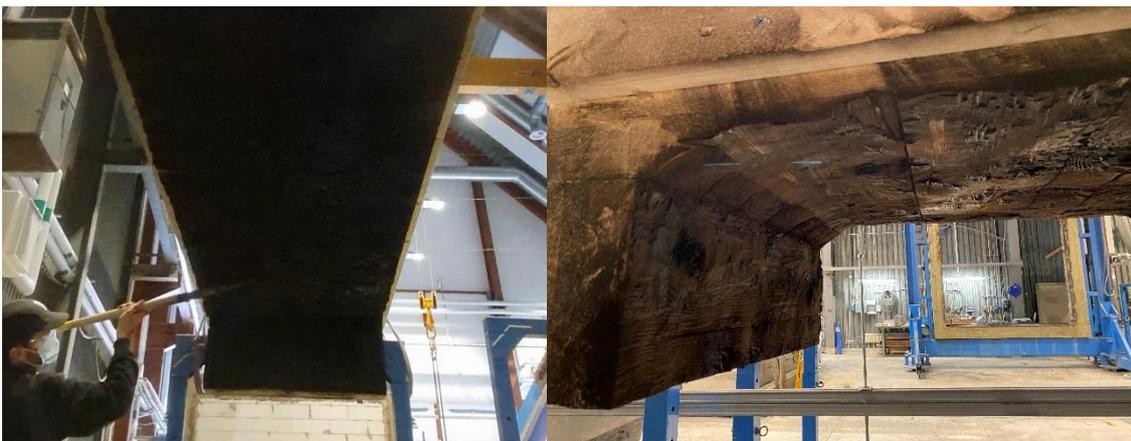
Figure 6: Removal of the char with a long-handled scraper (left) and surface after char removal (right)

The char layer was removed firstly using a long handle scraper (Figure 6) and a drilling machine with steel brush attachment.

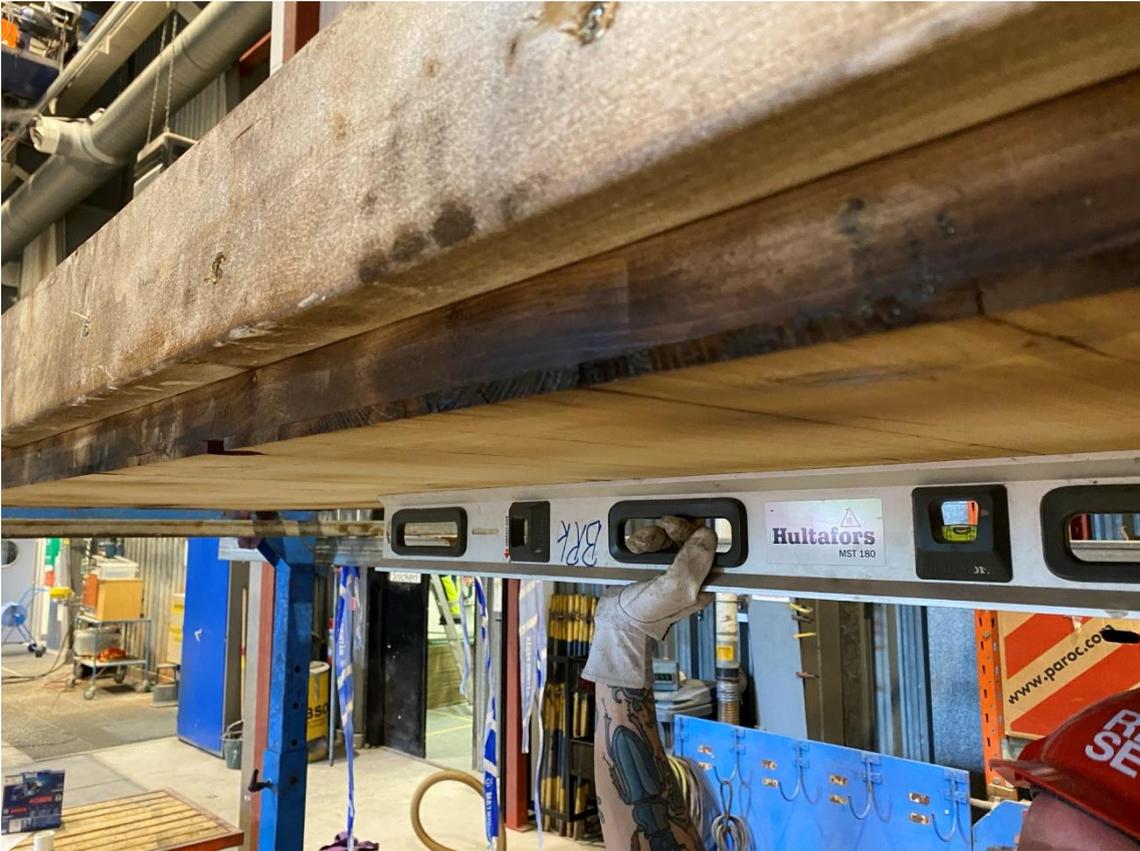
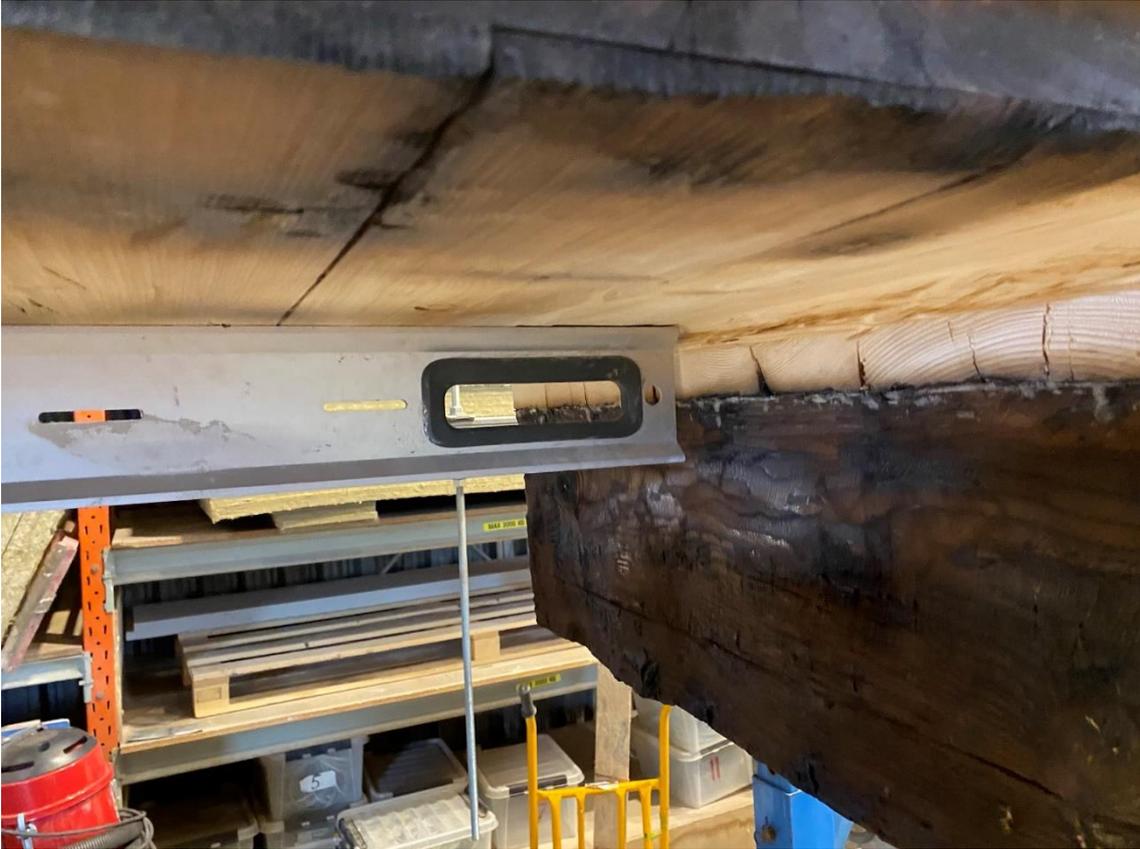
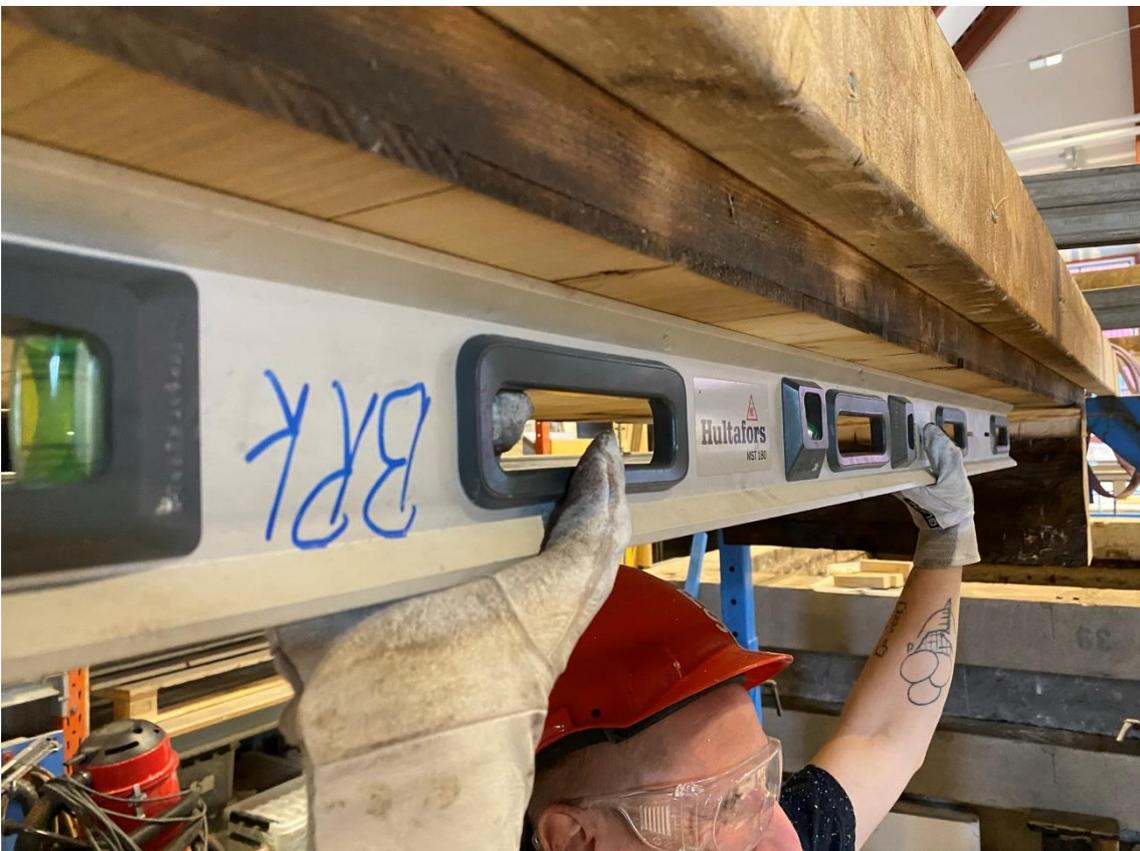
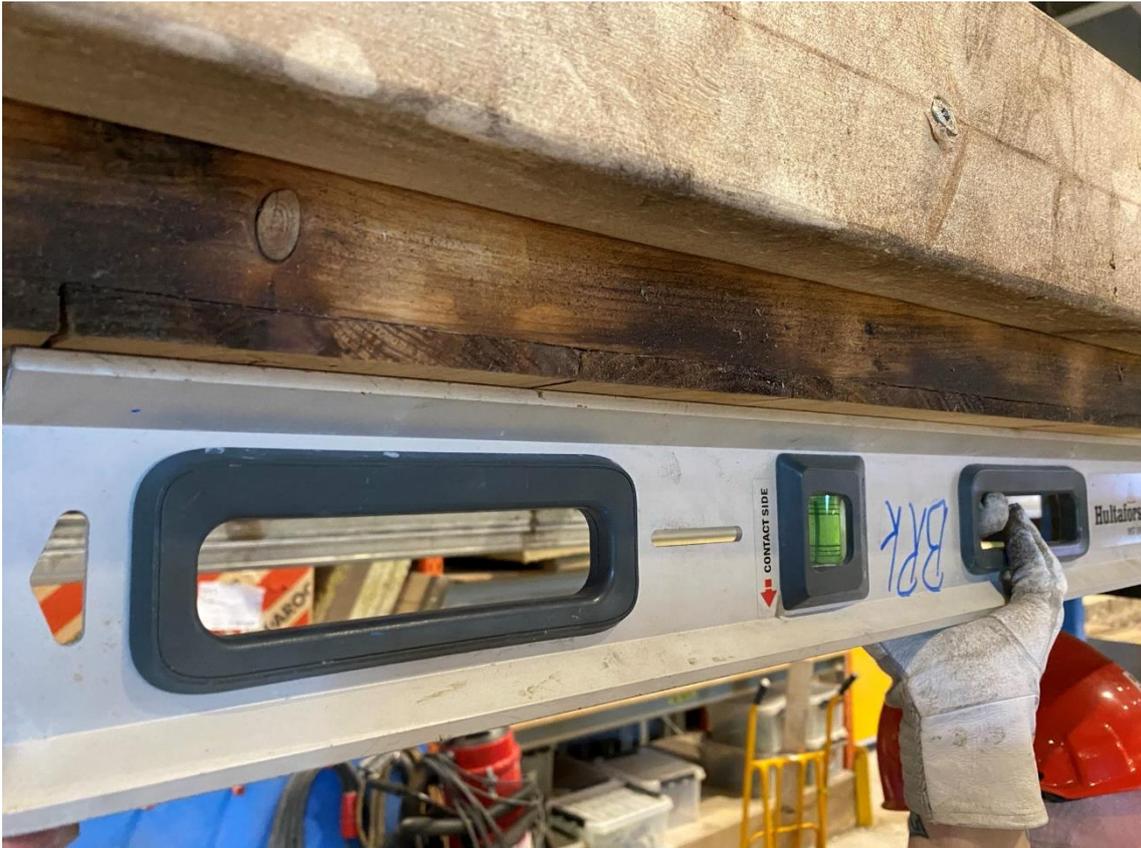
After planing, the planeness of the surface was assessed by holding a long straight level against it (Figure 10, Figure 11, Figure 12, Figure 13) and measuring the variability of the surface with a laser distance meter attached to the milling frame (Figure 14). The variability of the distance between the planed surface and the plane of the sliding frame was within 1 mm ( $\sim 0.04$  in), with exception of some locations with deeper charring and near the ceiling-wall corner. Near the ceiling wall corner, distance variations up to 2 mm ( $\sim 0.08$  in) were seen. The deepest identified gap was 8 mm ( $\sim 0.31$  in) which was at a location where the char depth exceeded the milled depth (Figure 14, right). Additional adhesive were applied at such locations as further discussed in Section 4.5.

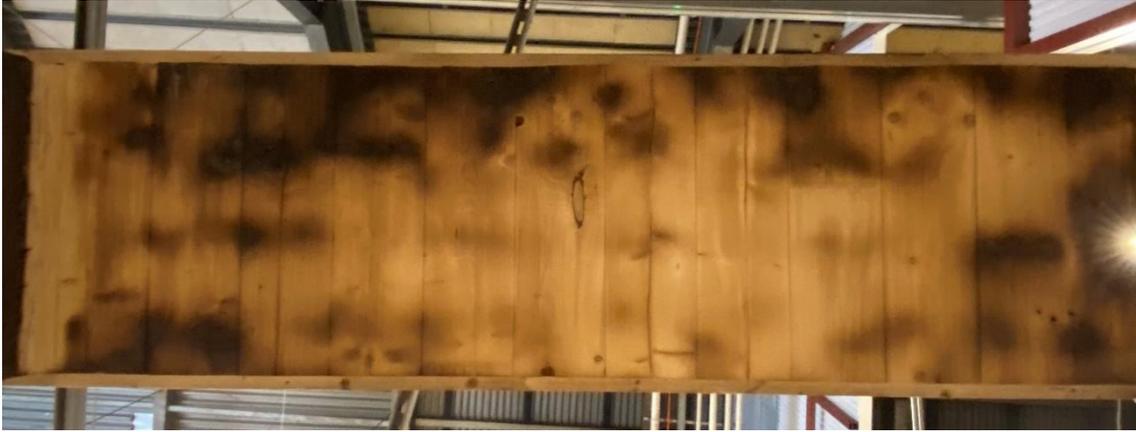
The planed surface contained some discolorations, which indicates that the materials in these locations are affected by heat and may have reduced material properties. As discussed before, this is only expected to influence the shear capacity which is generally acceptable to a relatively large extent. For structures with very high shear loads it is likely more appropriate to plane away all or nearly all discoloured material of a cross layer.

Figure 15: The planed surface photographed from below

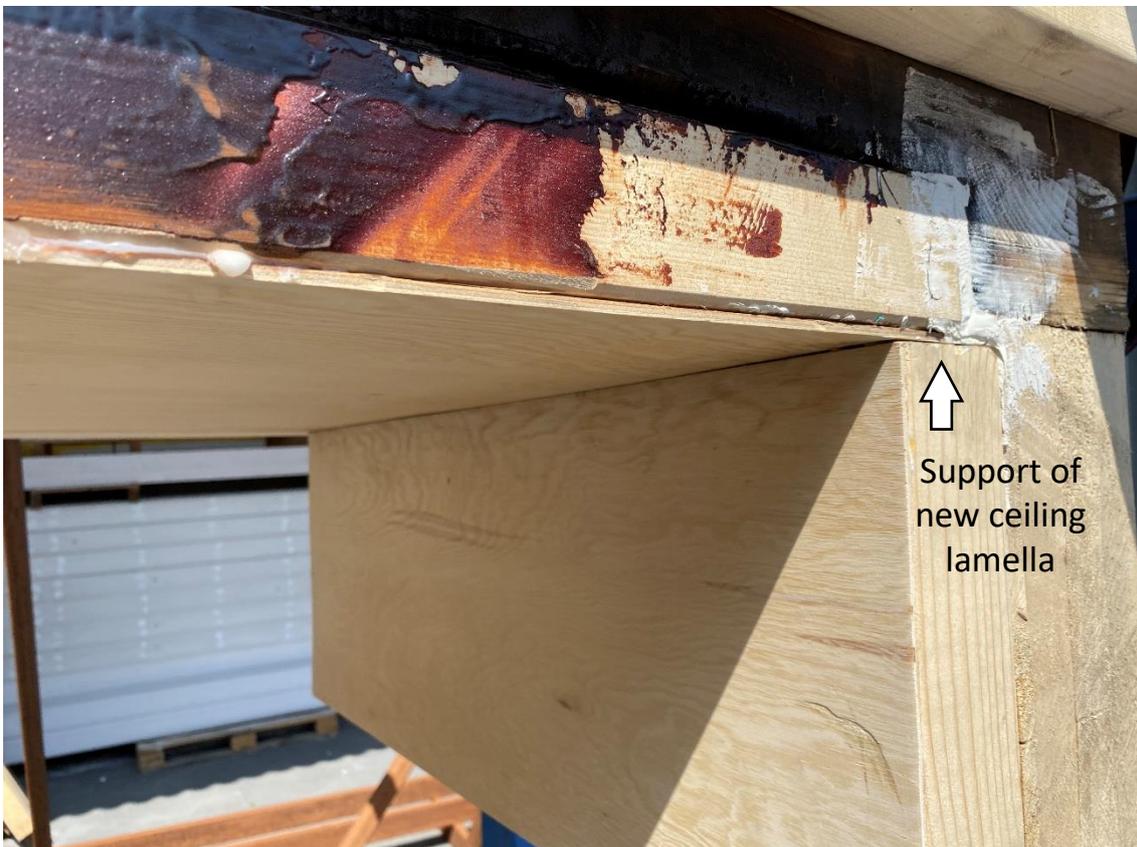
Figures of the specimen after rehabilitation are shown in Figure 21 and Figure 22. Figure 23 shows a closeup of the ceiling joint, where the new ceiling lamella is structurally supported by the new wall lamella<sup>7</sup>. To achieve this the ceiling should be repaired prior to the wall.

Figure 23: Ceiling-wall joint after rehabilitation work

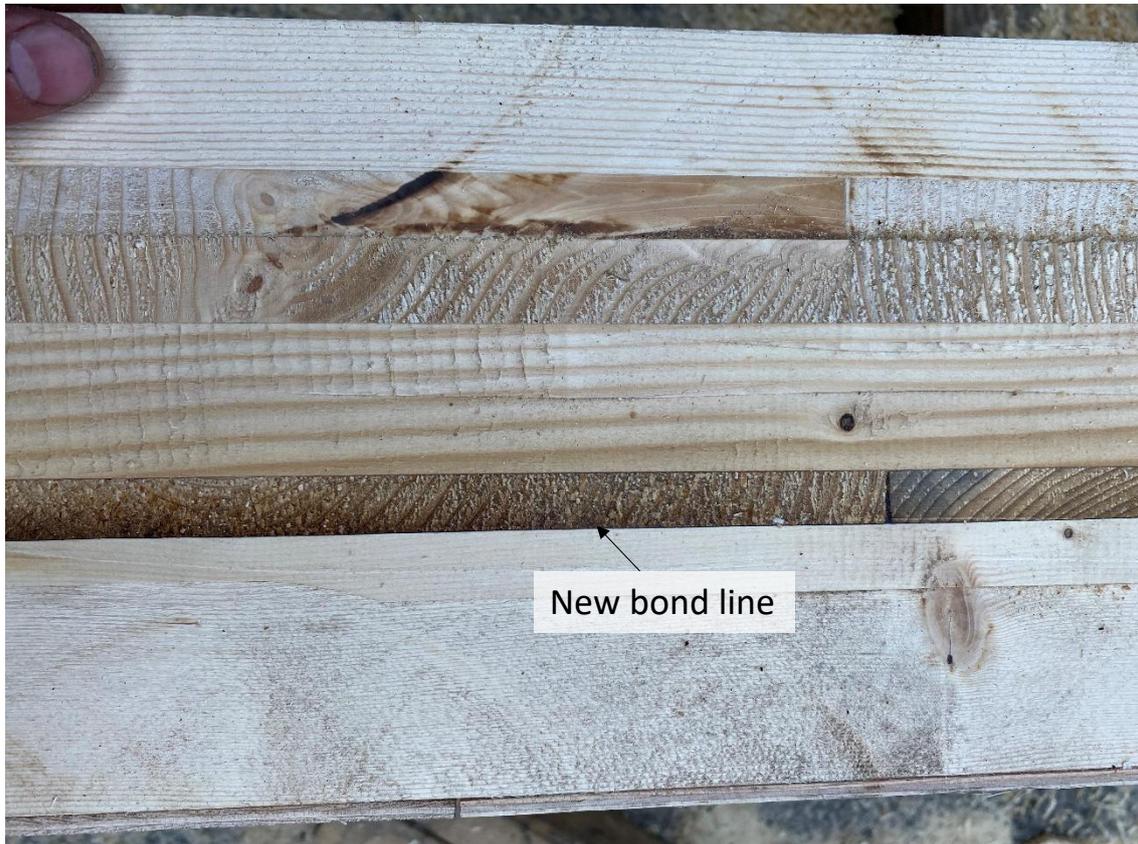
After the rehabilitation process, a longitudinal cut was made splitting the ceiling in two long elements. In this cut the glue line thickness was between 0.1 and 0.2 mm (0.004-0.008 in) with exceptions of (1) a location where the char depth was higher than the depth that was milled away, and (2) approximately the last 120 mm (5 in) to the ceiling-wall corner. Figure 24, shows the bond line at a typical part of the longitudinal cross section. Figure 25 and Figure 26 show the longitudinal cross section at the corner joint and the location of deeper char, respectively. Near this corner, the glue line thickness varied between 0.4 and 1.4 mm (0.015-0.055 in). At the location of deeper charring, a length of approximately 90 mm (3.5 in) of the longitudinal section had an increased glue line thickness, exceeding 1.5 mm (0.06 in) for a total length of approximately 20 mm (0.8 in). The measurements in the longitudinal cross section, therefore, indicated that a gap filling adhesive graded for glue line thicknesses up to 1.5 mm ( $\sim 0.06$  in) was appropriate for this case study.

Figure 24: Photo of the longitudinal-section of the rehabilitated CLT member and an indication of the location of the PRF bond line

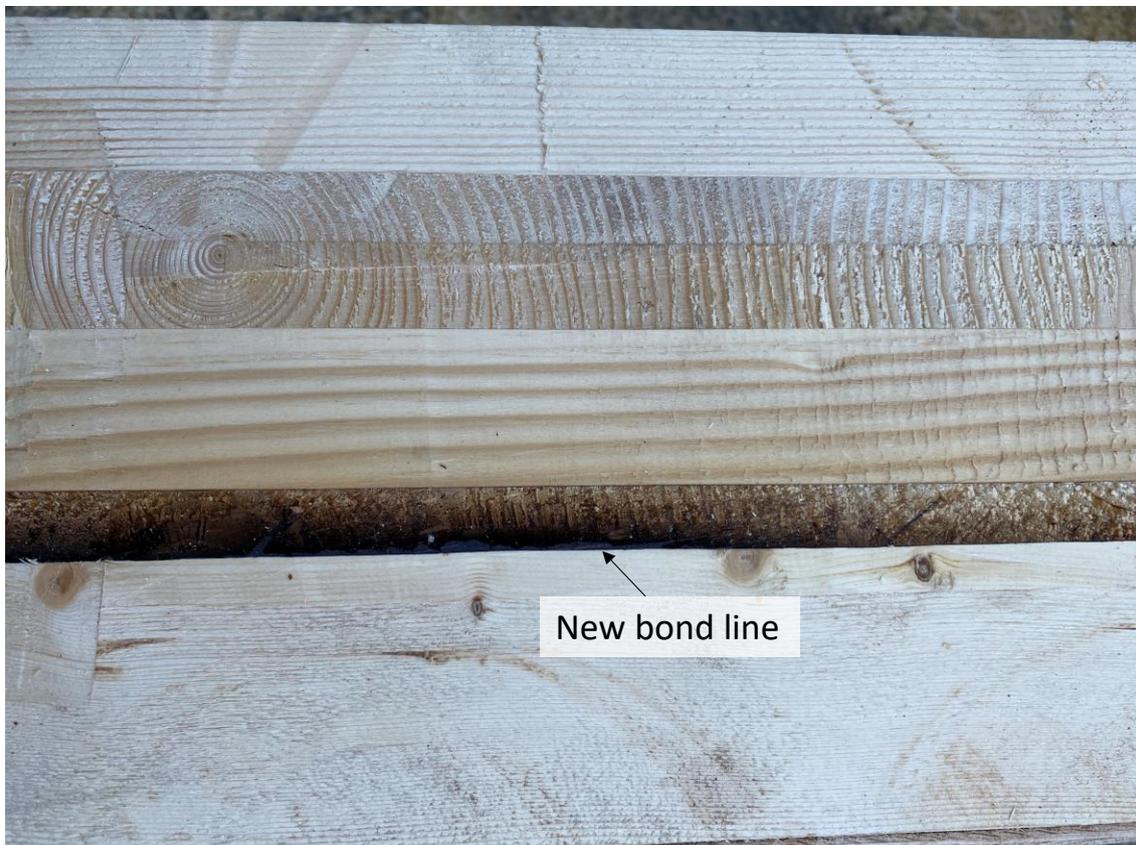
Figure 26: Photo of the longitudinal-section of the rehabilitated CLT member at the location where the char depth slightly exceeds the milled depth.

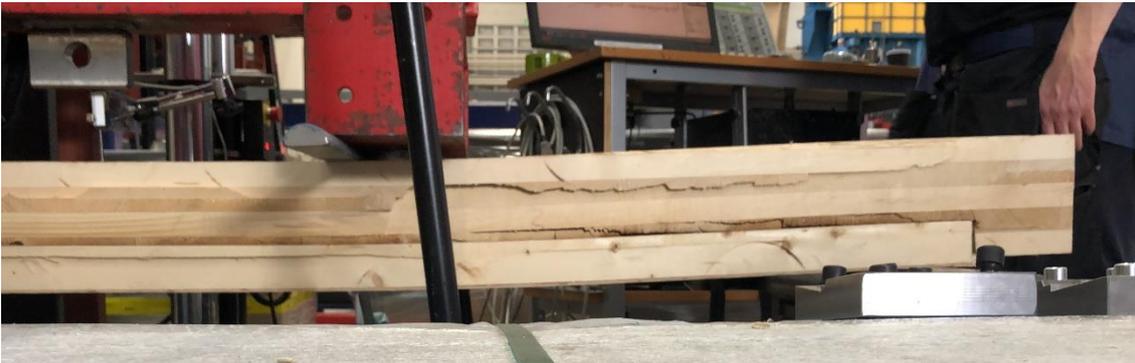
Both specimens were tested to failure. The failure mode for both specimens was rolling shear failure in the lowest cross-layer (Figure 28). The failure occurred in material of the original CLT member. No signs of any failure were seen in the repaired part of the cross section, indicating sufficient performance of the new components (i.e. lower lamella and bond line) of the rehabilitated CLT. The failure loads were 112.0 kN (56.0 kN per load point) and 113.2 kN (25,180 lb and 25,400 lb).

Figure 28: Repaired specimen tested to failure. Shear failure occurred in the cross layer.

The shear capacity has reduced for the rehabilitated specimen as the shear capacity of the test specimens was 18% lower than the characteristic capacity of the original CLT. As rolling shear failure was observed in a layer that was visibly affected by heat, it is expected that the elevated temperatures have weakened the cross layer, which led to a reduction of shear capacity. Despite the reduction of shear capacity, the specimens showed a performance that is sufficient for most, practical applications for floors and is expected to only be critical for short floor spans in combination with exceptionally high loads<sup>8</sup>.

- A case study aiming to fully recover the shear capacity by including iterating step 4 of the six-step procedure of this study, until there is no discoloured material in the planed cross-section.
- Case studies of the rehabilitation of various of joints.
- A study of rehabilitation of CLT with high water damage
- A study of rehabilitation of CLT members with longer spans, to allow determining the ultimate moment capacity.
