Fire Resistance Testing of CLT Floor/Ceiling Assemblies to Establish Contribution of Gypsum Protection

*Indicative testing conducted following the test methodology described in
ASTM E119: Standard test methods for fire tests of building and
construction materials*

**American Wood Council
222 Catocin Circle SE, Suite 201
Leesburg, VA 20175**

WFCi Report #17091r1

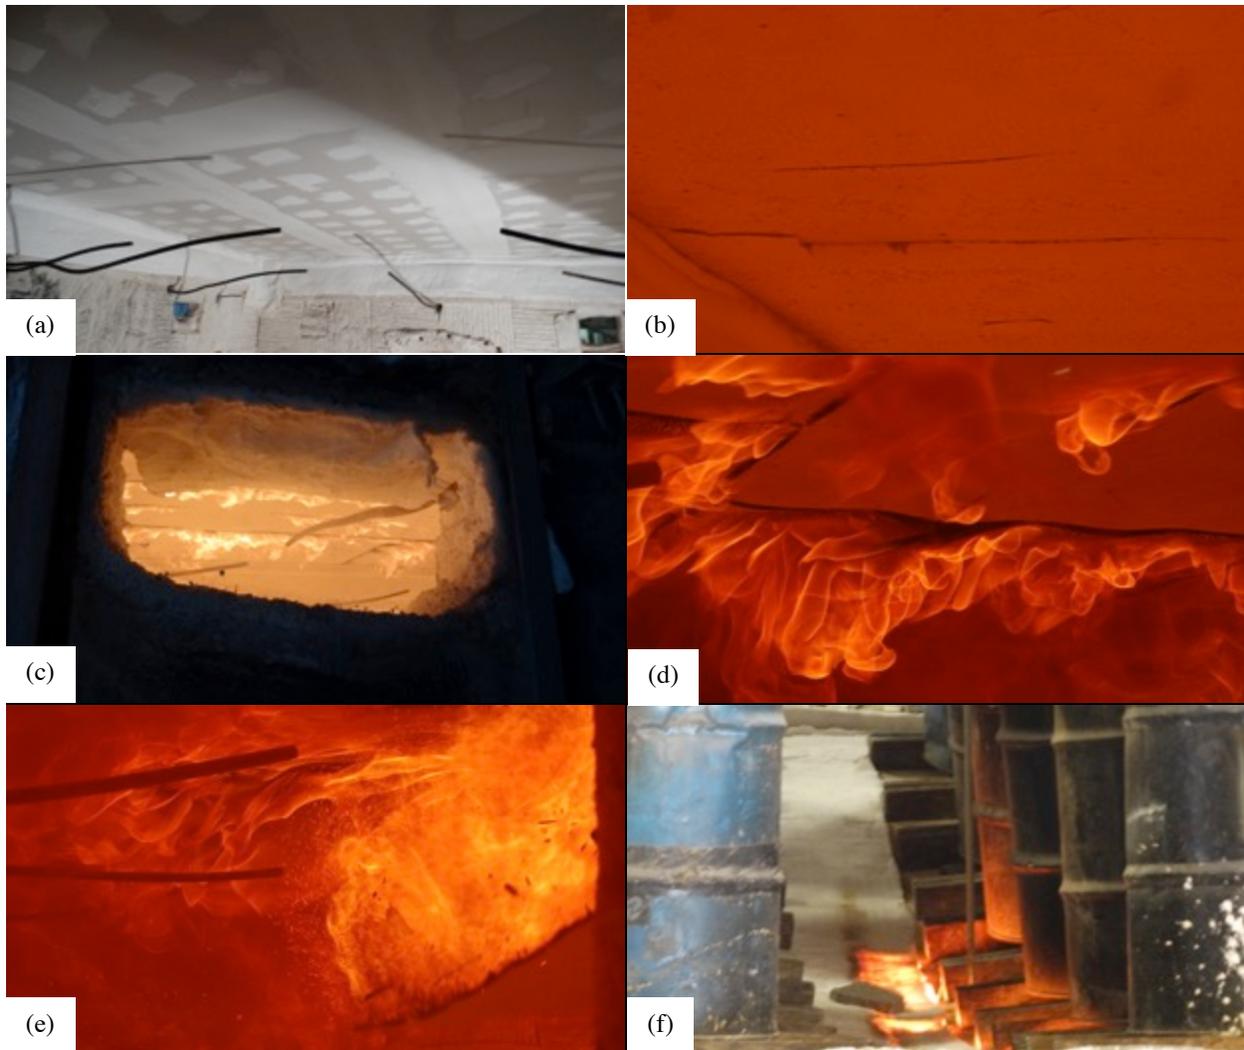
The test was terminated at 191 m 0 s, after the deflection was beyond 12" (189 m 42 s) and structural failure of the assembly was imminent. Also, sustained flames were observed on the unexposed surface near the joint at 190 m 0 s. Unsustained flames were observed at 185 min, but this was due to localized pressure increase from the water application to the furnace. Thus this assembly fulfilled the requirement of maintaining the applied load without passage of flame for 3 hr 10 m.

Figure 7. Test 1 floor assembly during test showing (a) before test, (b) field crack – 24 min, (c) flames – 33 min, (d) peeling – 49 min, (e) falling material – 63 min, and (f) glowing at spline joint – 190 min

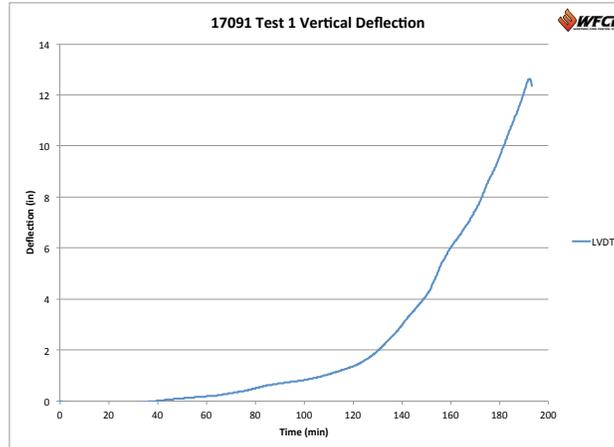
No significant floor deflection, as measured by the LVDT (Figure 10), was observed until 40 min into the test, after which deflection gradually increased until about 125 min into the test, after which the deflection began to increase significantly faster. The deflection surpasses 12” at 189 m 42 s, and the test was terminated shortly thereafter due to imminent collapse.

Figure 10. Test 1 deflection measurement near center of assembly.

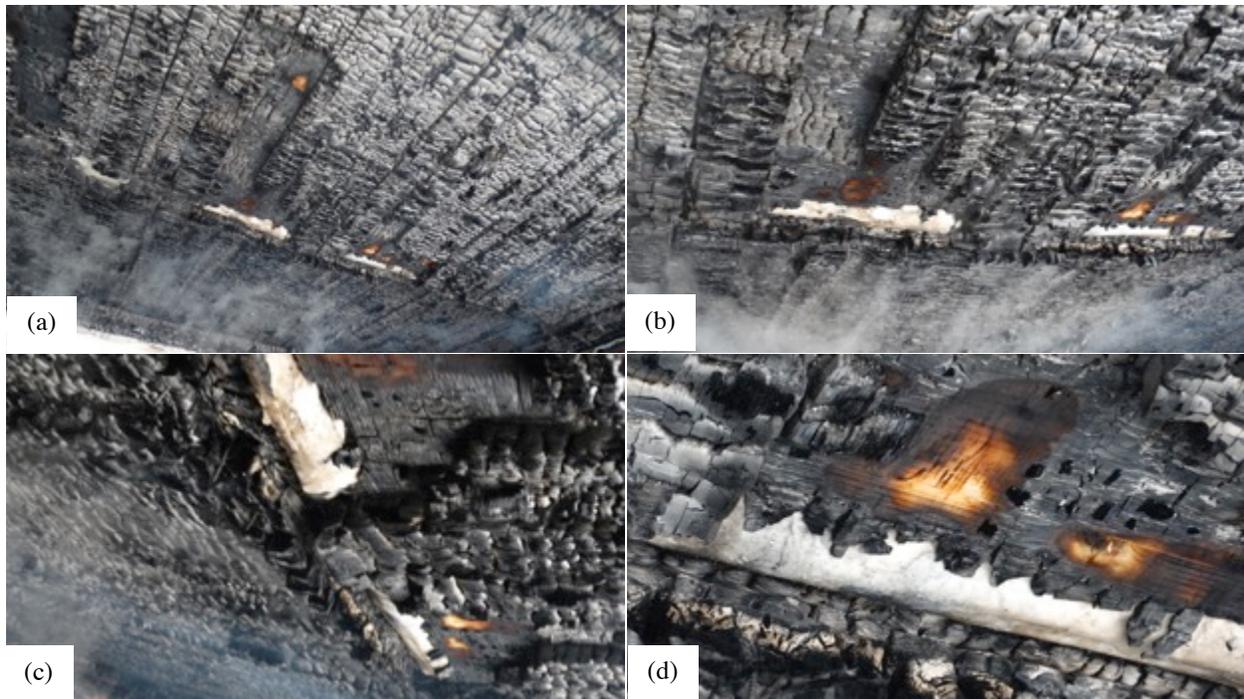
After the furnace was shut off at test termination, the floor was extinguished with water. The post-test examination showed charring into the 4th ply layer with the first three mostly fallen during the test (Figure 11). Charring was more significant at the spline joint.

Figure 11. Test 1 post-test assembly showing (a-b) overall assembly and (c-d) joint.

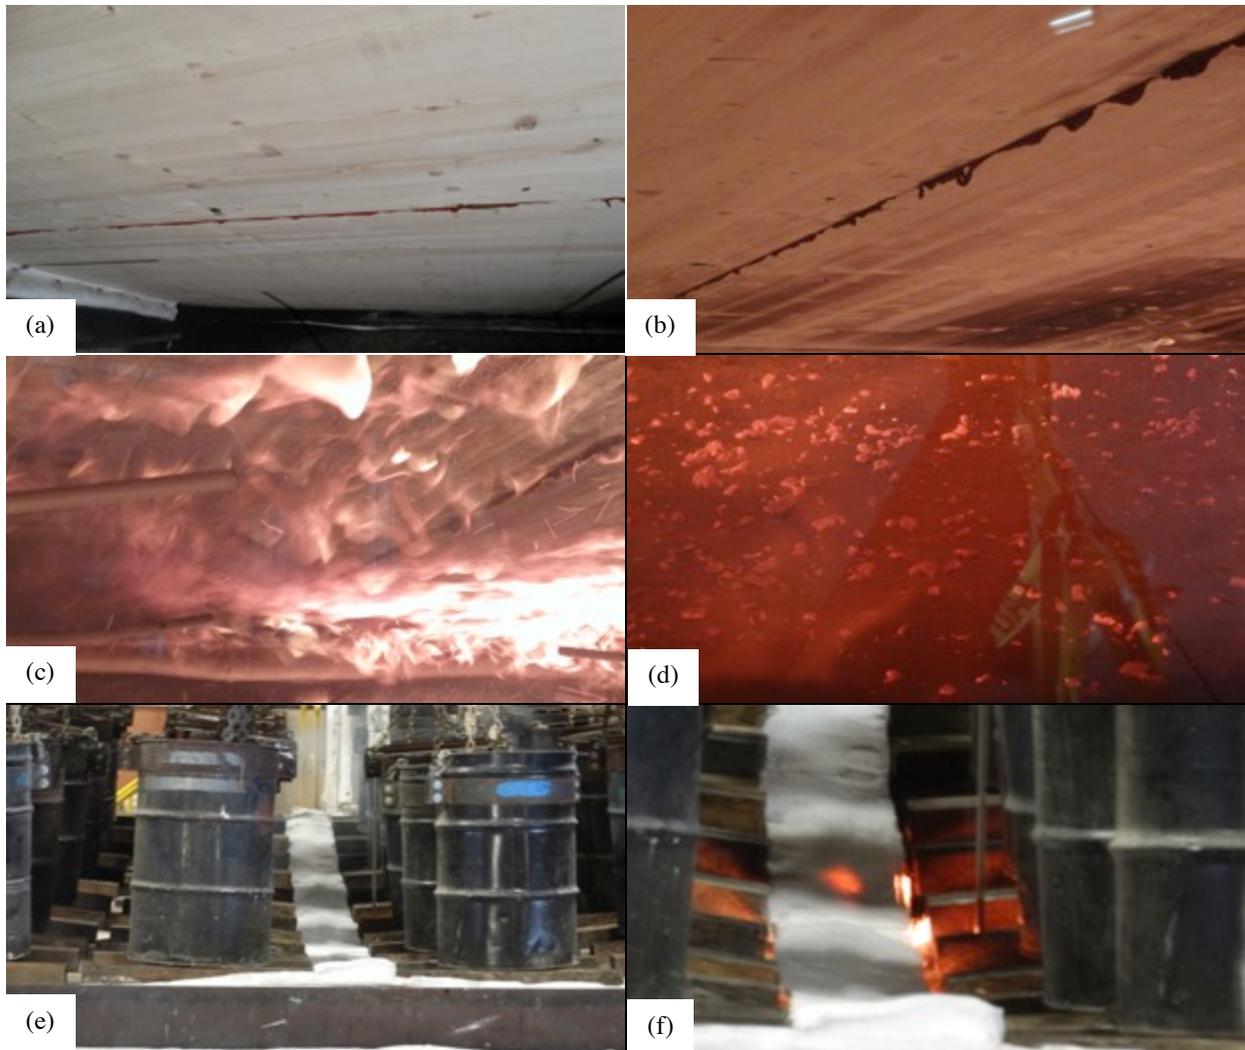
The test was terminated at 151 m 30 s, after the deflection was beyond 12” (149 m 24 s) and failure to the assembly was imminent. Also, sustained flames were observed on the unexposed surface near the joint at 149 m 20 s. Unsustained flames were observed at 140 min, but this was due to localized pressure increase from the water application to the furnace. Thus this assembly fulfilled the requirement of maintaining the applied load without passage of flame for 2 hr 29 m.

Figure 12. Test 2 floor assembly during test showing (a) before test, (b) darkening – 1 min, (c) flames – 5 min, (d) embers – 35 min, (e) deflection – 138 min, and (f) sustained flames – 149 min.

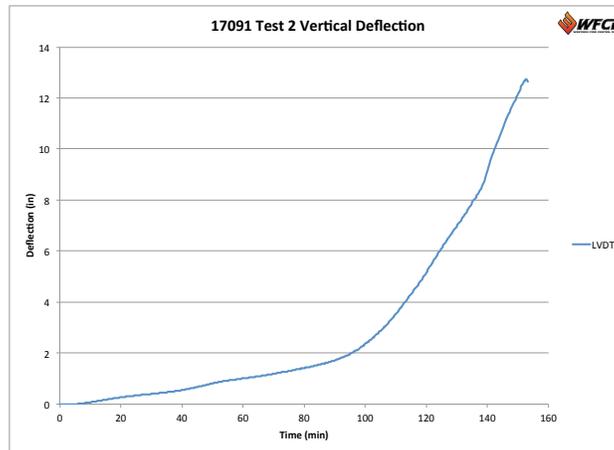
No significant floor deflection, as measured by the LVDT (Figure 15), was observed until 5 min into the test, after which deflection gradually increased until about 100 min into the test, after which the deflection began to increase significantly faster. The deflection surpassed 12” at 149 m 24 s, and the test was terminated shortly thereafter due to imminent collapse.

Figure 15. Test 2 deflection measurement near center of assembly.

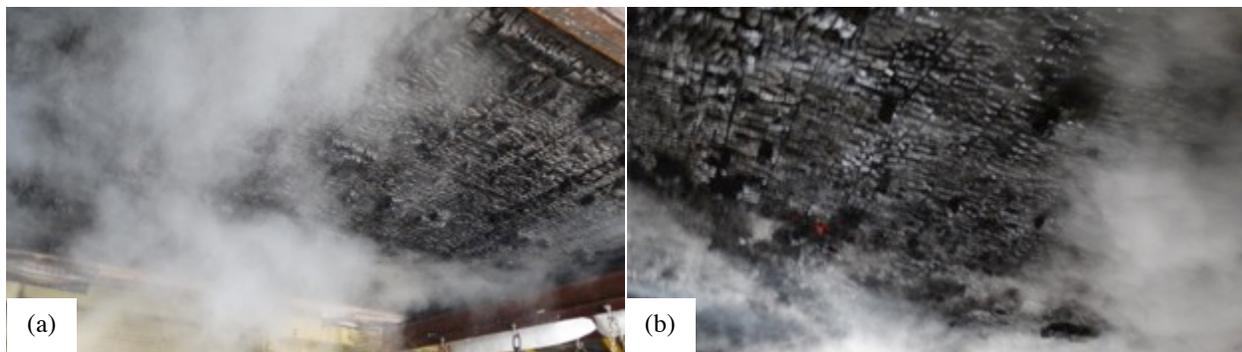
After the furnace was shut off at test termination, the floor was extinguished with water. The post-test examination showed charring into the 4th ply layer with the first three mostly fallen during the test (Figure 16). Charring was more significant at the spline joint.

Figure 16. Test 2 post-test assembly showing (a-b) overall assembly.

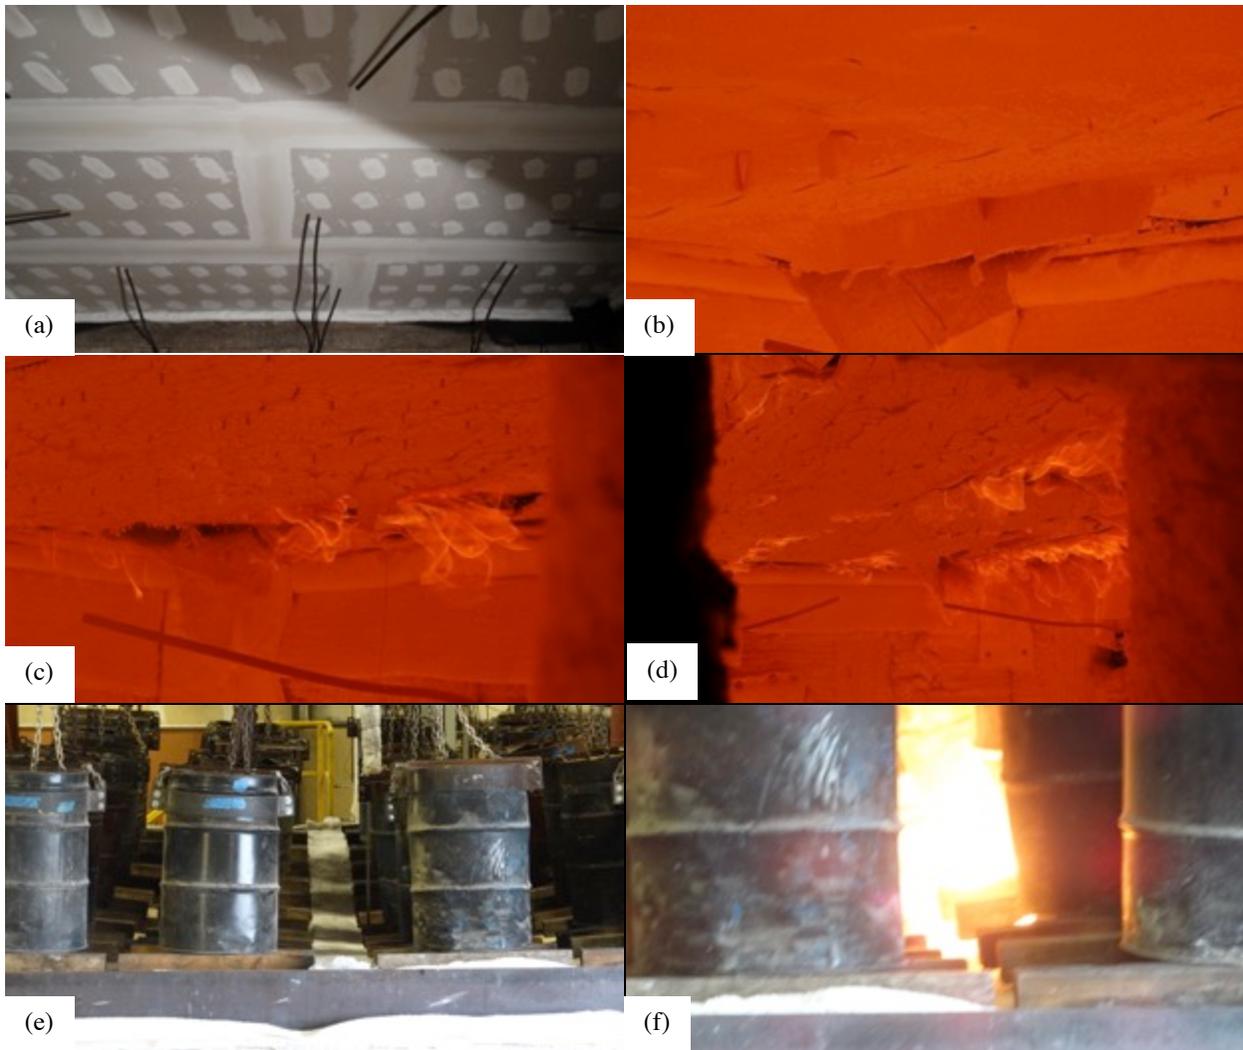
The test was terminated at 276 m 40 s, after the deflection was beyond 12” (276 m 31 s) and failure to the assembly was imminent. The assembly collapsed during extinguishment. Also, sustained flames were observed on the unexposed surface near the joint at 276 m 0 s. Unsustained flames were observed at 266 min, but this was due to localized pressure increase from the water application to the furnace. Thus this assembly fulfilled the requirement of maintaining the applied load without passage of flame for 4 hr 36 m.

Figure 17. Test 3 floor assembly during test showing (a) before test, (b) fallen face layer – 98, (c) fallen middle layer – 128 min, (d) increasing flames – 134 min, (e) bowed floor – 273 min, and (f) flames – 277 min.

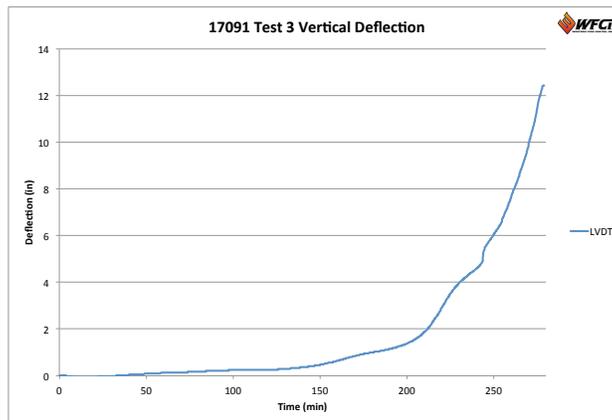
No significant floor deflection, as measured by the LVDT (Figure 20), was observed until 125 min into the test, after which deflection gradually increased until about 210 min into the test, after which the deflection began to increase significantly faster. The deflection surpassed 12" at 276 m 31 s, and the test was terminated shortly thereafter due to imminent collapse. The assembly did indeed collapse during extinguishment at 278 m 9 s.

Figure 20. Test 3 deflection measurement near center of assembly.

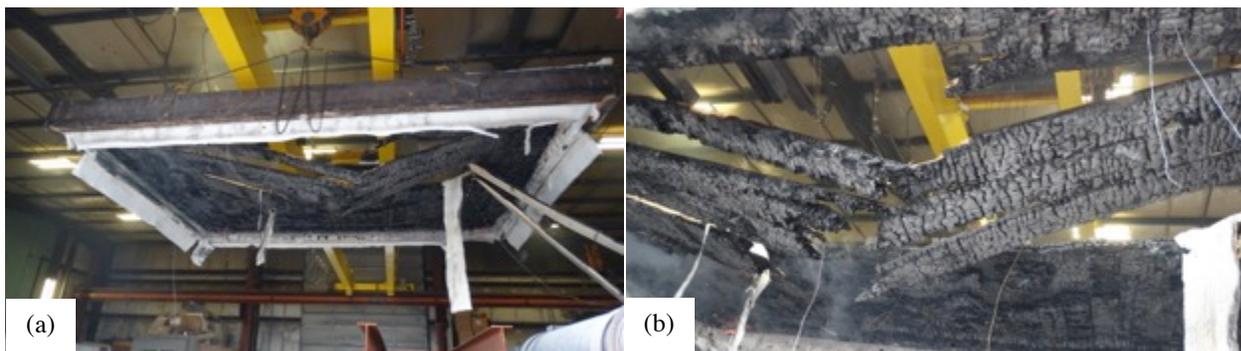
After the furnace was shut off at test termination, the floor was extinguished with water during which the west side of the assembly collapsed. The post-test examination showed some charring into the 4th and 5th ply layers with the first three mostly fallen during the test (Figure 21). Charring was more significant at the spline joint.

Figure 21. Test 3 post-test assembly showing (a) overall assembly and (b) fractured panel.
