Cyclic tests¹ of engineered shearwalls considering different plate washer sizes

Prepared for: American Forest & Paper Association (AF&PA)

Prepared by: David Rosowsky, Lori Elkins, and Cameron Carroll

Rev. 5/19/2004

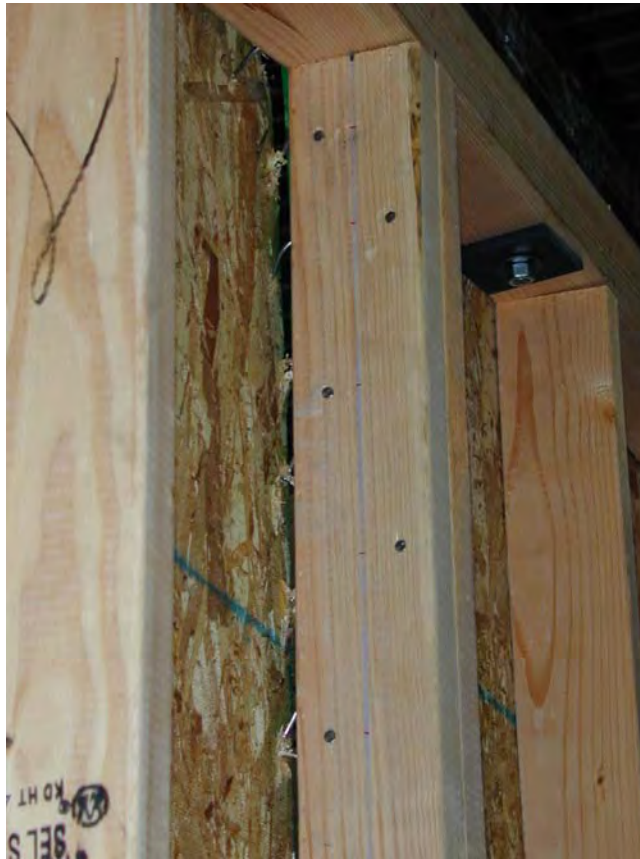
Figure 5. Fastener pull-out at panel edges along center stud (Specimen A1)

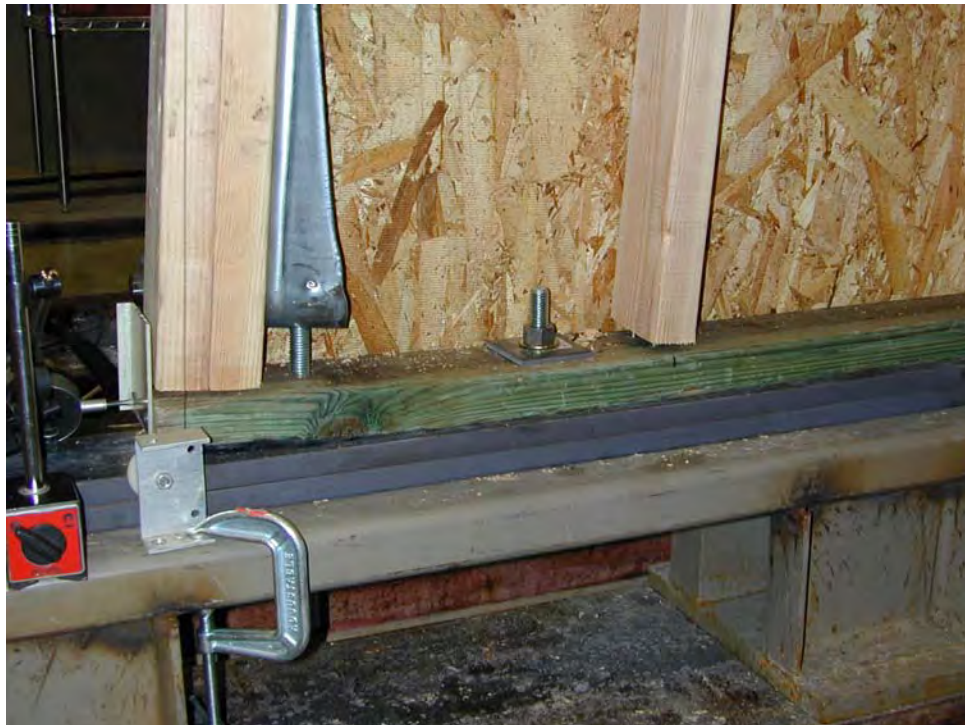
Figure 6. Uplift of sole plate at hold-down (Specimen A1)

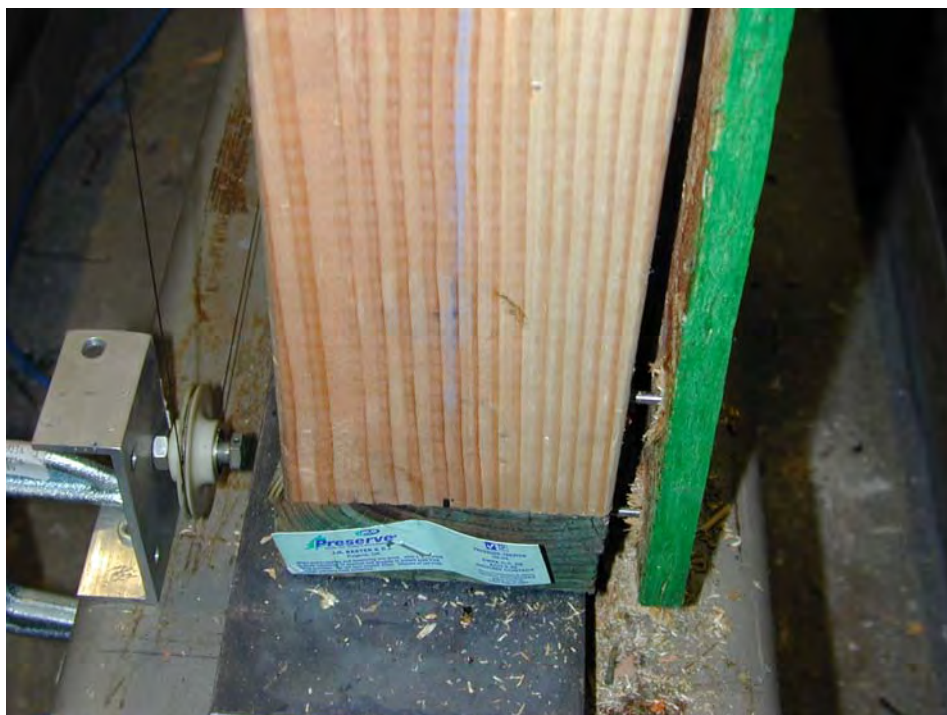
Figure 7. Sheathing pull-away at corner (Specimen A1)

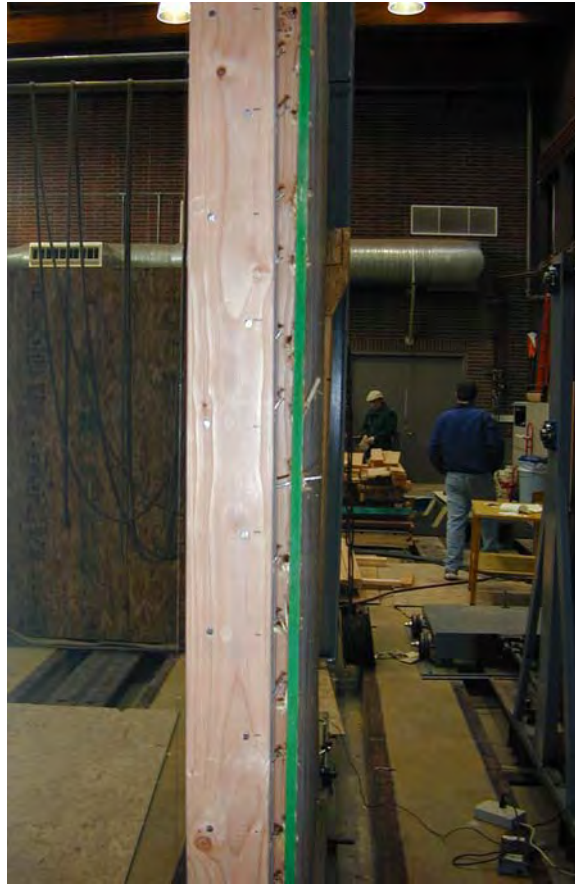
Figure 8. Sheathing edge pull-out (Specimen A2)

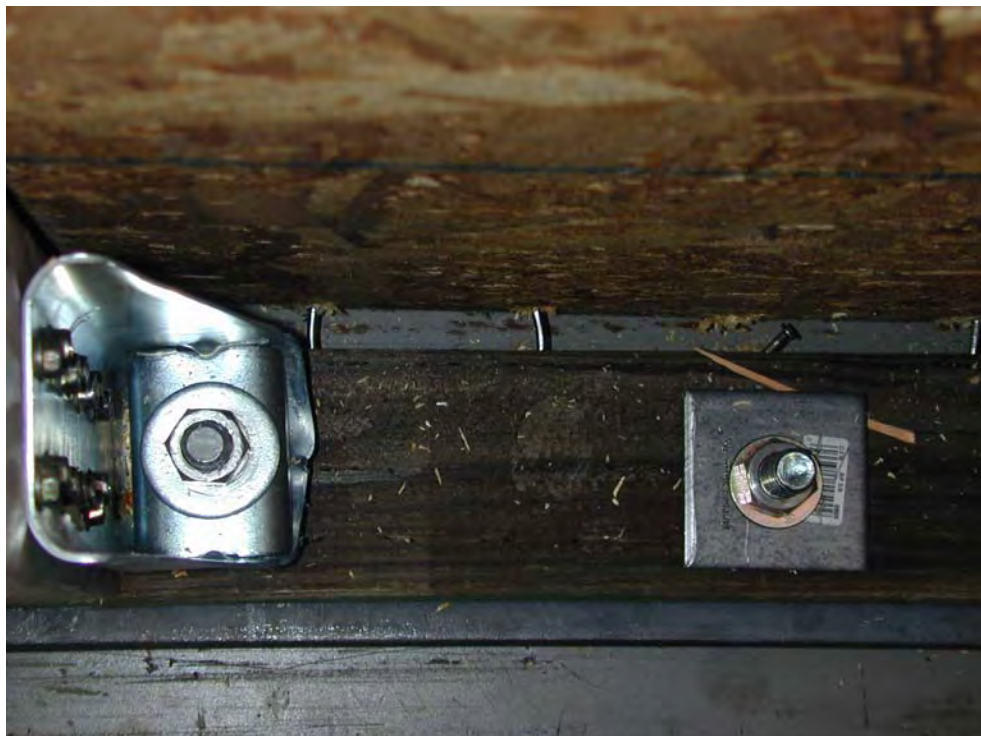
Figure 9. Sole plate after failure, no splitting (Specimen A2)

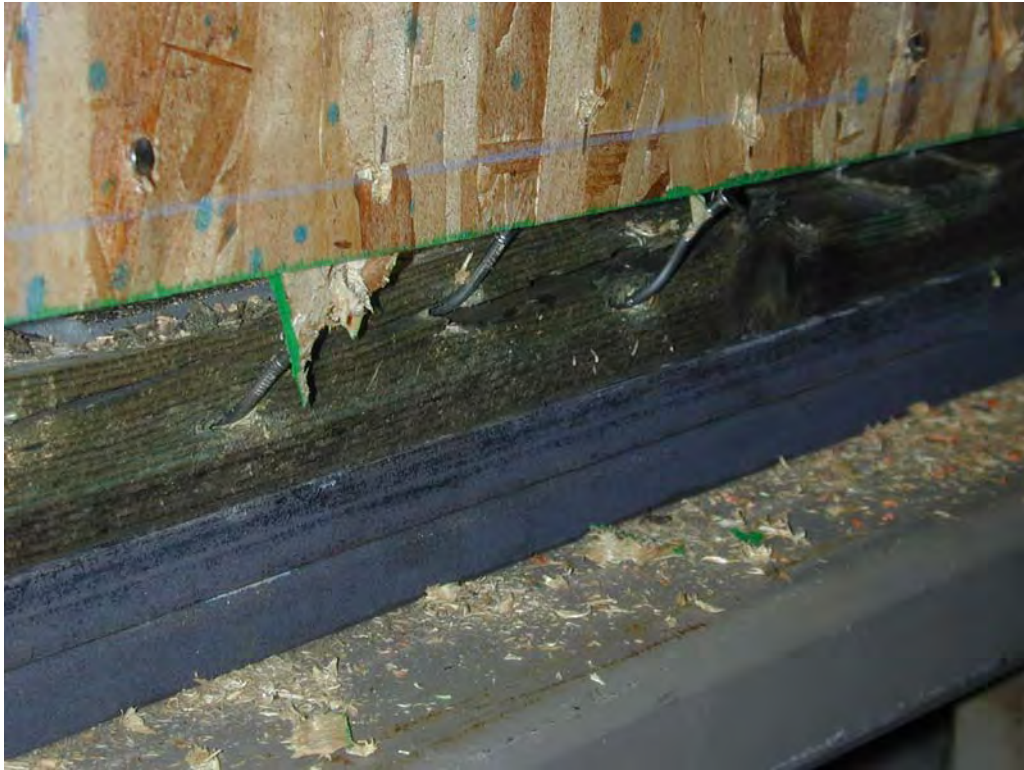
Figure 10. Fastener failure at sole plate, nail bending/ripping through sheathing (Specimen A3)

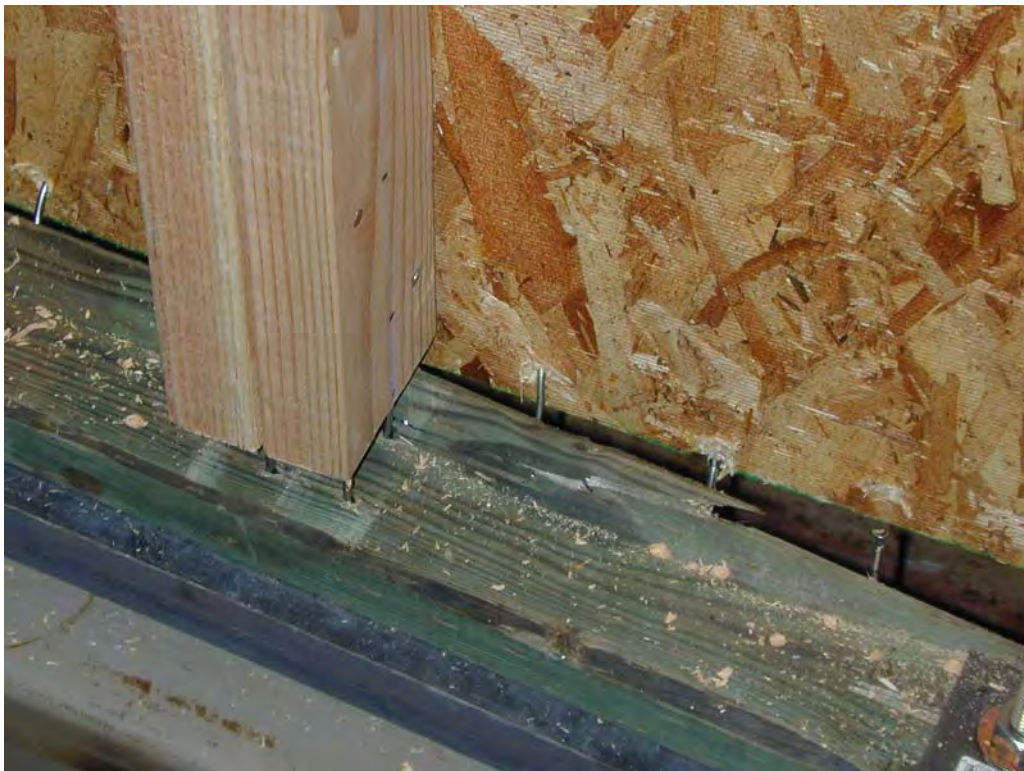
Figure 11. Failure at bottom of wall, some splitting of sole plate (Specimen A3)

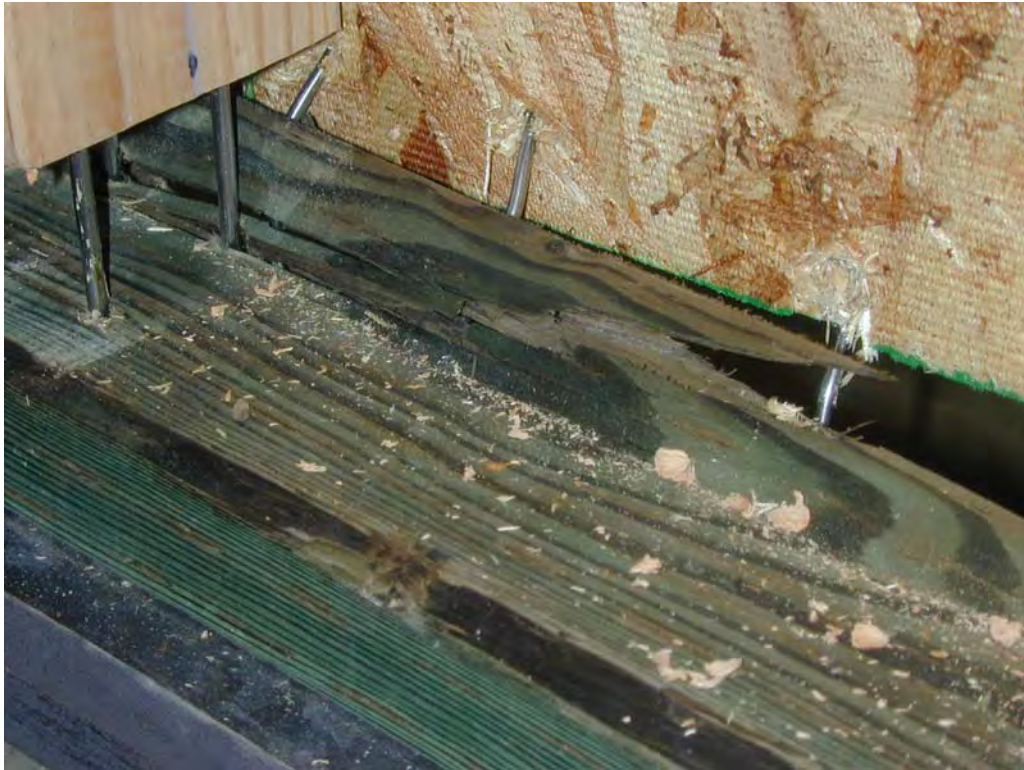
Figure 12. Close-up of sole plate splitting (Specimen A3)

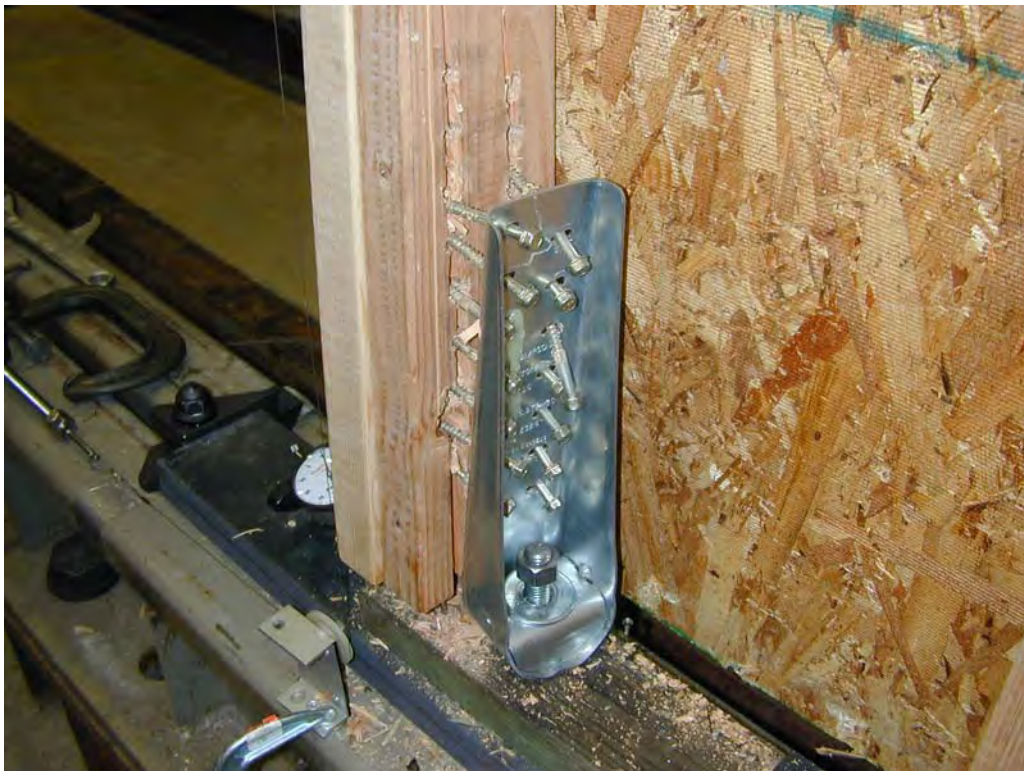
Figure 13. End stud failure at hold-down (Specimen B1)

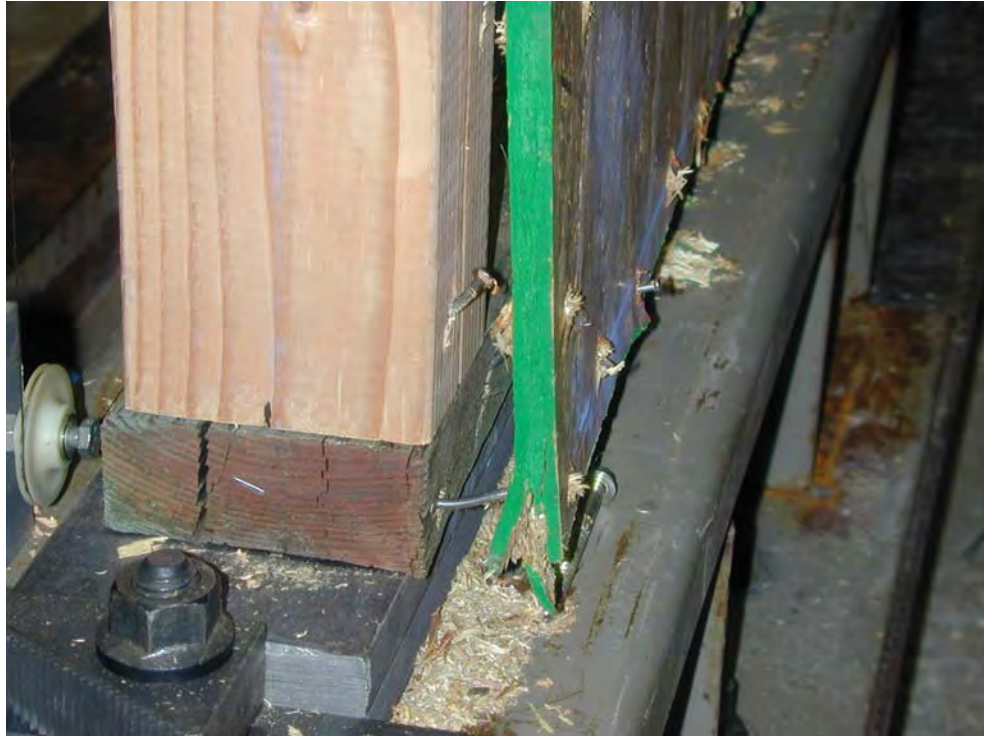
Figure 14. Failure showing split at end of sole plate (Specimen B1)

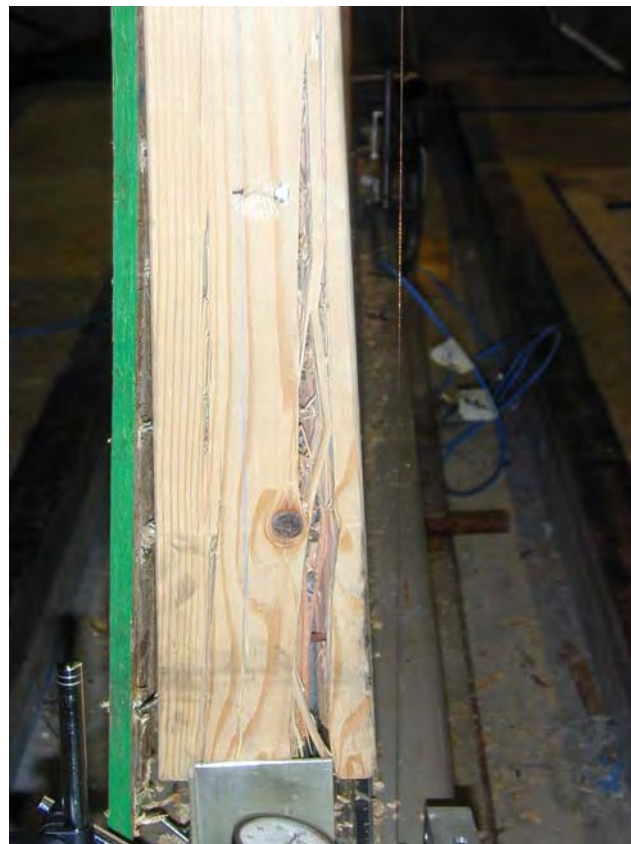
Figure 15. End stud failure (Specimen B1)

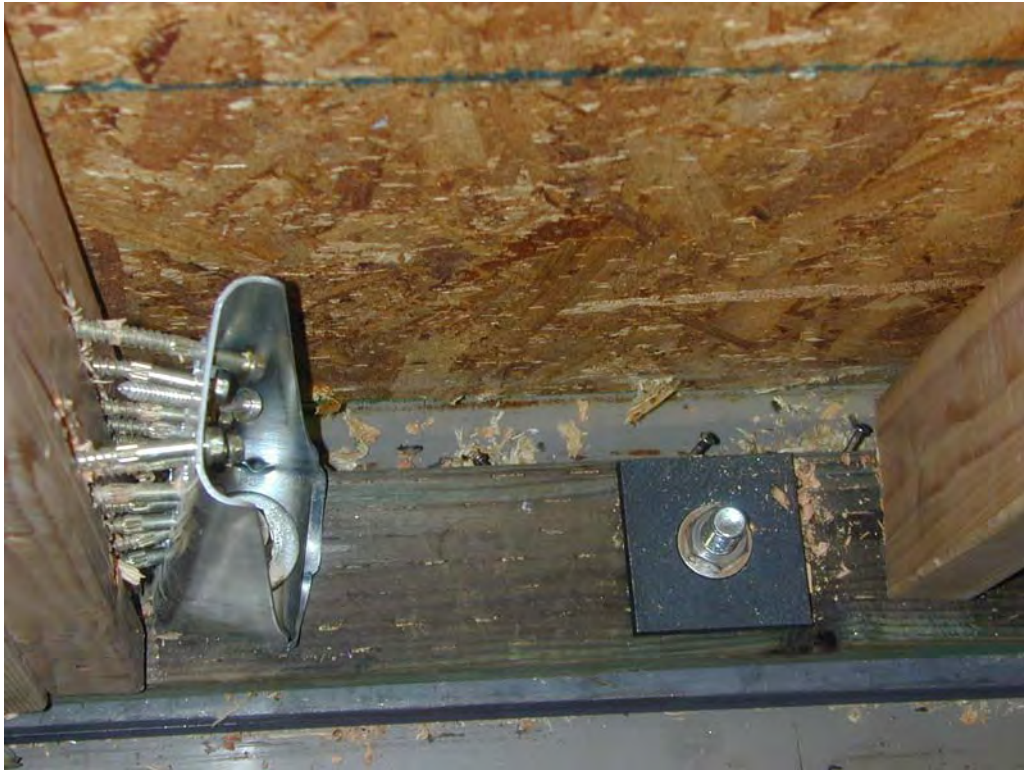
Figure 16. Multiple failures, but no splitting of sole plate (Specimen B1)

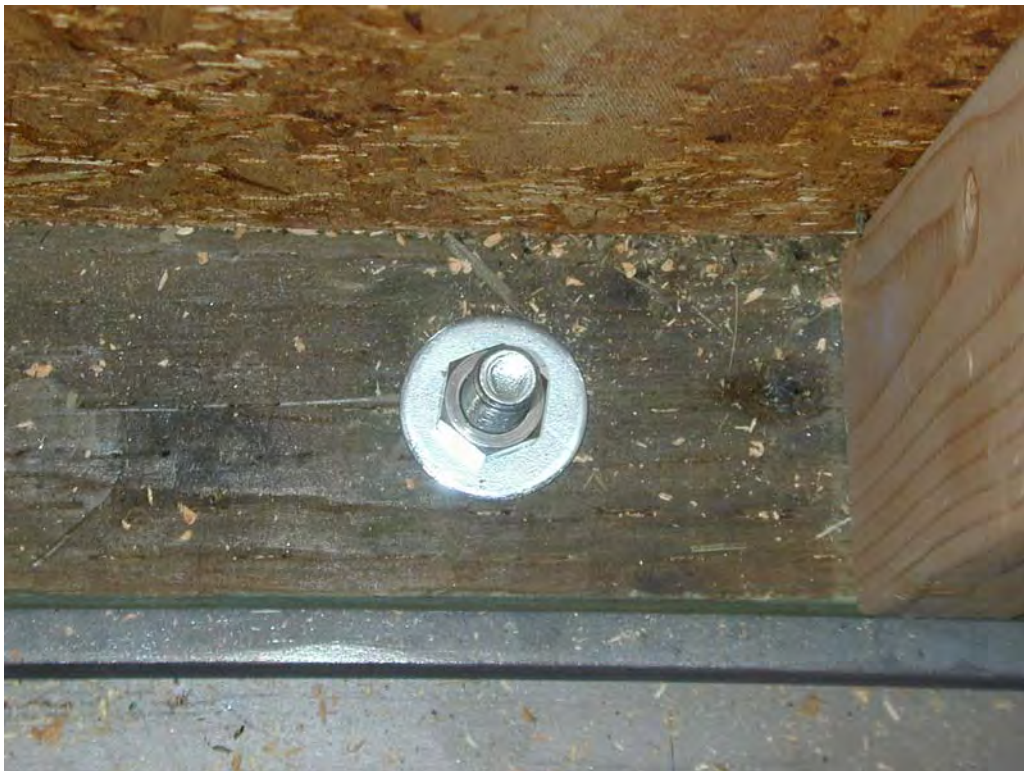
Figure 17. Start of a split in sole plate (Specimen C1)

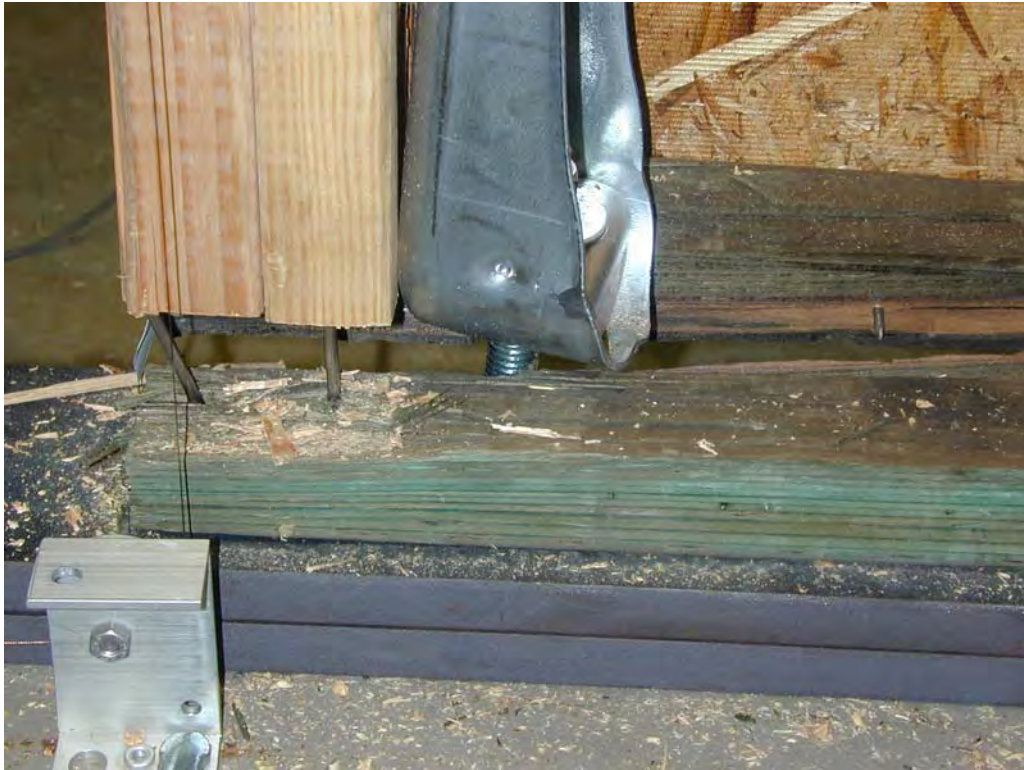
Figure 18. Sole plate splitting at hold-down (Specimen C1)

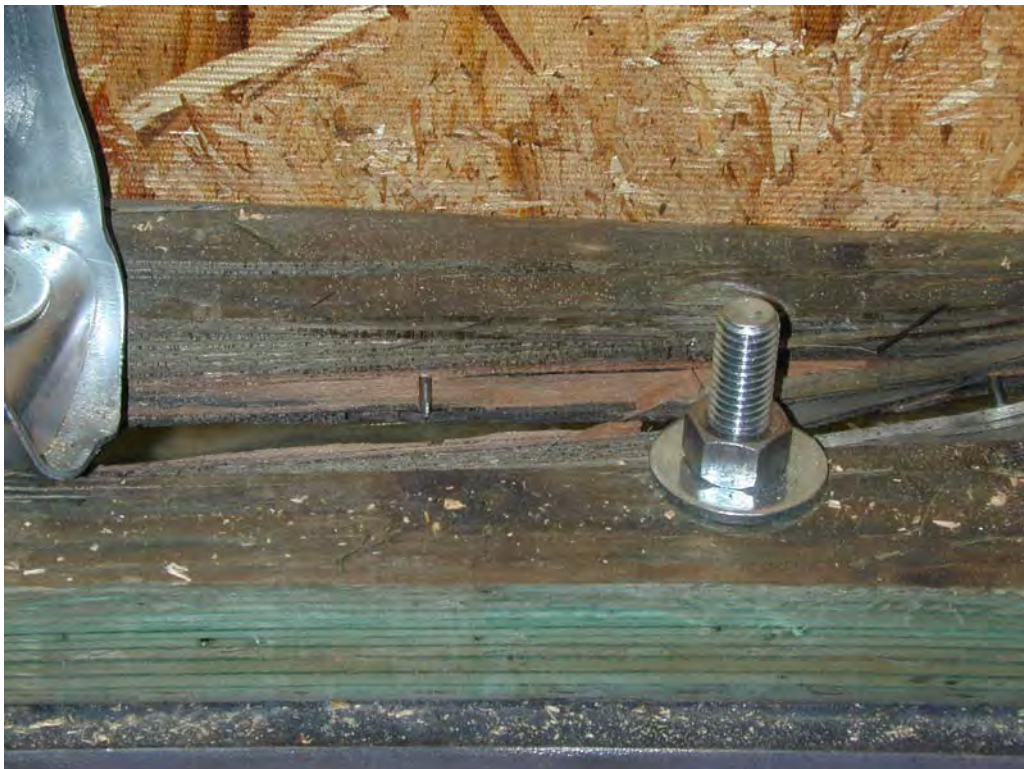
Figure 19. Sole plate splitting from hold-down to first washer location; no bending of washer (Specimen C1)

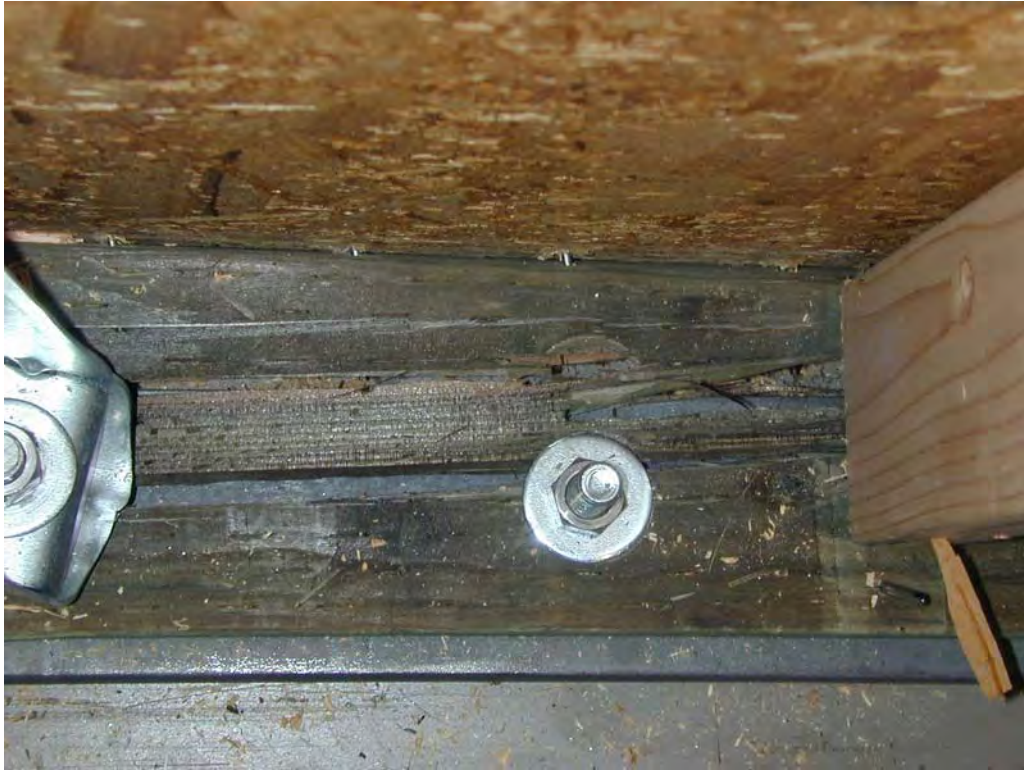
Figure 20. Top view of sole plate splitting from hold-down to first washer (Specimen C1)

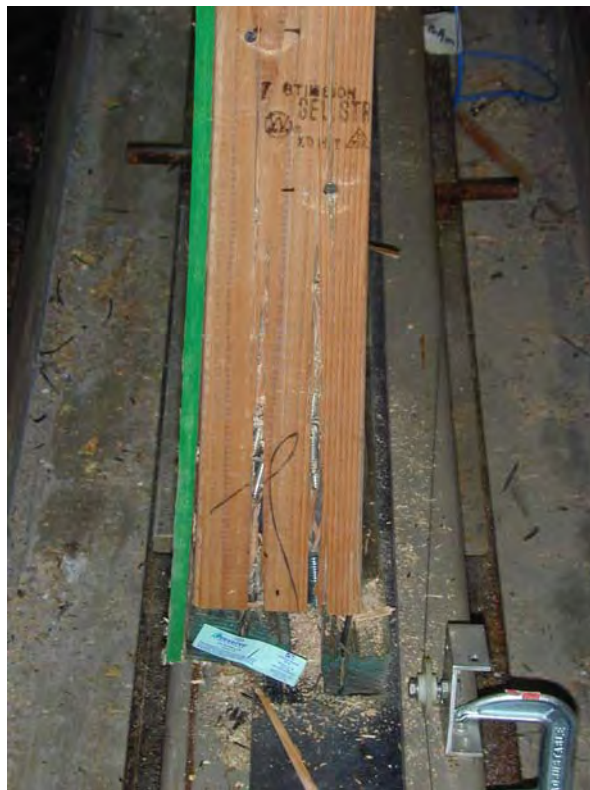
Figure 21. End stud and sole plate failures (Specimen C1)

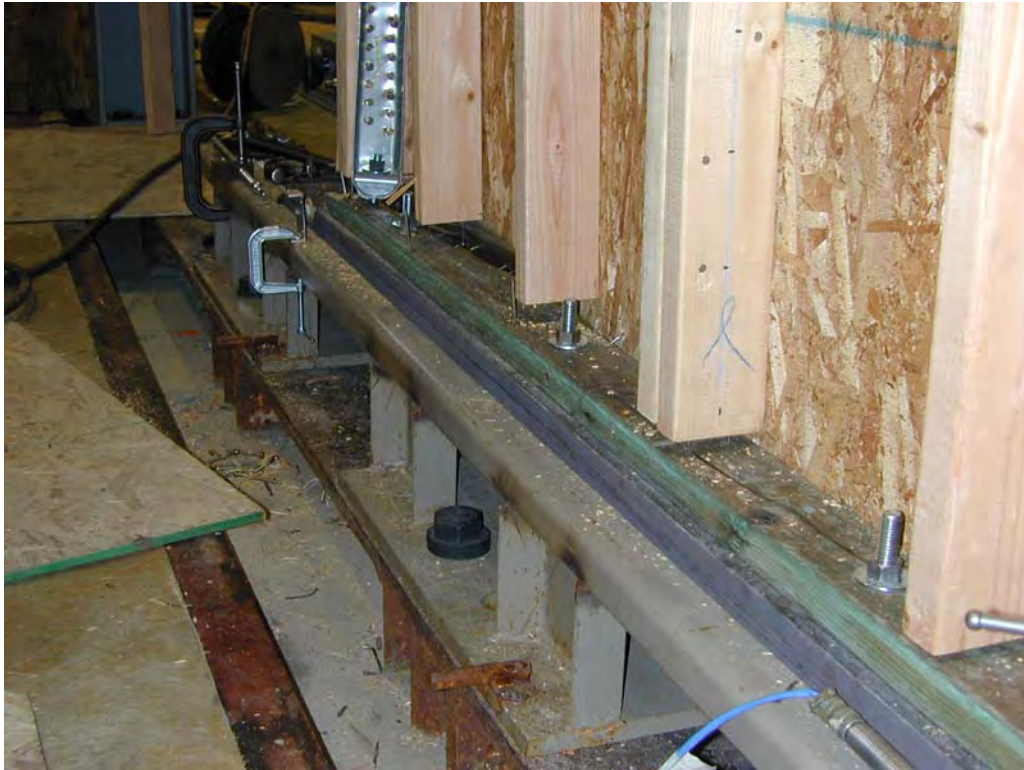
Figure 22. Sole plate split along its length (Specimen C1)

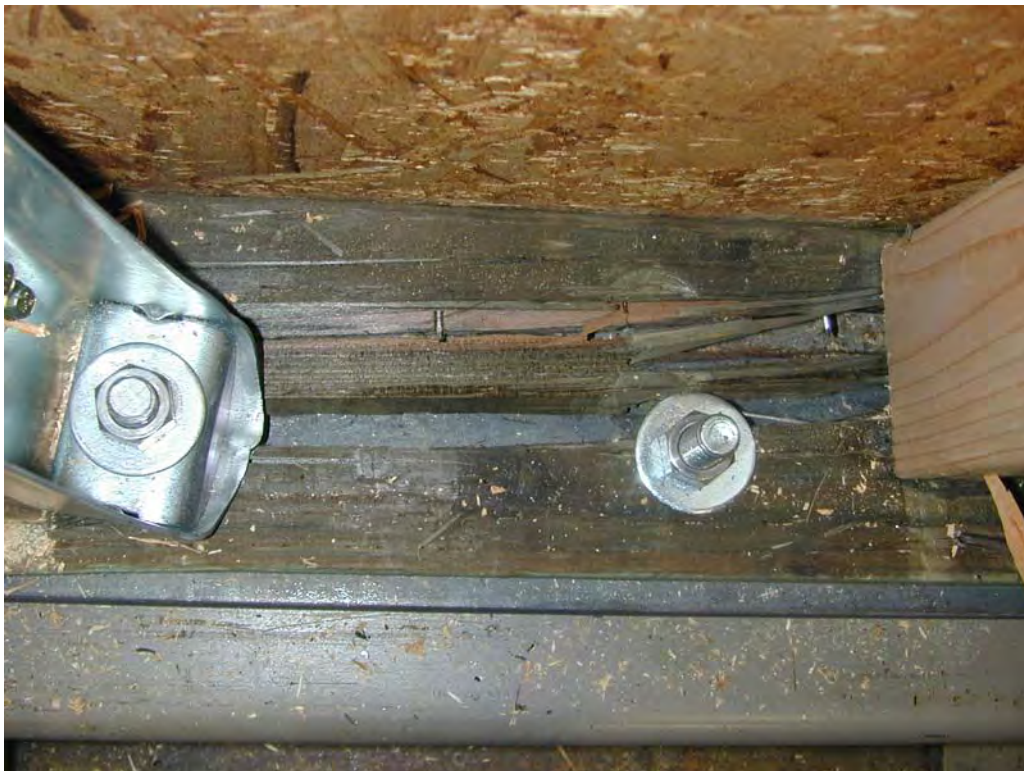
Figure 23. Multiple slits at sole plate (Specimen C1)

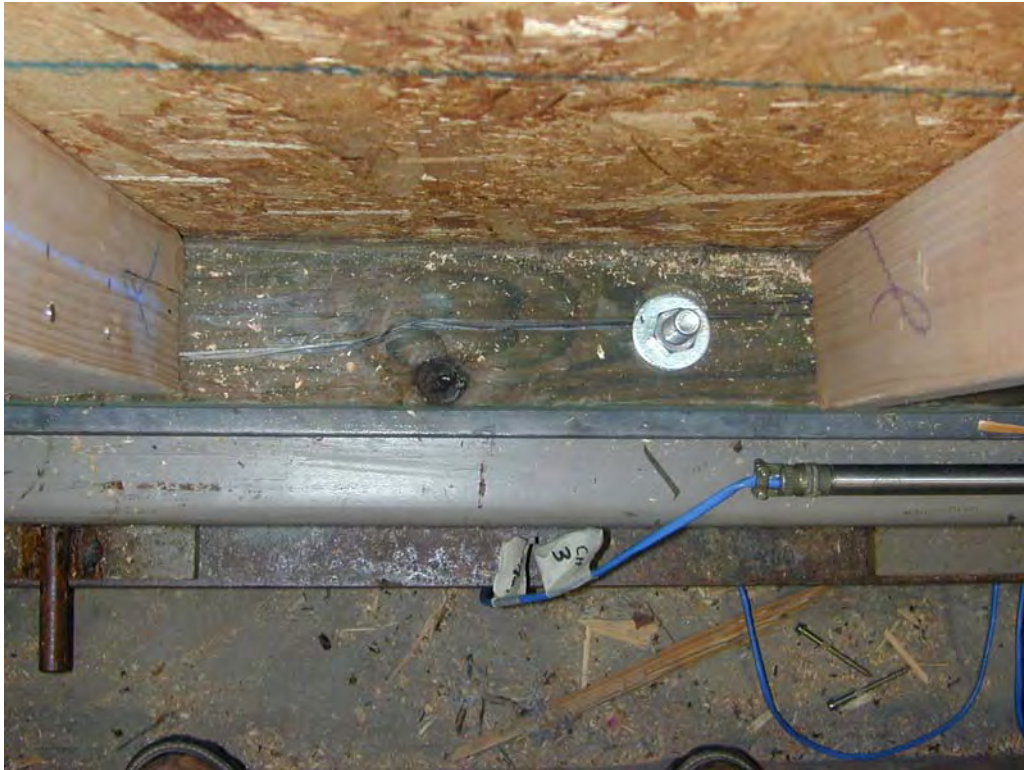
Figure 24. Sole plate split between interior studs (Specimen C1)

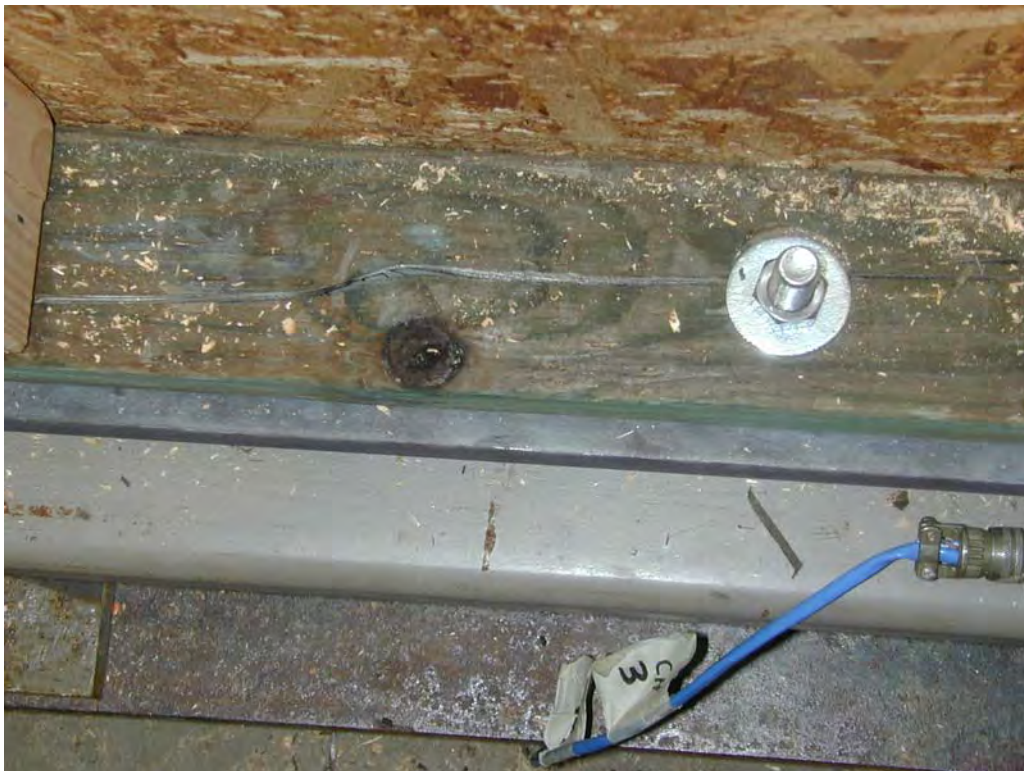
Figure 25. Sole plate split through interior bolt location (Specimen C1)

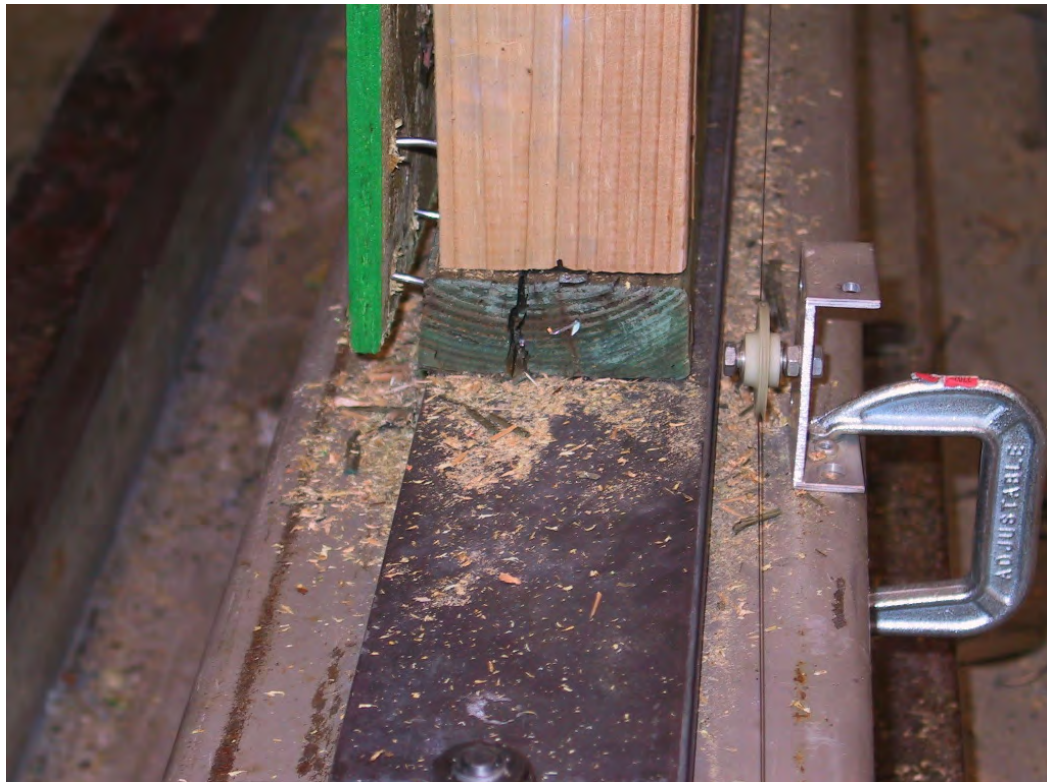
Figure 26. Failure at end of wall showing sole plate splitting (Specimen C2)

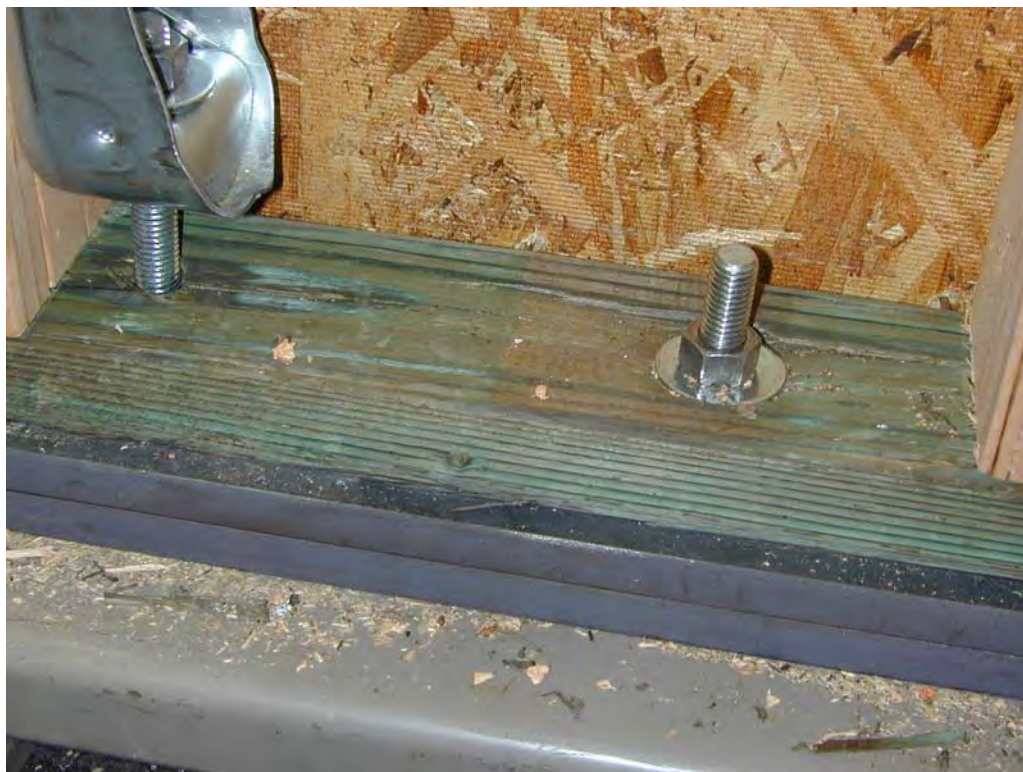
Figure 27. Anchor bolt showing slight embedment (but no bending) of washer (Specimen C3)

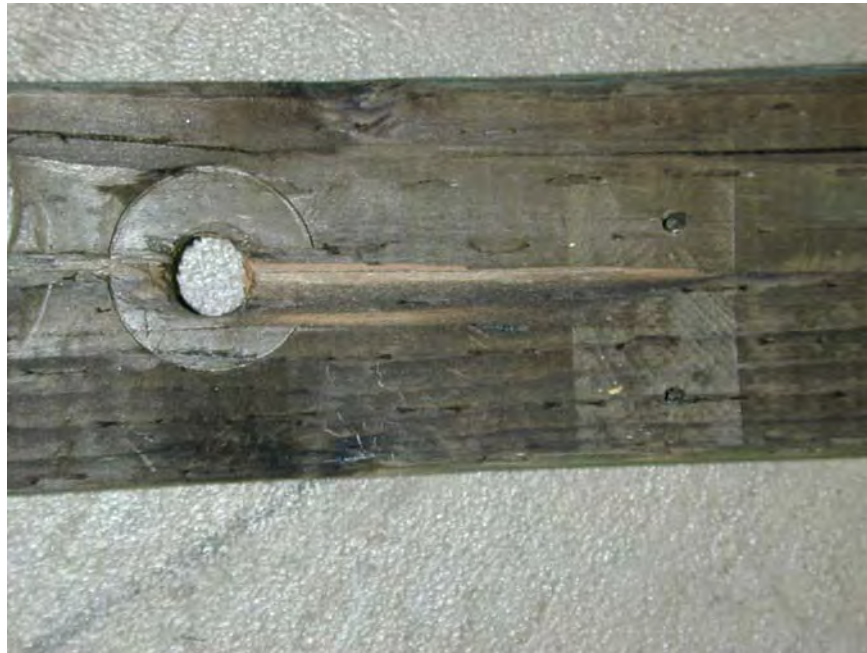
Figure 28. Sole plate (post-test) showing washer embedment (Specimen C2)

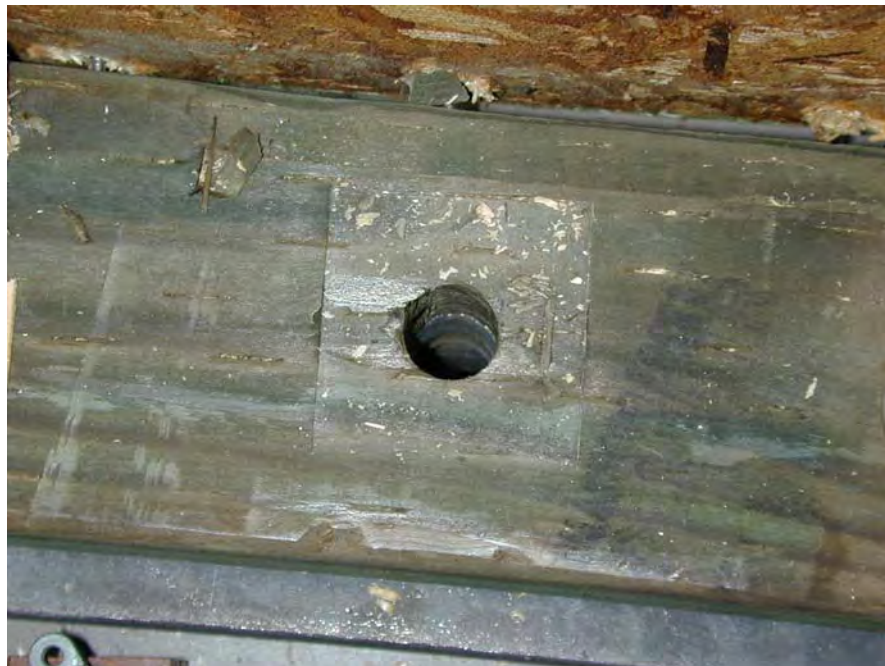
Figure 29. Sole plate (post-test) showing slight washer embedment (Specimen D2)

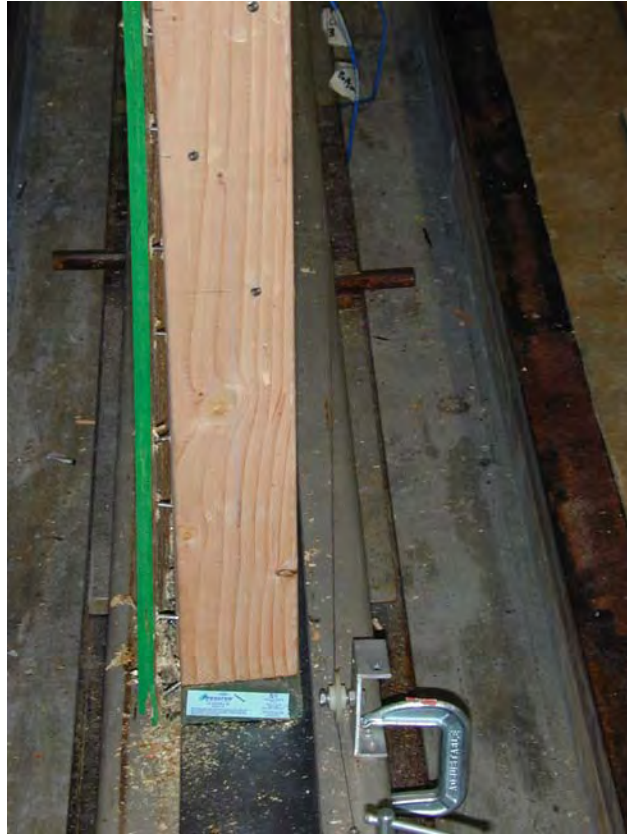
Figure 30. Sheathing separation from framing (Specimen D2)

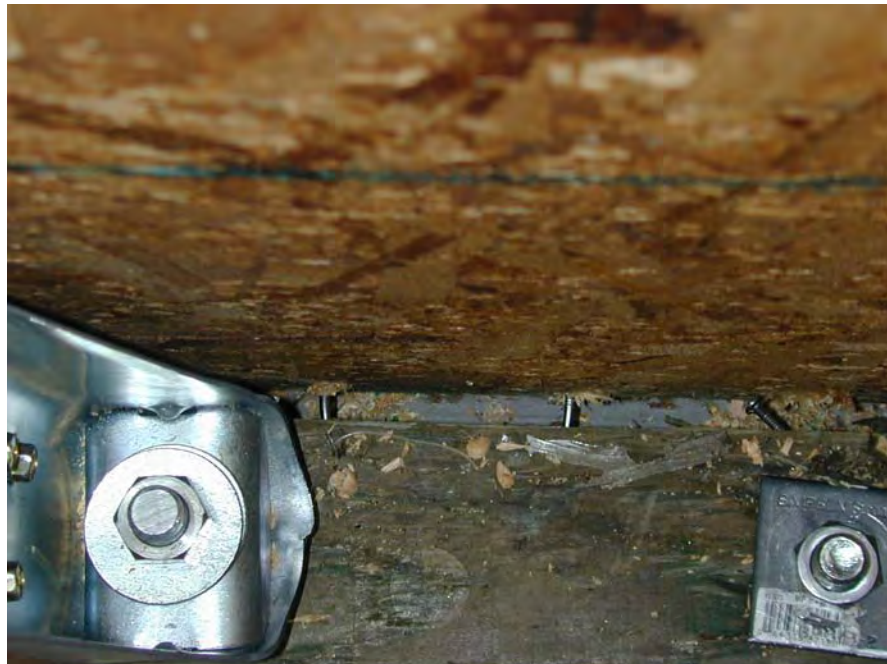
Figure 31. Sheathing separation from bottom plate, showing bolted anchor and hold-down (Specimen D3)
