Summary Report

Fire Safe implementation of visible mass timber in tall buildings – compartment fire testing

RISE Report 2020:94

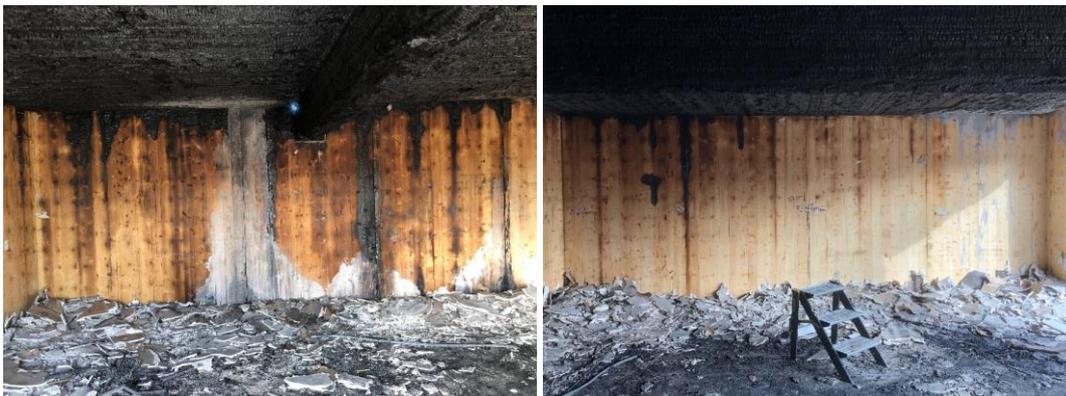
Figure 13 and Figure 14 show photos of CLT surfaces after removal of the gypsum after Test 1 (2 gypsum board layers). Local charring was seen, especially in locations near the intersection of walls and the exposed ceiling and in some lap joints between two wall panels. Figure 15 shows the top of the back wall after removal of the ceiling. The right picture shows the location of the most significant charring that took place in a lap joint. As indicated before in Figure 5, there was no fire sealant applied at the interface between the gypsum boards and the ceiling of Test 1. In all other tests a fire sealant adhesive was used in this location only at locations where a gap was visible between the outer boards and the ceiling. The location of the local maximum char depths on gypsum protected surface after Test 1 was determined and indicated in the char diagram of Section 4.5. Figure 16 and Figure 17 show the CLT surface after removal of the gypsum boards for Test 2 to 5. It should be noted that the gypsum boards in Test 2 and 3 were removed by the local fire brigade with water mist, which left stains and some damage of wood grains. Water mist was used to identify alternative techniques to extinguish potential smoldering behind the gypsum boards using less water than conventional methods.

Figure 13: **Test 1**, Back wall (left) and right wall (right) after removal of the 2 gypsum board layers.

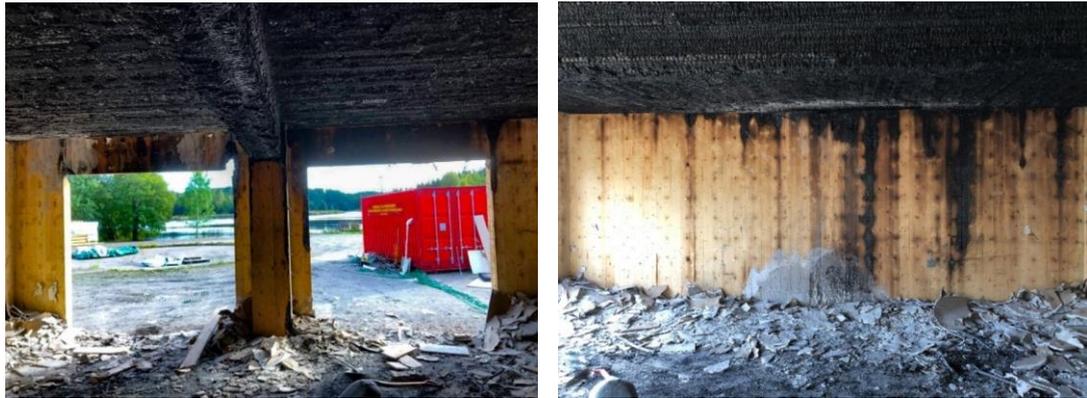
Figure 14: **Test 1**, Front wall (left) and left wall (right) after removal of the 2 gypsum board layers.

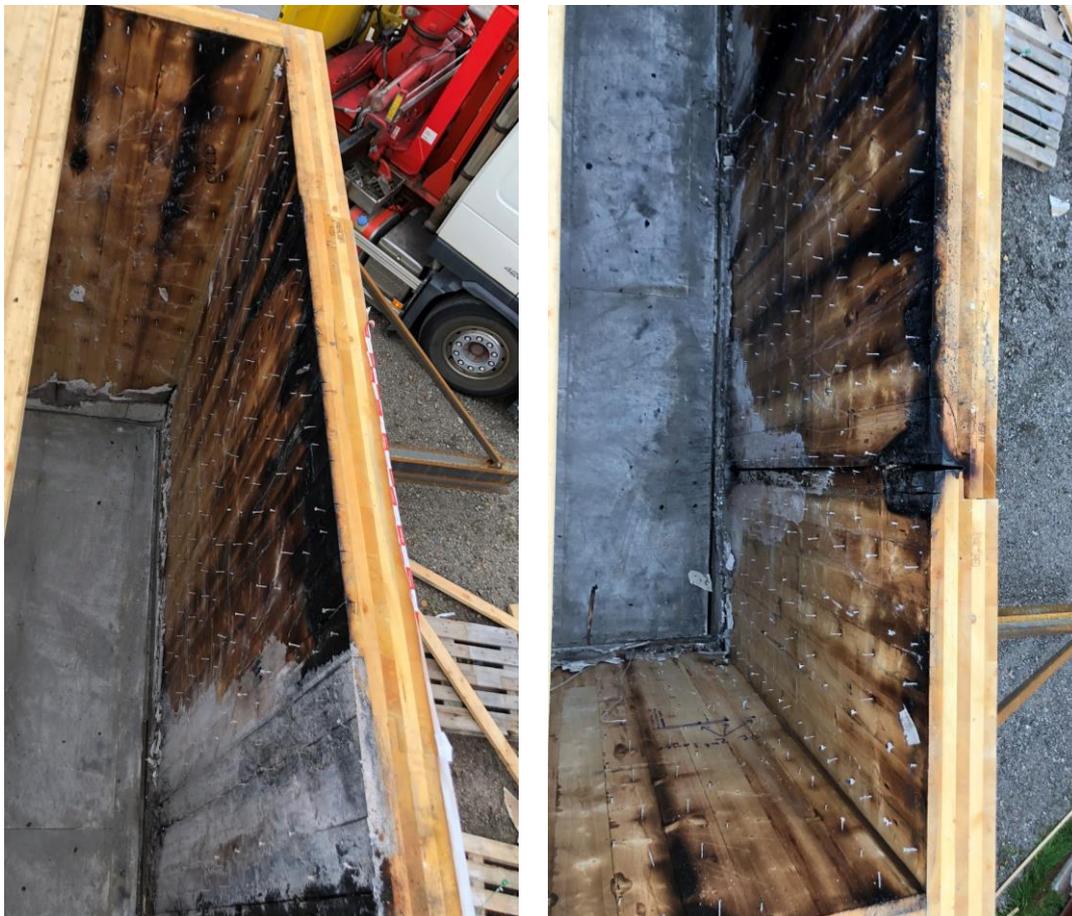
Figure 15: **Test 1**, Top of back wall after removal of ceiling.

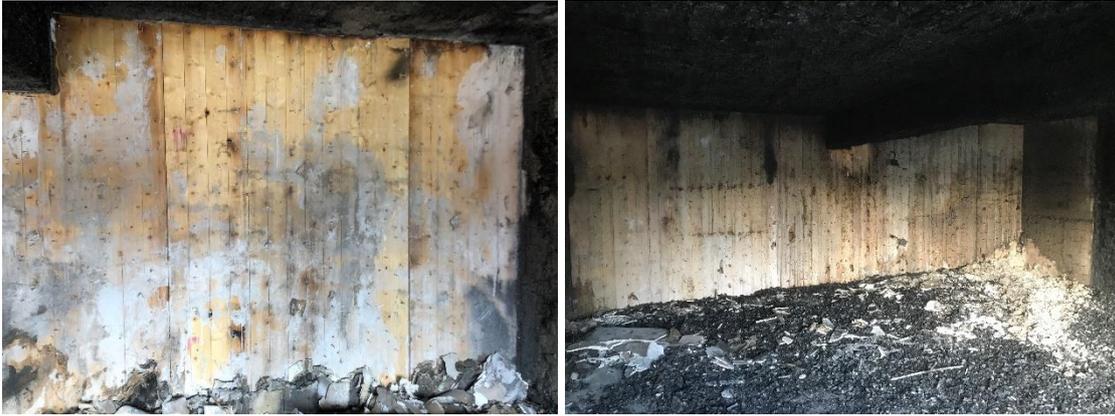
Figure 16: Protected walls of **Test 2** (left) and **Test 3** (right) of left wall after removal of the 3 gypsum board layers.

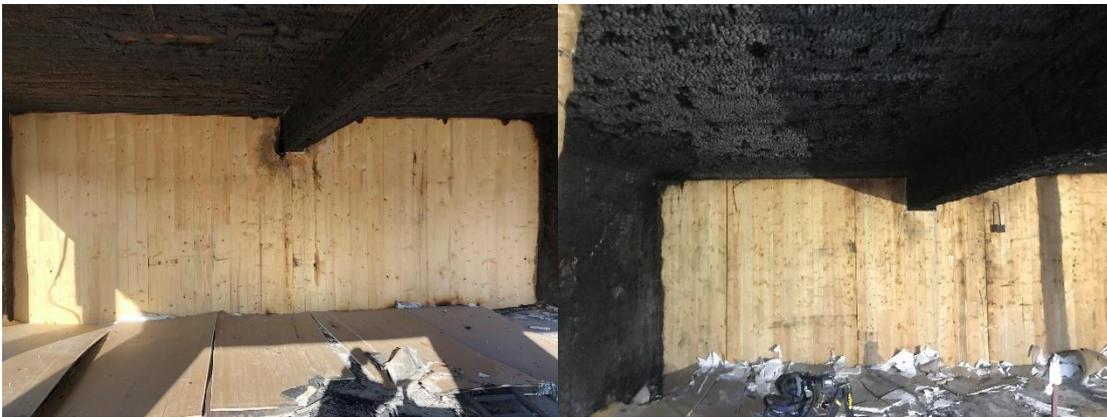
Figure 17: Protected walls of **Test 4** (left, 2 GB layers) and **Test 5** (right, 3 GB layers) after removal of gypsum boards.

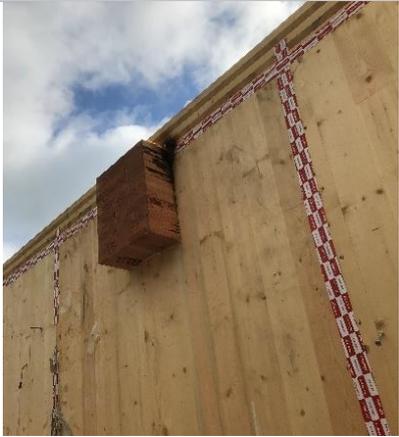
Location	Description	Images
Test 1	Beam-wall joint at back wall	<p>Minor flaming at one of the top corners of the beam at the location where the beam penetrated the back wall.</p> <p>Note: the rectangular hole in the CLT was made on site using a hand-held reciprocating (tiger) saw. The geometrical imperfections are not representative for factory made cuts.</p> <p>Some fire sealing adhesive, but no construction tape or expanding tape was used at this detail.</p>

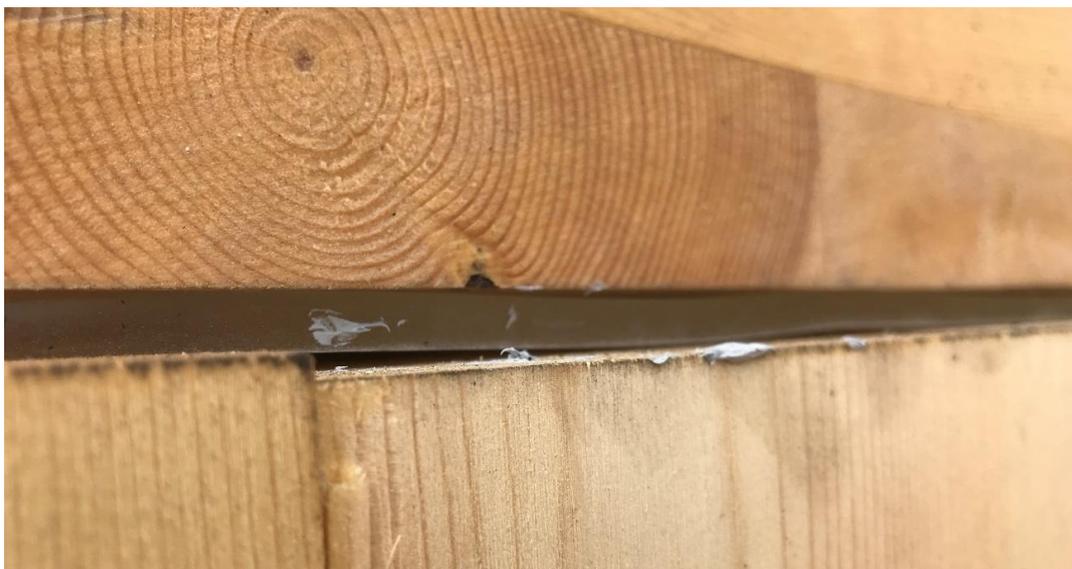
Figure 27: Location of imperfect detail at wall-ceiling joint with a resilient profile identified before the test

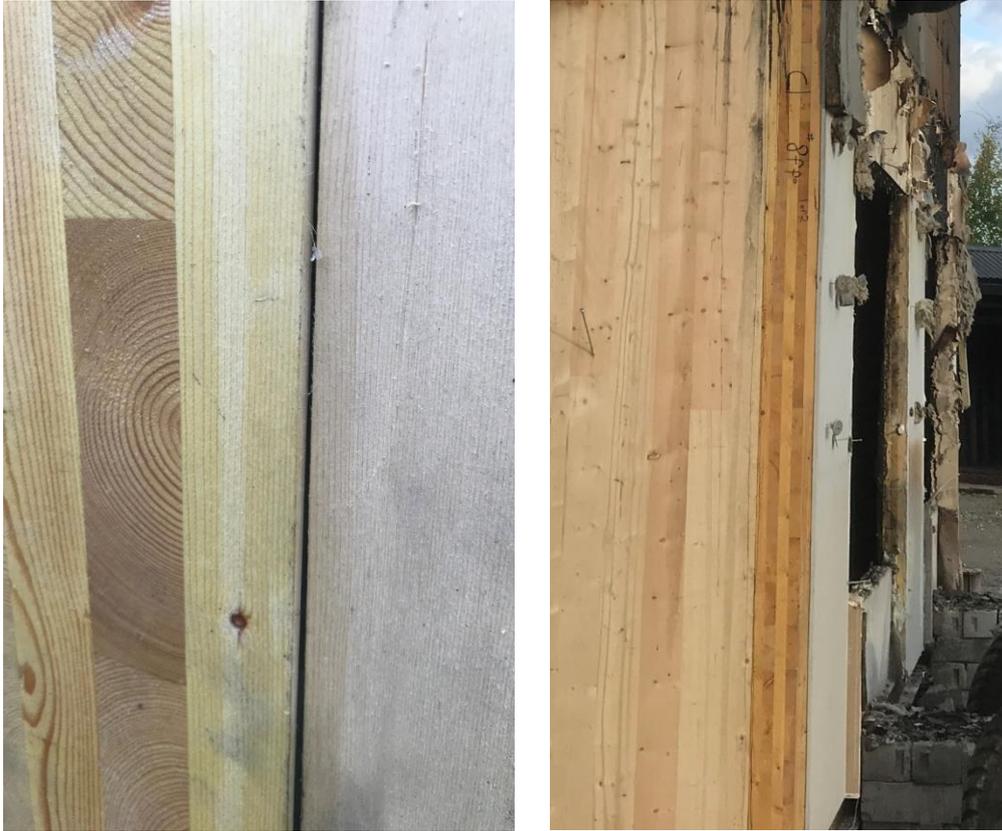
Figure 36: Typical wall-wall butt joint with construction sealing after the test.

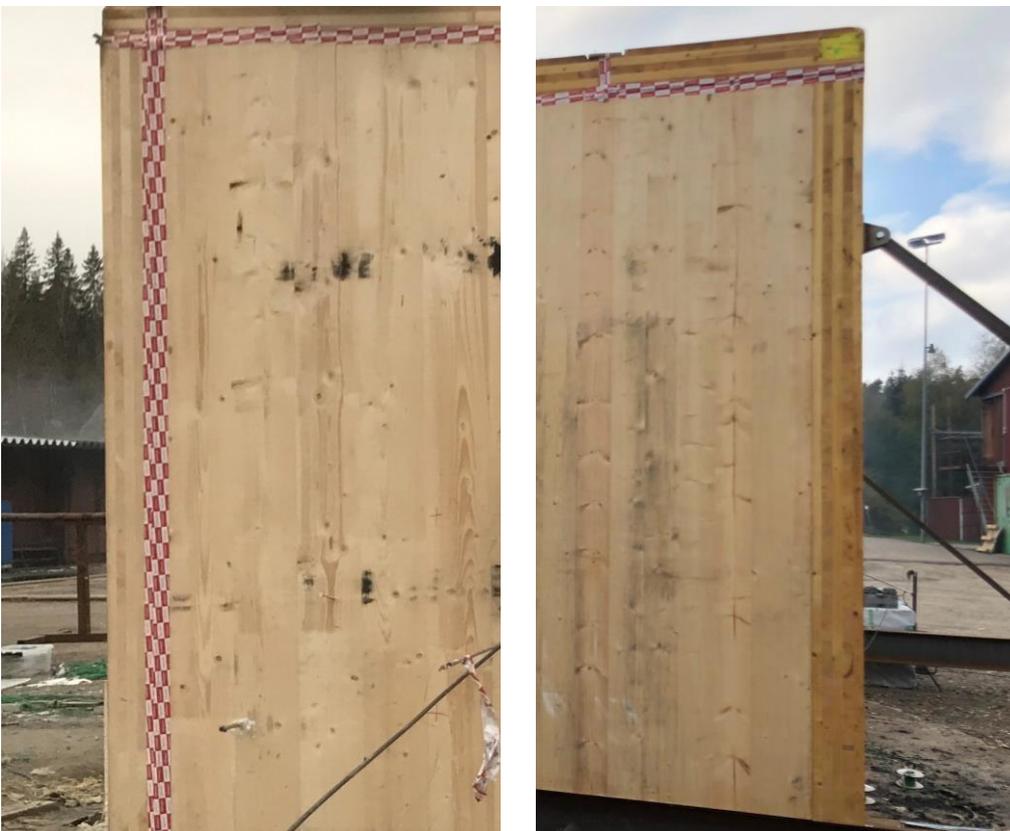
Figure 37: Typical wall-wall butt joint with construction tape (left) and expanding tape (right) after the test.

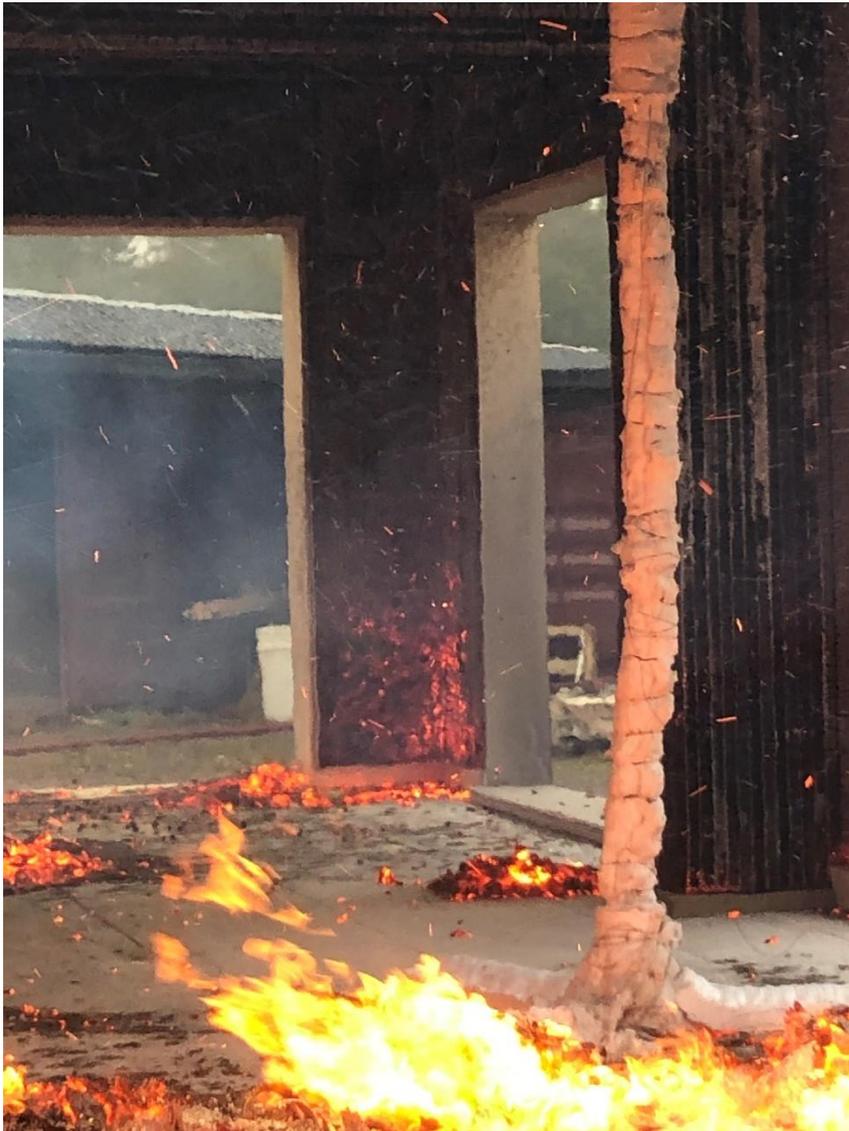
The data and analysis in Section 4.5 showed that the char depths at the end of the tests were higher in the bottom of corners with two exposed walls intercepting. It is expected that this is caused by a radiative feedback loop in the lower part of the corner located in a relatively oxygen rich environment (further analysis using oxygen measurements will be included in the final project report). The photo of Figure 38 shows such a corner at a late stage of decay of Test 4. At the time of this photo, smoldering combustion in most other surfaces started to extinguish as concluded using an infrared camera. However, the bottom corner was visibly smoldering more severely than other surfaces.

Figure 38: Photo at the final stage of Test 4

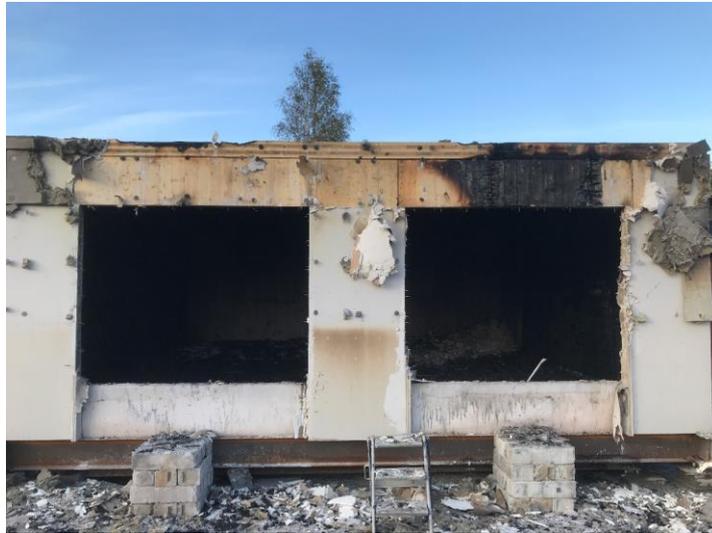
Figure F. 12. Test 3 - Detail above opening (left) and front façade after removal of gypsum boards. NOTE: Stone wool B (1200 x 555 x 45) was thinner and had smaller batt dimensions than stone wool A, which was used in other tests (1200 x 2700 x 50mm). The stone wool batt above the right opening fell at an early stage.
