## **Is Your Deck Safely Connected to Your House?**

by Frank Woeste, P.E., Loren Ross, P.E. and Paul Coats, P.E., C.B.O.

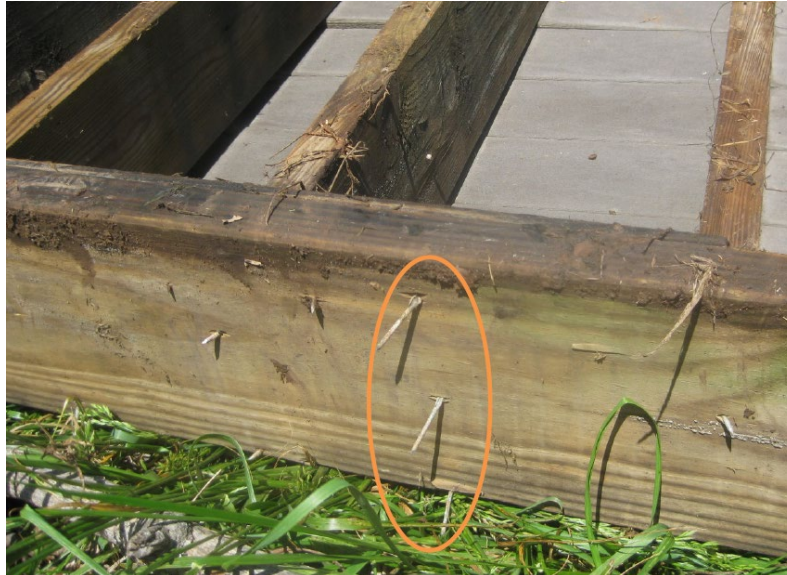
When decks that are simply nailed to the house are loaded by occupants, vertical and lateral loads stemming from the weight and movement of the occupants can cause the ledger nails to bend or pull out of the wood sheathing and house band joist. Decks have collapsed in this way with as few as one or two occupants present. The failed deck structure shown in Figure 3 depicts a case where the deck shifted laterally, away from the structure, and fell to the ground.

Had the deck fallen vertically, the nails would have bent over. In this case, the nails are essentially straight, indicating that the nails withdrew from the wall before total collapse. Nails used in withdrawal have limited strength, and may provide only enough support for the weight of the deck itself and not that of the occupants. Undoubtedly some nailed-only ledger decks are still standing probably because they haven't been heavily loaded to the IRC-anticipated 40 psf live-load (about one person on every 2-ft. by 2-ft. floor area).

*Figure 3. Close-up of deck ledger that was connected to a structure with nails only. Even though only lightly loaded by occupants, the deck shifted laterally, pulling the nails out of the supporting structure. (photo by Frank Woeste)*

This question can be answered in a few minutes. If only nail heads are visible on the surface of your deck ledger, you most likely have a nailed-only deck ledger. The deck should be identified as unsafe, its use forbidden, and immediately repaired or replaced in accordance with the recommendations of a qualified designer or construction professional.

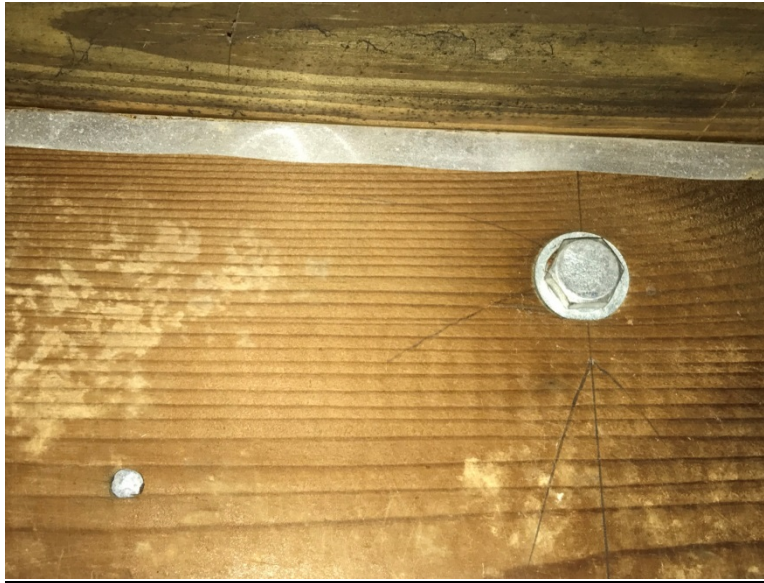
The proper lag screw diameter per the IRC can be verified by the fact that ½" lag screws have a hex-head that is ¾" wide. In Figure 4 below, the contractor used ½" diameter lag screws to connect the ledger through the wall sheathing into the house floor band joist. The nail at the bottom left was likely used only to position the ledger on the wall while the lag screws were installed.

*Figure 4. Section of a deck ledger with ½" diameter lag screw installed. (Photo by Frank Woeste)*

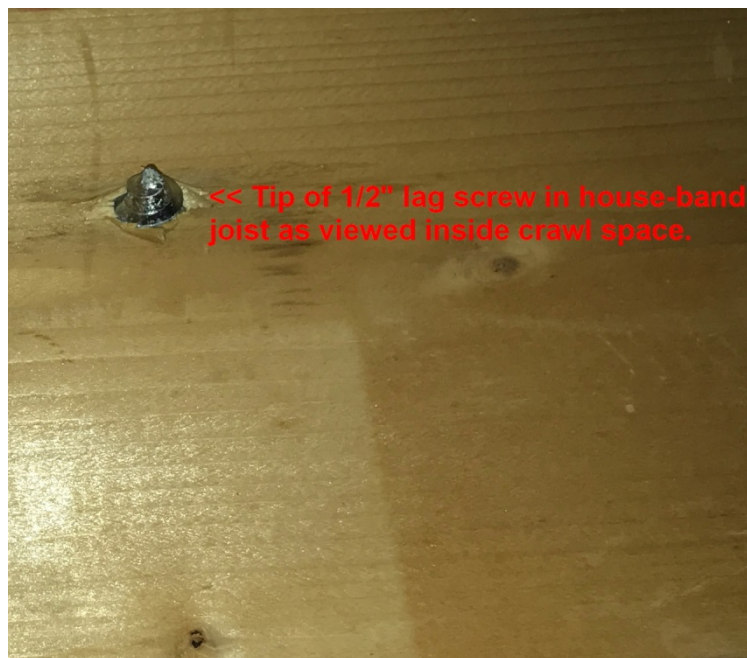
Figure 6. The visible tip of the lag screw as depicted indicates compliance with the IRC requirement that lag screws fully extend beyond the inside face of the house floor band joist. (Photo by Frank Woeste)

Because the tip of the screw extends beyond the inside face of the house band joist, the lag screw is clearly the proper length as required by the IRC. If the tips of the lag screws are not visible, an investigation by qualified construction professional is recommended.
