# Comparative Fire Test of Timber and Steel Beams

This report deals with the results of such a comparative test conducted by the Southwest Research Institute, San Antonio, Texas.

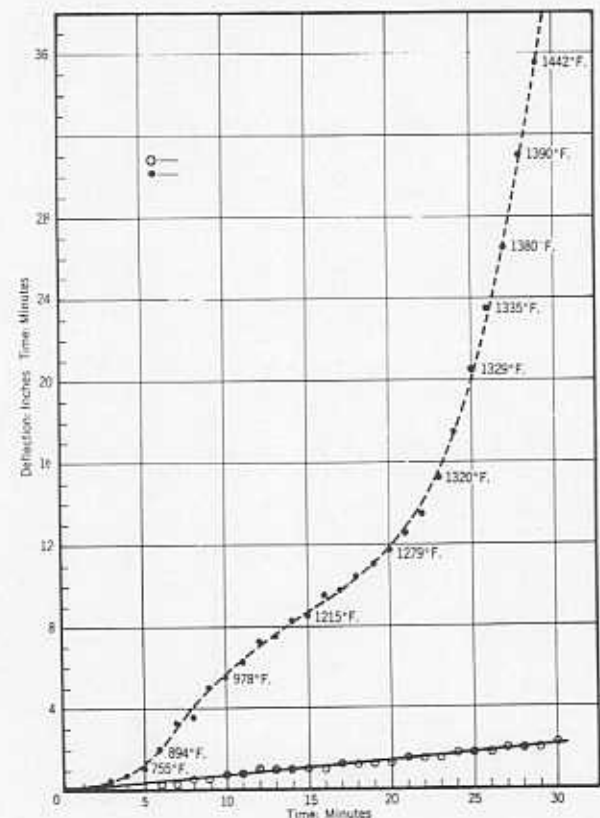
Figure 6. Comparative deflection of wood and steel beams during the test.

Deflection of the steel-supported panel occurred early in the test and continued at a reasonably uniform rate for 20 minutes. At this point, a sharp rise in deflection rate of the steel beam developed and increased rapidly until the conclusion of the test.

After 29 minutes of fire exposure, the steel-supported roof panel had exceeded the 36-inch capacity of the deflection measuring rod. By comparison, the wood beam at this time had deflected a total of only 2 inches. At 30 minutes, the steel beam collapsed into the structure, bringing its section of the roof down and making it impossible to maintain temperature control to continue the test.

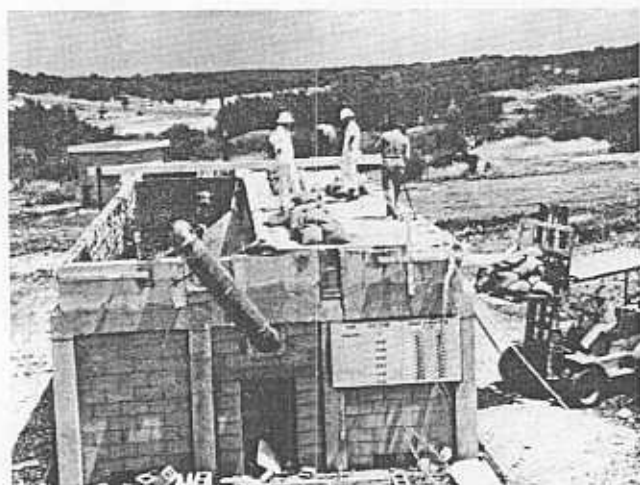
Figure 7. Interior of the test structure immediately after the steel had collapsed indicating that flaming on the wood member had ceased as soon as the source of heat was removed.

statement, Figure 7 is a view of the under side of the roof before a fire hose was applied to cool the structure, prior to disassembly of the roof panels. The water was also used to extinguish the afterglow, on the laminated wood beam, to obtain an accurate measurement of the amount of char on the wood beam at the time of failure of the steel beam.

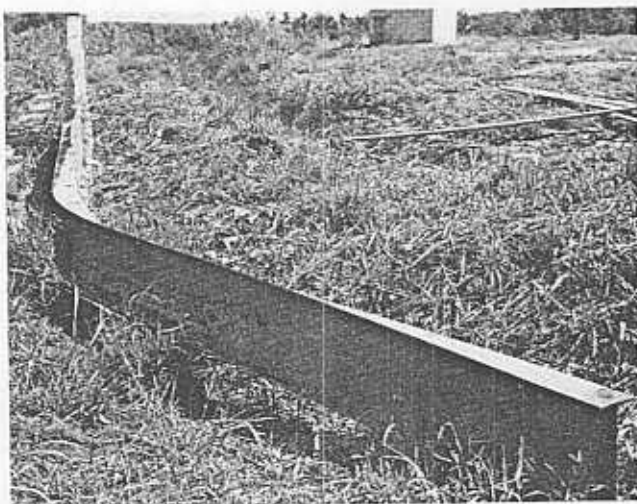
Although the steel supported panel fell into the test chamber after 30 minutes of exposure, it is evident that its structural integrity was in doubt long before this.

The deflection-temperature relationships, indicated by these results, are in agreement with the generally recognized behavior of steel structural members when exposed to building fires. That is, unprotected steel begins to lose strength at 800° to 900°F., and will fail to support load over 1200°F. The condition of the steel beam, pictured in Figure 9, provides additional evidence to support this conclusion.

Figure 9. Condition of the steel beam after the fire test exposure.

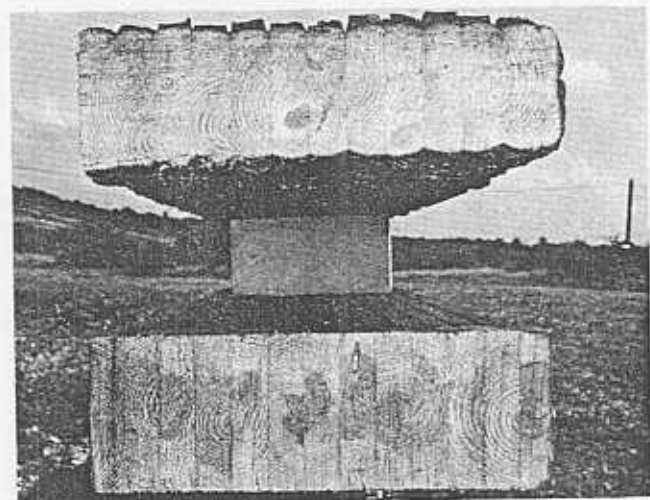
sawed through at a representative section, revealing a depth of char penetration of approximately ¾-inch on each side and 5/8-inch on the bottom. This is illustrated in Figure 10. The photo also shows that, as the char progressed, the loss of wood substance resulted in shrinkage of the individual laminations.

While penetration of char at the glue line was slightly greater, the deflection record demonstrates that the integrity of the casein adhesive bond was maintained during fire exposure.

Thus, after 30 minutes of fire exposure, during which temperatures in excess of 1500°F. were recorded, 75 per cent of the original wood section remained undamaged and the beam continued to support its full design load.

Figure 10. Condition of the wood beam after the fire test exposure.
