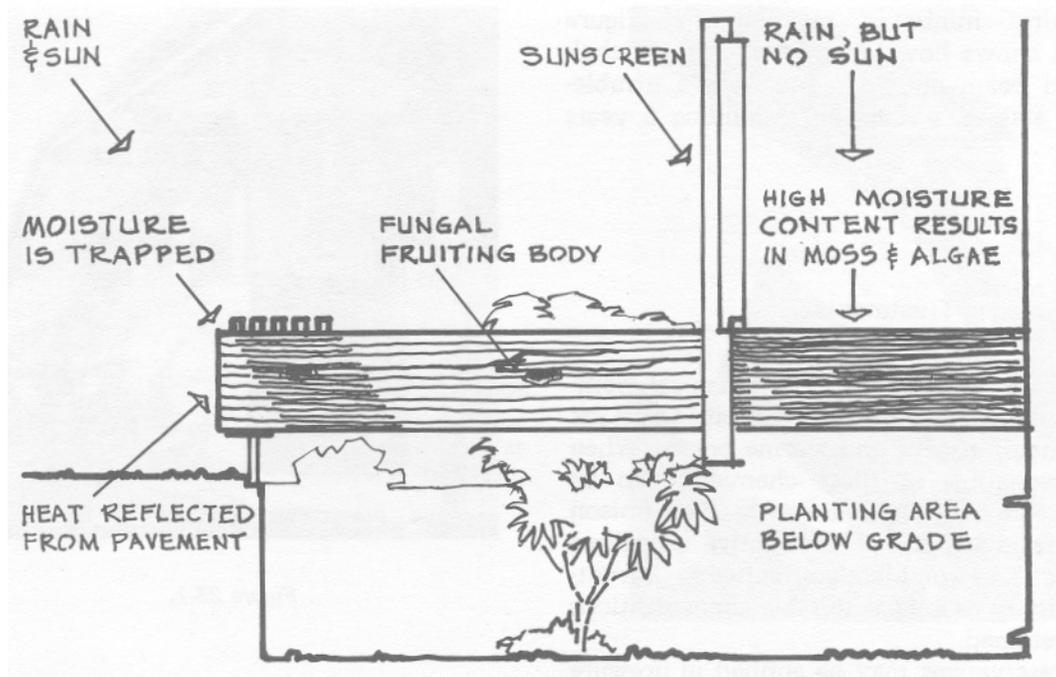
Figure 21-24.--Stain needs constant maintenance when *subjected to* maximum exposure.

Maximum exposure.--One of the buildings studied, with exposed structural wood members on its west side, had been stained a dark color. Several situations encouraging weathering and decay, due to inadequate maintenance and lack of independent protection, were observed, as illustrated by sectional view in figure 21-24. The glulam beams supporting the main floor are fully exposed to rain and sun. Their ends may be further affected by the sun reflection and the heat radiating from the nearby aggregate paving. Because a portion of the beams is shielded by a sunscreen, but not shielded from rain, high moisture content persists in these exposed areas and green algae and moss have formed. The bench slats also entrap moisture on the beams, and where the slats abut against a metal post, more algae growth can be seen (possibly due to condensation on the metal surface, which eventually soaks into the end grain). After 9 years of service, the beams show heavy checking and decay in some areas.

How has stain affected this exposed structure? Since there was inadequate maintenance, the stain has been successful only in achieving a uniform color. (The stain was renewed only once, 3 years ago.) Had it been properly maintained, the stain would have helped to slow moisture movement, but additional protection was needed to combat the severe exposure. Although two coats of a water-repellent preservative were applied after the building was erected, this was not sufficient. Pressure treatment, prior to erection, would be the only alternative to reduce internal decay caused by deep checking.

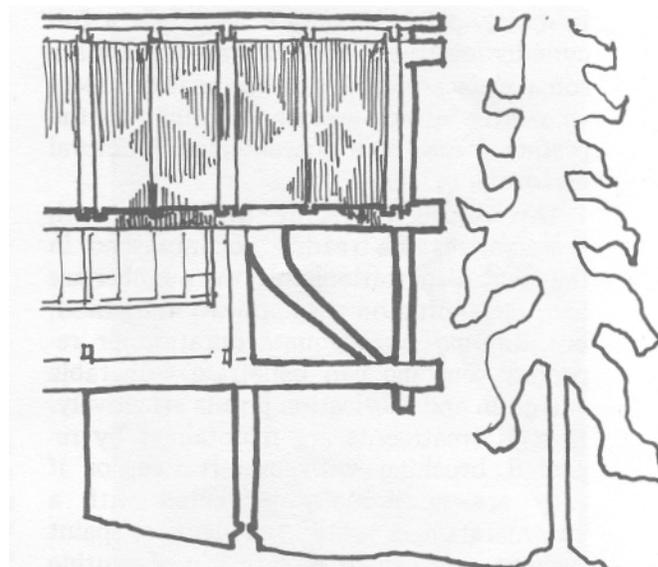
Figure 22-25.

Because of the natural finish used and the unusual independent protection involved, the Winkenwerder Forest Sciences Laboratory building at the University of Washington provided a good example of protection through coating (fig. 22-25). A natural finish, developed by the U.S. Forest Products Laboratory, was used as a protectant against fungal attack. This is basically boiled linseed oil with a preservative (pentachlorophenol) to prevent discoloration from lingering dampness plus wax for water repellency and iron oxide or other pigments for color. Unlike most natural finishes that need renewing after one or two years, this coating was still in good condition after 4 years of service. The tops of a few of the beams (where exposed to rain) show some bare summerwood but this is not extensive.

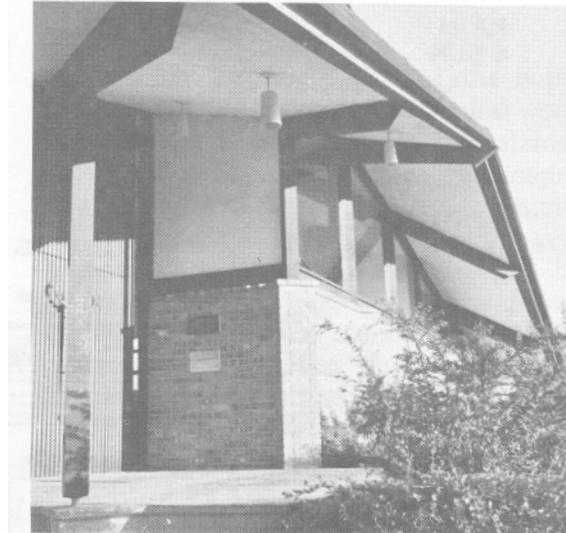
Figure 23-1.

requires minimum maintenance. Figure 23-1 shows how large overhangs and sheltered beam ends can maintain a troublefree stained surface on a building 6 years old.

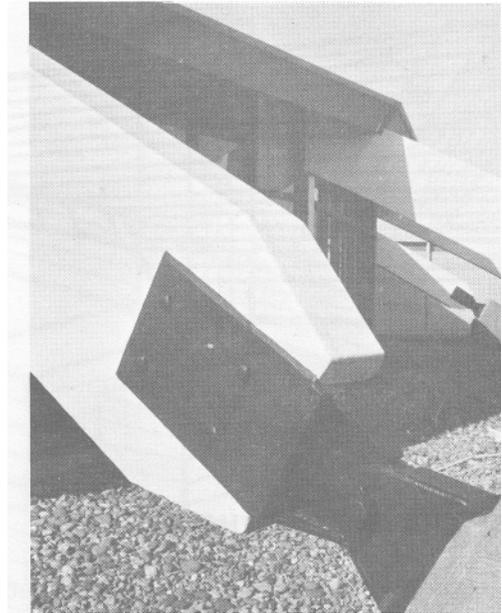
Figure 24-9.--A resin-fiber glass coating can trap, as well as exclude, moisture.

The resin-fiber glass coating on the glulam arches in figure 24-9 forms a vapor barrier that both excludes and traps moisture. Blisters seen on another example during a warm summer day in August indicate that moisture may be trapped at the wood-resin interface. Because this coating was applied for decay protection after the arches were in service for 9 years, their moisture content probably was not sufficiently low before application. Moisture also could enter through the bottom of the arch or at the sealed joints around the steel plate of the buttress connection. In time, high moisture content at the wood-resin interface could cause decay. Complete encasement would not eliminate this situation because the coating could be punctured during erection of the structure or at any time while it was in service.

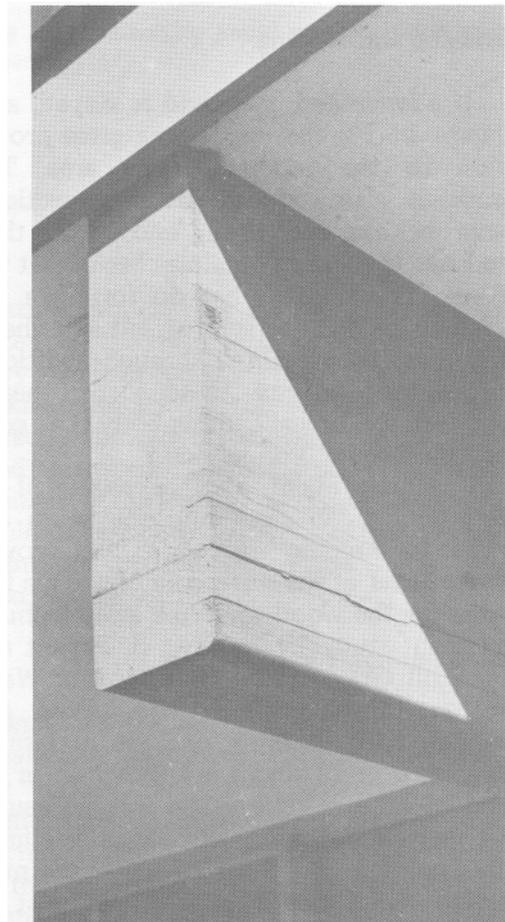
Figure 25-17.--An elastic polysulfide polymer end coating minimizes moisture exchange and gives with the wood.

good adhesion is very important in such an end coating. Its efficiency is shown in figure 25-17; substantial surface checking has developed along the sides of a beam but only minor checking is visible across the end face. This demonstrates the severe dimensional change of the wood surface near the exposed beam ends.

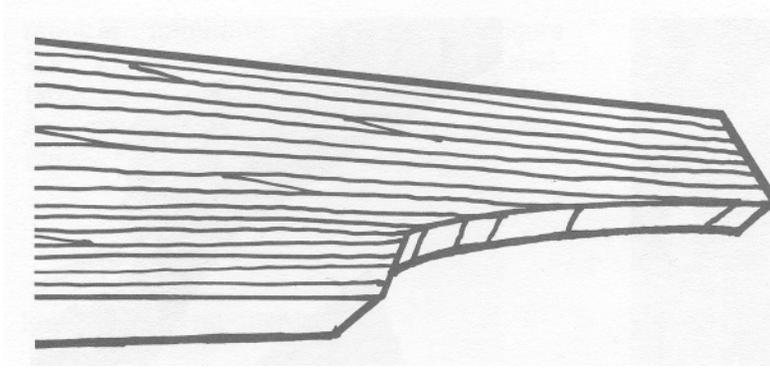
Figure 26-1 O.--Shaping beam ends can reduce checking but will not stop decay.

If a laminated beam end is shaped, as in figure 26-10, the upper area gives protection to the undercut lower area. This cutback also reduces the cross-sectional area of exposed beam ends and, thus, reduces the size of possible checks that will form. The checks that do form are less obvious on the end surface, but side checking must be prevented through additional protection: one of these shaped beams supported a fungal fruiting body (i.e., conk or "mushroom") on its side.

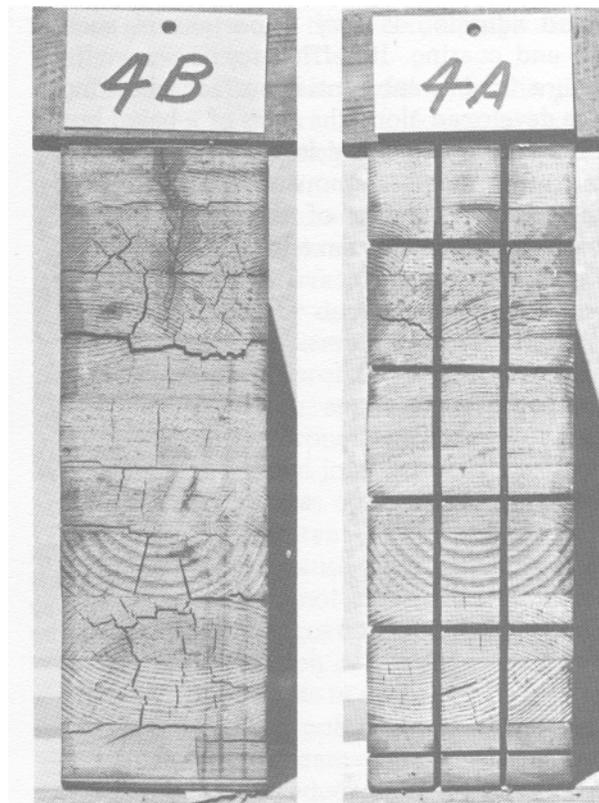
Figure 27.--1 Y2-inch-deep saw kerfs provide stress relief and reduce checking. 413 is the control.

Checking might also be regulated by introducing "checks" into the beam end prior to building erection. These provide stress relief at the surface by creating a free edge for the wood to shrink away from. In a recent study by Dr. Ben S. Bryant and Mr. Bill Gray of the University of Washington this hypothesis was tested and validated (4). A fairly uniform pattern of deep saw kerfs (about 1-1/2 inches) in the end of a beam relieves the stresses caused by uneven shrinking, and virtually eliminates random end checking under the most severe conditions (fig. 27). It must be

remembered that checks are still present, even though uniform in size, which means additional protection against decay should be provided. Thorough treatment with a water-repellent preservative and yearly inspection would be one solution.

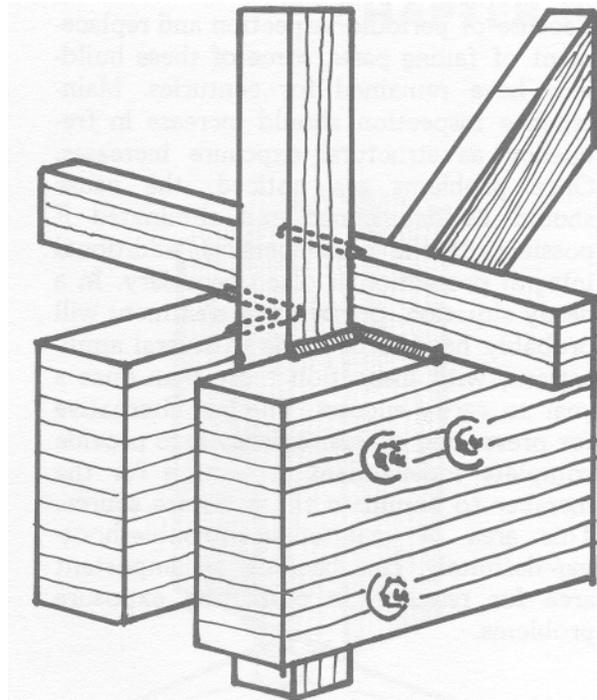
Figure 28-25.--Caulking could prevent water entrapment.

Caulking has been used for centuries to prevent entry of undesired water into certain areas. In contemporary wood structures, many areas for undesirable water collection require caulking treatment. Besides acting as a joint sealer in exposed structural connections, a caulking bead could act as a dam to direct waterflow away from critical structural areas. In any case, a clean, even bead is essential for good appearance as well as for total success. Caulking should act in much the same way as flashing by providing a continuous protective cover over a joint but leaving a way out for possible entrapped moisture. Caulking could be used as shown in figure 28-25 to prevent water that falls on the horizontal members from running into vertical joints.

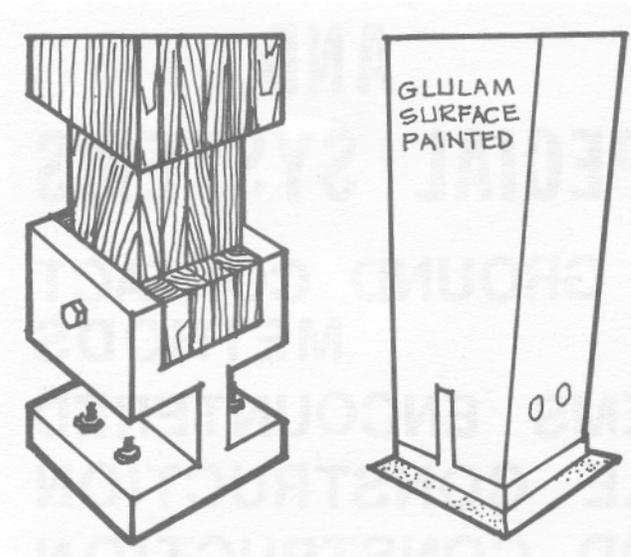
Figure 29-22.--Steel shoe connection. End grain and horizontal joints are exposed.

The steel shoe connection is used to support the majority of wood structures. Fabricated steel pieces either enclose the base of the wood member (fig. 29-22) or are inserted into a slot in that member, as seen in figure 30-14. Otherwise, the wood column rests directly on a concrete foundation block, on a flat steel plate with foundation support, or on a steel post which provides the support. In one unusual application, shown in figure 31-8, vertical steel bars act as anchors to a tied arch.

Water entrapment is the major cause of performance problems in exposed wood joints. Exposing the end grain to water is a critical factor of the joint shown in figure 29-22. Water that runs down the column can accumulate on the end-grain surface, where it easily soaks into the wood fibers. Excessive checking may occur when the swollen wood dries. The arch buttress in figure 32-20 partially protects the joint from water runoff with metal flashing, but some water can still penetrate around the edges of the flashing and enter between the end of the arch and the steel shoe. Once water has entered any of these very narrow places by capillary action, it will not easily evaporate and may remain for a long time.

Water also very commonly causes a problem where surfaces abut. This direct contact occurs in all steel shoe joints illustrated, but conditions of exposure and the amount of contact cause variability in joint performance. Figure 29-22 shows maximum contact between the glulam wood column and the heavy steel shoe. Two vertical exposed joints allow water to enter this contact area and remain, due to

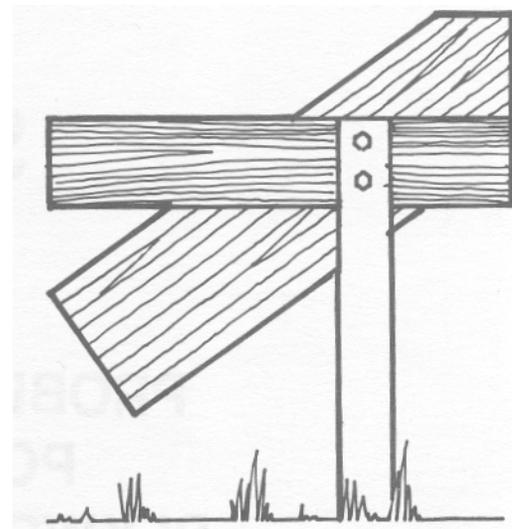
Figure 30-14.--Steel tongue connection. Exposed steel is minimized.

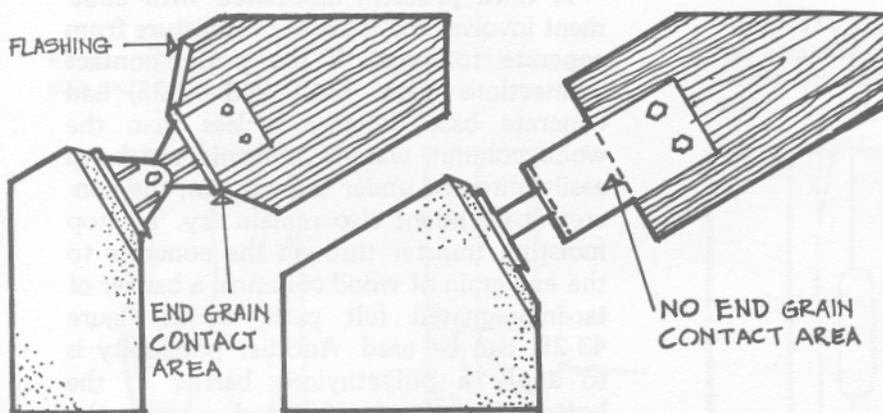
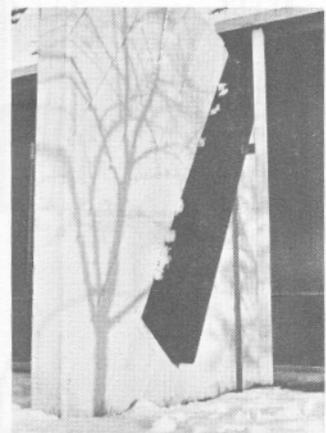
Figure 32-20.--Flashing helps to protect end grain.

Figure 33-4.--Water entrapment eliminated for endgrain protection.

Figure 34-5.--End grain protected by its sheltered position.

A solution to the problem is seen in figure 33-4 where the design separates end grain of the arch from the steel shoe to prevent retention of moisture. The steep angle of the wood-concrete connection in the arch shown in figure 34-5 allows maximum air circulation and reduced end-grain exposure to water runoff.

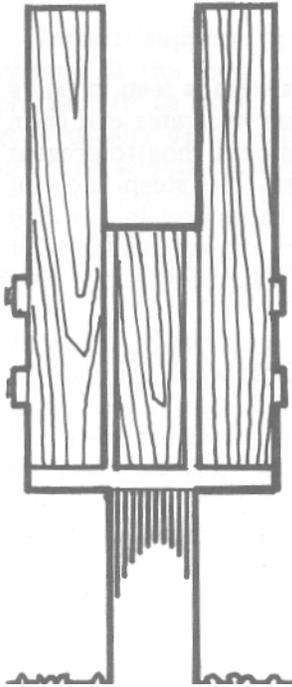
Figure 35-10.--Steel shoe does not trap much water: side-grain protection is provided.

lack of air circulation which retards eventual drying. The building has been in service 5 years. The double column connections pictured in figures 35-10 and 36-6 shelter vertical exposed joints, and the latter example provides minimum contact of surfaces and maximum airflow. Where stresses do not require bearing plates, the use of steel tongues (figs. 30-14 and 39-19) also eliminates exposed vertical joints, but horizontal joints entrap moisture by the flush edges of the steel base plates. The buildings are 8 and 5 years old respectively.

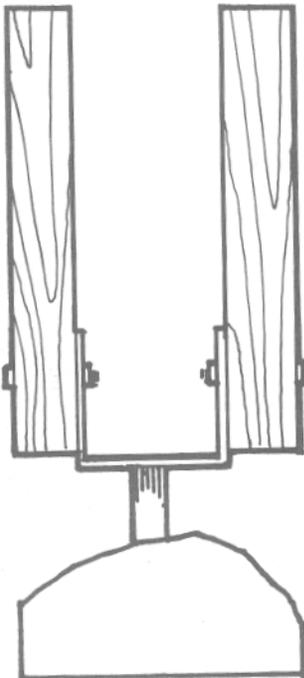
Figure 36-6.--Ground connection minimizes steel-wood contact. Both end grain and side grain are free from trapped water.
