# **Fire Safety Challenges of Tall Wood Buildings – Phase 2: Task 2 & 3 – Cross Laminated Timber Compartment Fire Tests**

**FINAL REPORT BY:**

**Joseph Su and Pier-Simon Lafrance**

February 2018

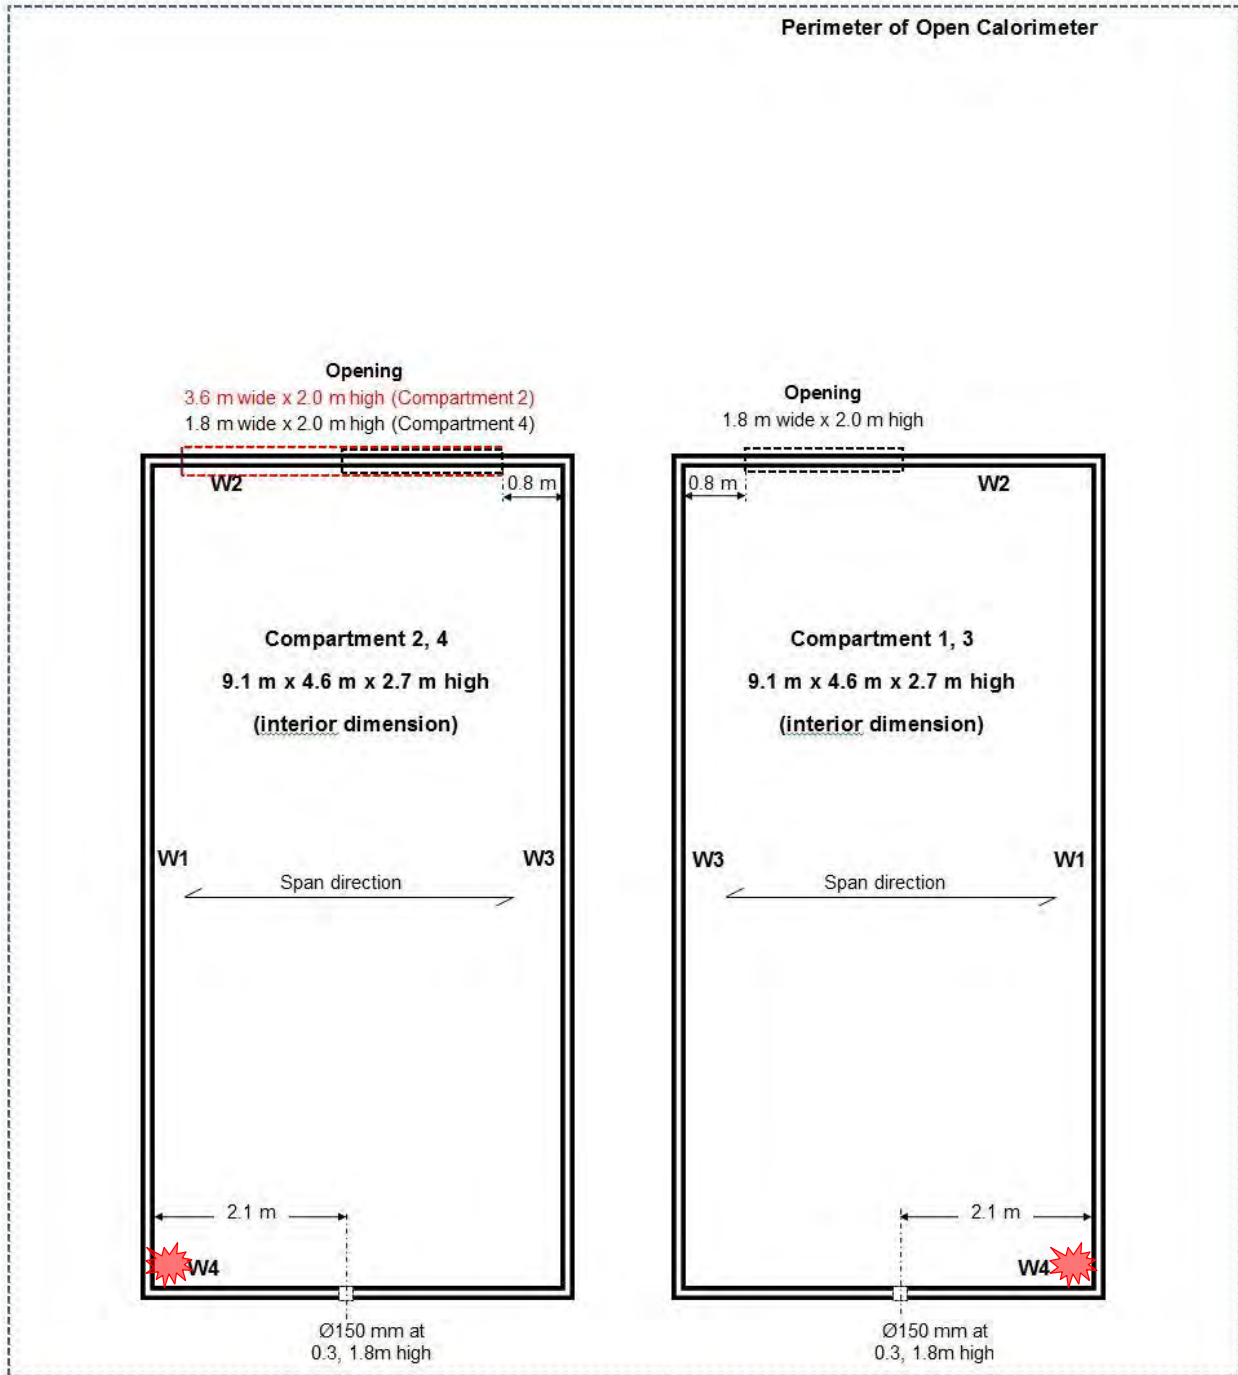
**Figure 1. Schematic of test compartments.**

Although sealants are normally required to seal the CLT panel joints in field applications, no sealant was used in the construction of the test compartments. The project focused on the contribution of CLT elements to a compartment fire and the structural performance was secondary. The absence of the sealant could allow minor smoke and flame leakage from the compartment, but would be unlikely to cause a significant difference in quantifying the CLT contribution. Test 1-3 was an exception where caulking was used to repair the compartment after a preceding fire test (the compartment was used twice; see Section 3.3 for details). For the two tests (Test 1-4 and Test 1-6) which involved an exposed CLT ceiling on the interior side, gypsum concrete was poured along each joint on top of the ceiling panels (see Section 2.1.3 for details).

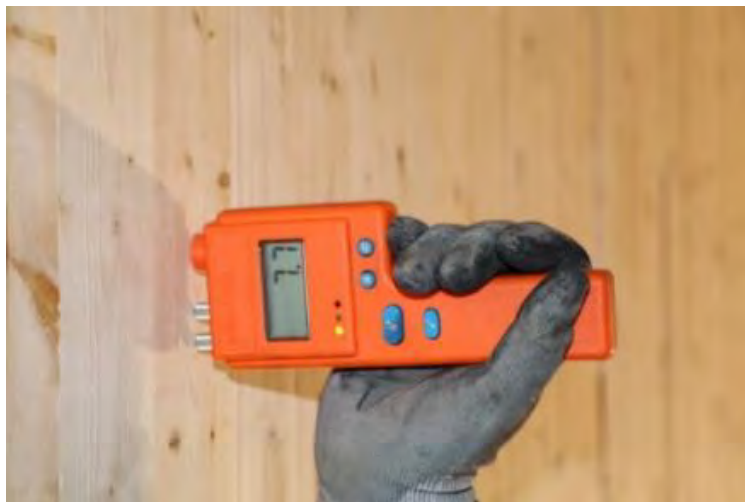
**Figure 10. Measurement of panel moisture content using Delmhorst (BD-2100) meter.**

Prior to fire testing the compartments, the moisture content of each wall was sampled using a handheld moisture meter (Figure 10). For Test 1-1 and Test 1-2, the measurements were made on the outside surface of the compartment after the gypsum board had been applied because there was no longer access to the inside surfaces. In Test 1-3 to Test 1-6, the measurements were made on the inside surfaces of the compartments shortly prior to installation of the gypsum board. Three measurements were made at random locations on each wall.

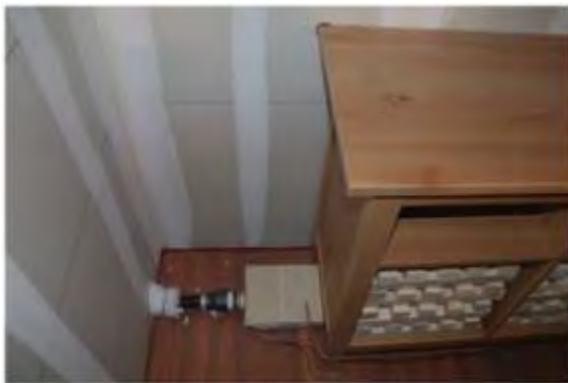
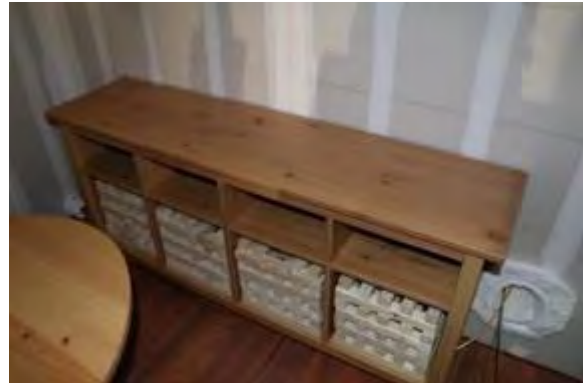
**Figure 18. Photographs of (a) burner with copper tube for pilot flame and (b) the object of first ignition (console table with wood cribs).**

A room corner ignition scenario was used in the CLT compartment fire tests. The ignition corner was formed by the adjacent W1 and W4 walls. The ignition source used was a natural gas diffusion burner (200 mm x 400 mm or 8 in. x 16 in.) placed in the corner partially under the shelving unit (console table). The natural gas flowed into a cavity below porous ceramic plates in the burner and then diffused upward. A small pilot flame was used to ignite the burner. The shelving unit (console table) was the first item ignited (Figure 18). A heat release rate of 50 kW (similar to a burning waste basket) from the burner was maintained until the total measured heat release rate from the compartment exceeded 1000 kW (due to ignited contents), at which time the burner was shut off. Four small wood cribs (85 MJ each) were placed in the console table to achieve a reliable ignition (Figure 18b). Two 'mock-up' tests of the ignition scenario were performed using a corner burn setup prior to the compartment test (Figure 19). The mock-up tests showed a reproducible fire growth and heat release sufficient to ignite neighboring contents in the compartment.

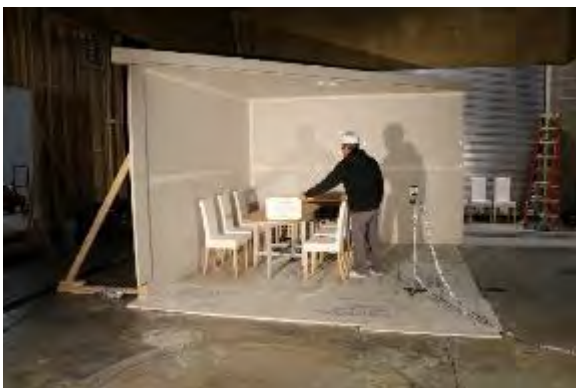
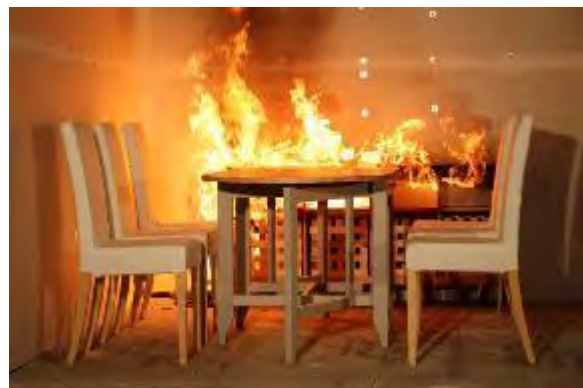
**Figure 19. Photographs of (a) mock-up corner burn setup and (b) the object of first ignition catching fire.**

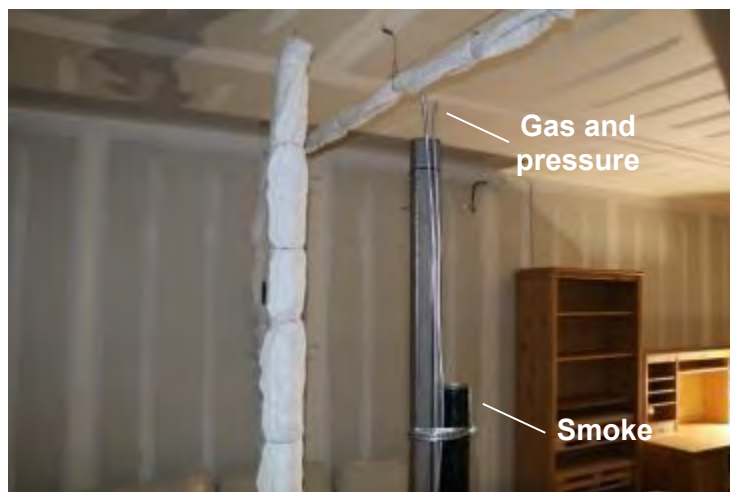
Figure 30. Photograph of stand with gas sampling tubes.

Gas samples inside the compartment were taken using metal tubes attached to a steel stand located at the centre of the room (Figure 20, Figure 21 and Figure 30). Samples for the gas analyzer and differential room pressure were drawn from two 6-mm (1/4 in) diameter stainless steel tubes with their opening 210 cm from the floor. Samples for the smoke meter were drawn from a 50-mm (2 in.) diameter steel pipe with an opening 160 cm from the floor.

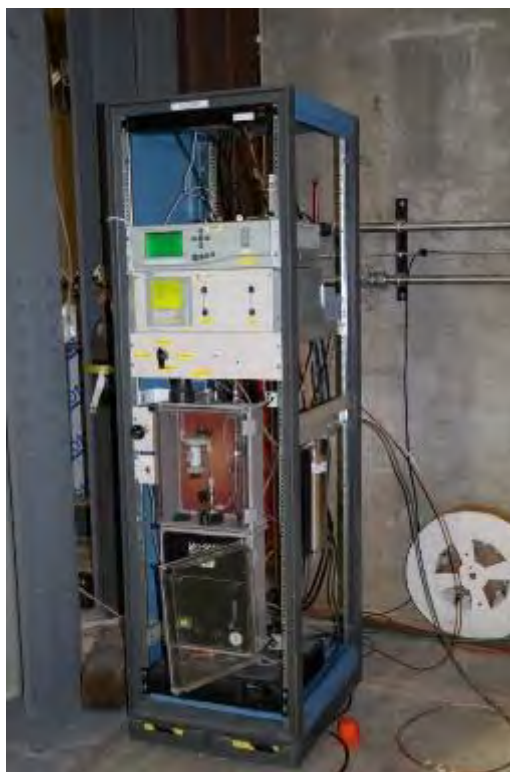
**Figure 31. Photograph of gas analyzer rack.**

Room gases were extracted and analyzed using the gas measurement rack shown in Figure 20, Figure 21 and Figure 30. A Permapure MiniGASS sample conditioning system was used to filter and dry the sample gas. The sample gas flow rate was set to 1 slpm for these tests. The delay time from the room inlet port to the gas rack was approximately 60 s. The oxygen was measured using a paramagnetic oxygen analyzer. Carbon dioxide and carbon monoxide were measured using a nondispersive infrared (NDIR) analyzer. The analyzers were calibrated prior to each test using calibrated zero and span gases. Nitrogen gas was used to zero each analyzer and room air was used to span the oxygen analyzer. Room air was assumed to have an oxygen concentration of 20.95%  $\pm$  0.05 %. The carbon dioxide span gas consisted of 9.0%  $\pm$  0.09%  $CO_2$  in  $N_2$  and the carbon monoxide span gas consisted of 4.0 %  $\pm$  0.04%  $CO$  in  $N_2$ . A high pressure air line was used to blow out the sample line during the test if the sample line became clogged by soot. The maximum range of the  $CO$  and  $CO_2$  measurements was 20 %. This range was exceeded during several of the tests. There were other periods where gas sample data was invalid due to loss of sample flow and loss of sample tube support. The sample tube deformed and fell onto the room floor during several of the tests. The gas sample measurements were more reliable early in the tests. All gas measurements are reported on a dry basis.

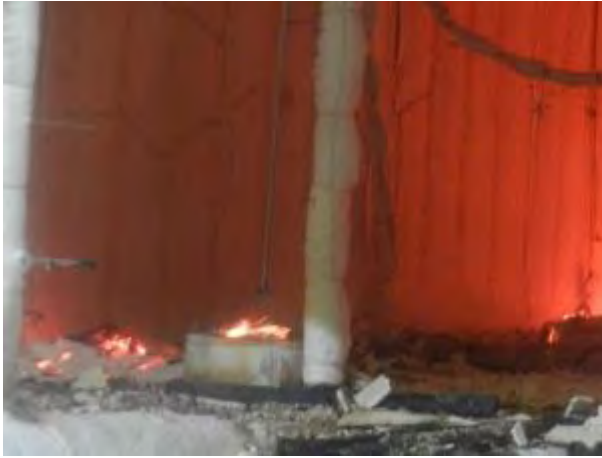
(a) CLT block near a TC Tree

Figure 53 shows the remaining thickness of the three small CLT blocks placed on the floor (only the top surface was exposed), each cut to half at the middle after Test 1-2. The char depth was 46 mm, 35 mm and 35 mm for the blocks placed at the front, middle and rear sections of the compartment, respectively.

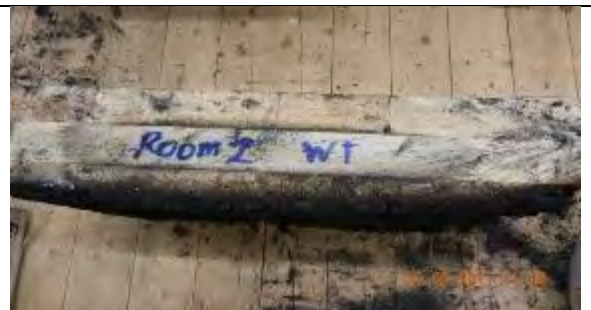
The photo in Table 8 shows the CLT sample that was cut from the W1 panel 10\_018 where the embedded thermocouples were installed. The thickness of the char was 86 mm (remaining CLT thickness was 89 mm). This confirms the measurement of the char depth by the embedded thermocouples ( $65 \text{ mm} < \text{char depth} < 90 \text{ mm}$ ).

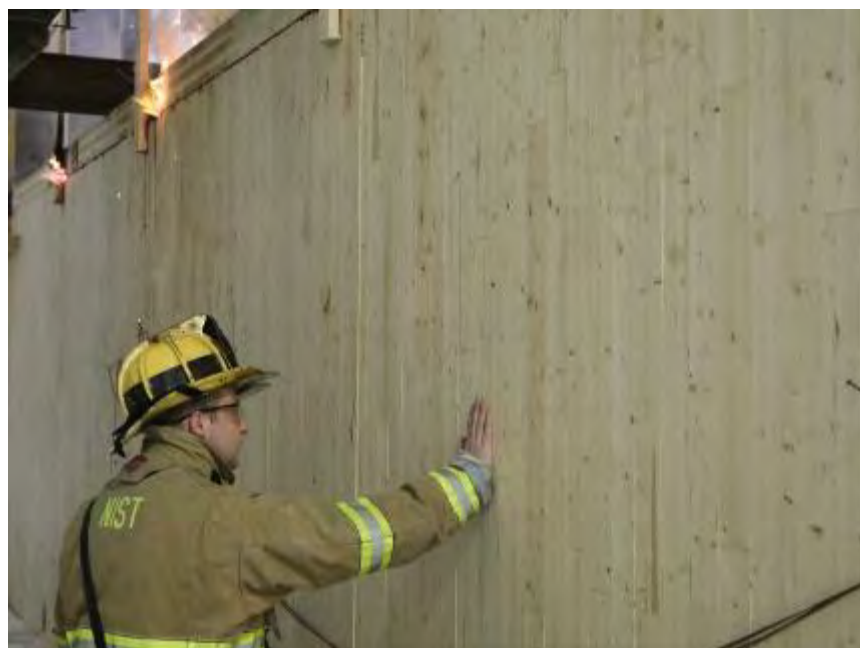
**Figure 68. Exterior of the W1 wall at 198 min in Test 1-3.**

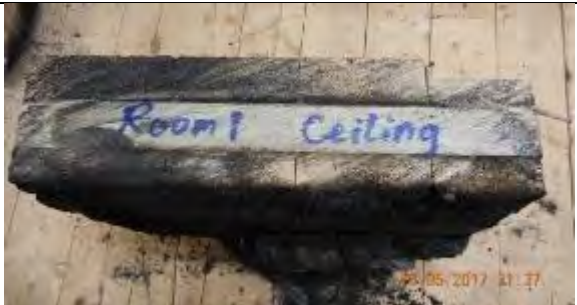
As shown in Figure 77, the exterior surface of the CLT ceiling and walls had no char; neither did the exterior surface. The ceiling panel spline joints were covered with gypsum concrete on top but no sealant was used at any CLT joint of the compartment. Neither the wall panel joints nor the ceiling panel joints developed char. However, there was minor surface char developed outside the two back corners at the wall-ceiling junction (no burn through), which could have been prevented if the wall-ceiling joint had been sealed.

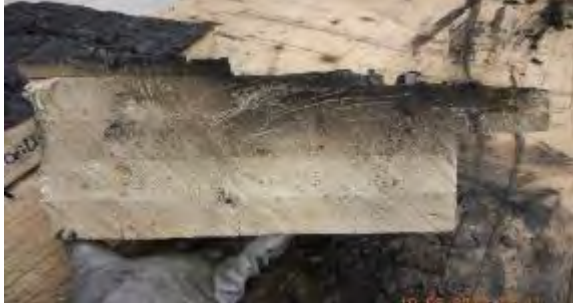
Figure 87 shows the exterior surface of the CLT ceiling and walls after the test. Although no sealant was used at any CLT joints of the compartment, there were only a few spots at the ceiling-wall joints and at the W1 panel joints where smoke escaped and char appeared. However, there was no burn through during the test.

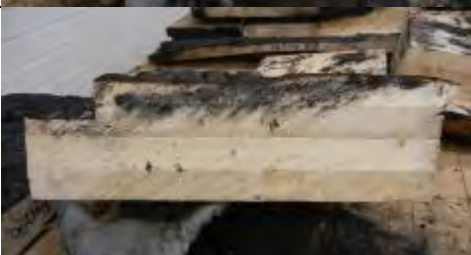
As shown in Figure 99, other than the char formed around the openings, the exterior surface of the CLT panels had char localized at the joint between the W1 wall and ceiling near the ceiling spline locations. Had sealant been used in the joints, the smoke leaked from the W1-ceiling junction could have been reduced and the burn through at the W1-ceiling junction spot and at one of the ceiling spline joints could have been delayed. However, based on the amount of char formed at these locations, the absence of sealant in joints had a negligible impact on the quantification of CLT contribution to the compartment fire.
