The Wood-Frame House as a Structural Unit

Presented at the 1965 Meeting
of the Wood Engineering Division
of the
FOREST PRODUCTS RESEARCH SOCIETY
New York, New York
June 26 - July 1

A full-scale house, 28' x 36', was structurally evaluated as a unit, by subjecting it to various combinations of simulated wind and gravity loads while continuously recording deflections at 29 points. Rigidity, attributable to members, components, and such structural elements as sheathing, flooring, and sheetrock, was also evaluated. Floor deflections and vibrations were recorded for 14 stages of construction, and racking tests were conducted at 7 stages of dismantling.

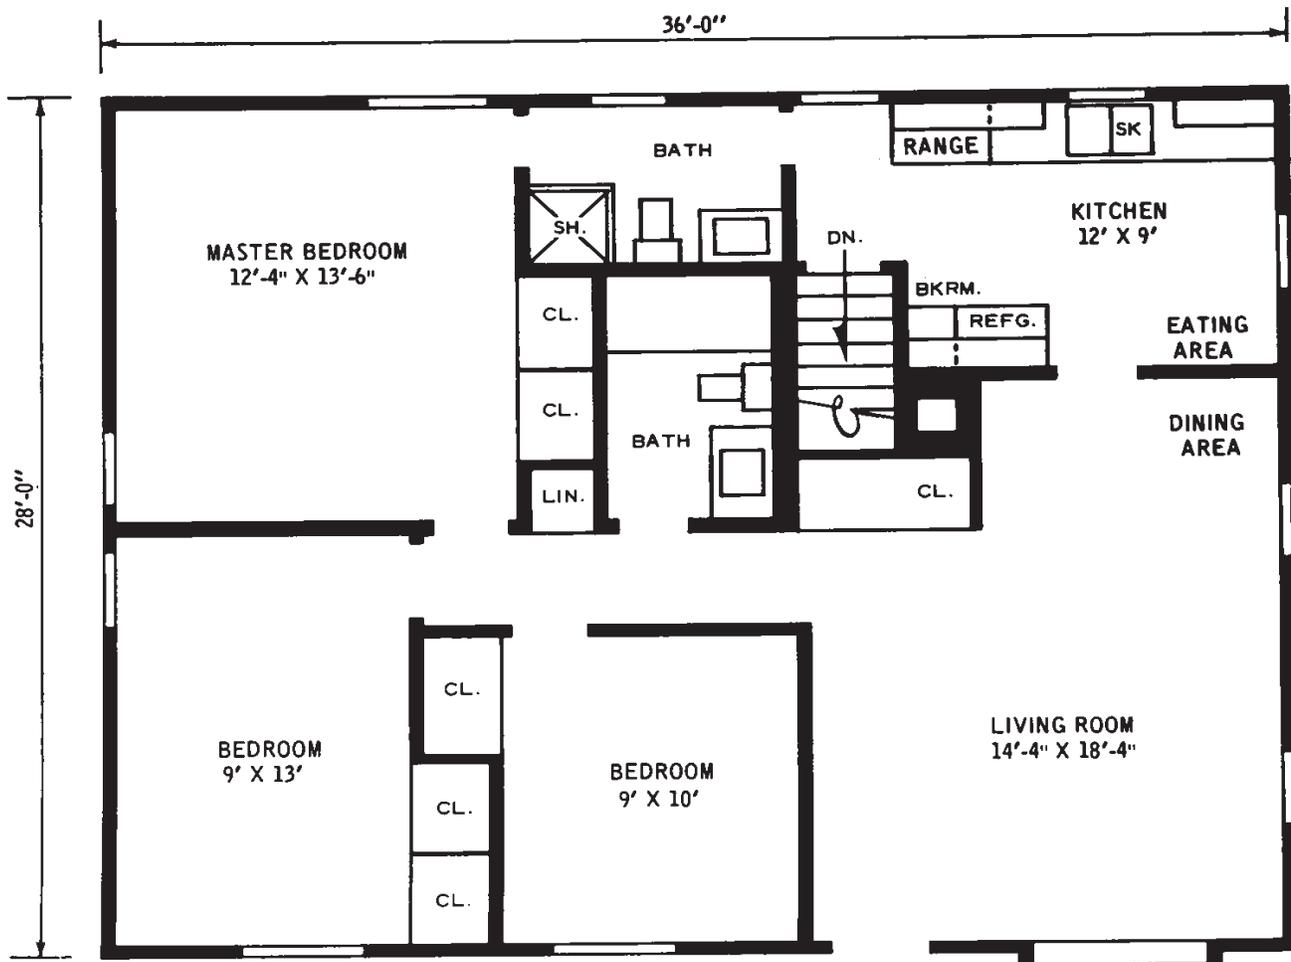
Figure 1. Floor Plan

Part I of the study was concerned with the deflection of floors under simulated gravity loading. Part II was devoted to floor vibrations induced by dynamic loading. Part III was concerned primarily with the overall structural performance of the house, as indicated by movements of walls, ceilings and roof surfaces, when subjected to combinations of simulated gravity and dynamic loading at various stages of construction. The floor plan of the selected design is shown in Figure 1.

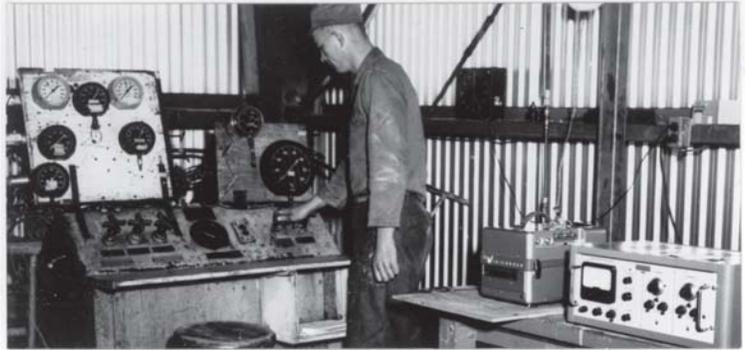
Figure 2.
Hydraulic Test Stand
and Vibration Equipment.

The machine at left was used to simulate gravity and wind load. Six different wind-load pressures were required and provided by a system of solenoid and pressure regulating valves activated by an electrical timer. At right are the oscillograph and amplifiers used for recording joist vibrations.

The hydraulic loading system, illustrated in Figures 2 and 3, is capable of simulating any combination of gravity and wind load imposed by nature. Gravity loads can be held constant while wind loads are cycled on and off. The cylinders were used in tension, as shown in Figures 4, 5, 6, 7, and 8, which also show the rigid frames and purlins holding the cylinders.

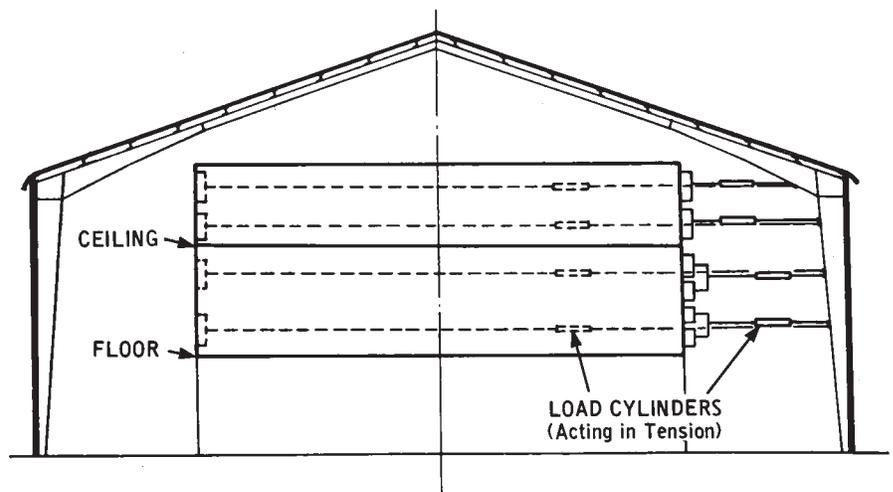
Figure 4.
 Side view of test house, inside rigid-frame laboratory, showing wind-load cylinders and connections for loading end walls.

All exterior wall and roof surfaces were subjected to simulated wind forces as indicated in Figures 4, 5 and 8. The house was tested at seven stages of construction, as described in Table 2. Uniform wind pressures were simulated by concentrating loads at two intervals on studs, spaced 16 inches o.c., and on trussed rafters, spaced 2 feet o.c.

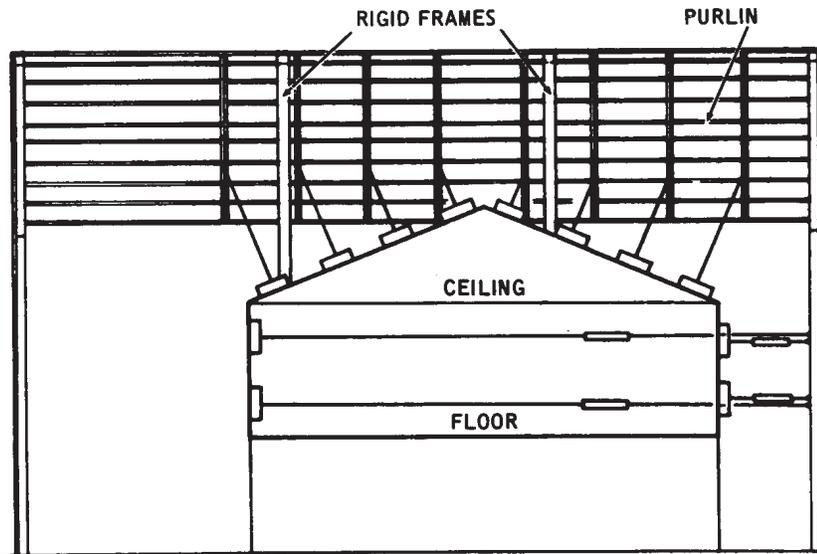
Figure 5.

Cross section of test house, inside the rigid-frame laboratory, showing wind-load cylinders and connections for side walls and roof loading.

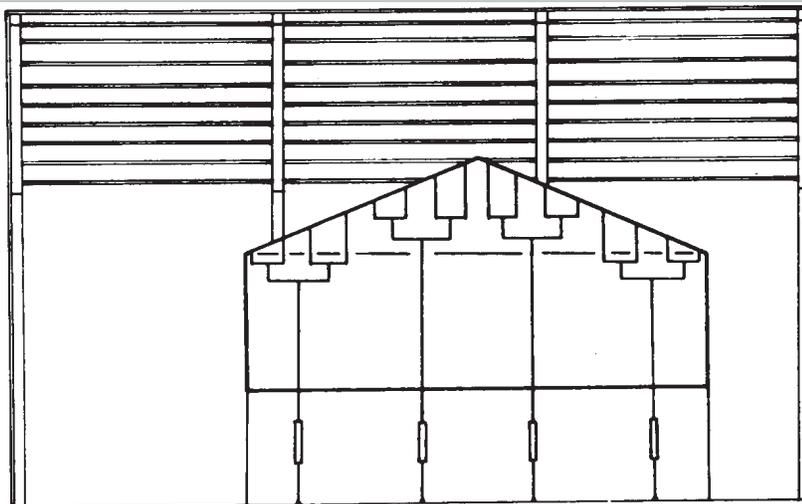
Cross section of test house with gravity-load cylinders and connections for roof loading.

Simulated gravity loads on the roof were applied as shown in Figure 6. The magnitude of loading always equaled the wind loading for each stage of construction. For example, immediately after applying three cycles of 12 psf for each stage of construction, a gravity load of 12 psf was applied for five minutes.

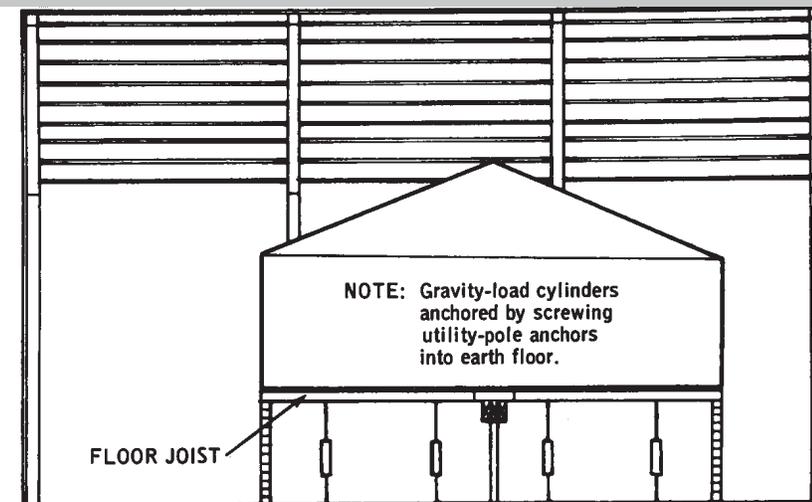
Figure 7.

Cross section of the house, showing gravity-load cylinders and connections for loading floor joists.

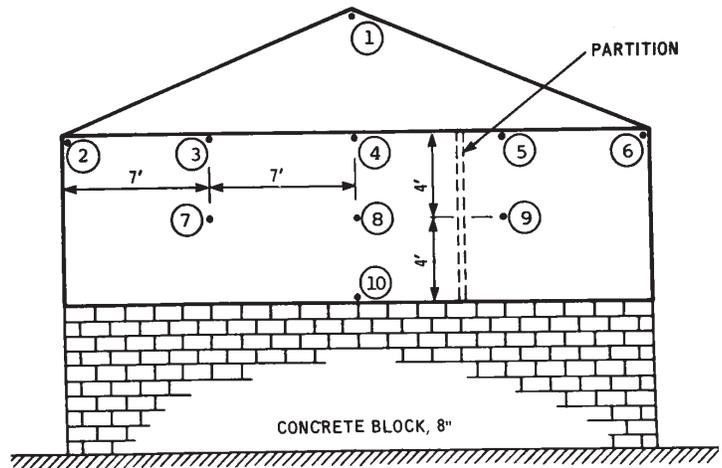
Figure 9.

Leeward end, showing numbers and locations of deflection recorders.

Horizontal movements were continuously recorded at 19 points on the leeward end and side walls, as in Figures 9 and 10. Because all horizontal deflection recorders were mounted on the steel frame, to which the horizontal loading cylinders were attached, it was necessary to establish a correction factor for each recorder at each load level. Correction factors were established by using transits to measure the horizontal movements of the steel frame wherever recorders were mounted. The degree of

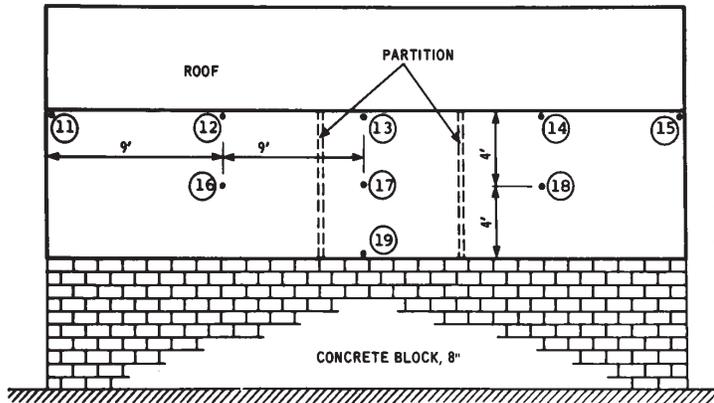
Figure 10.

On leeward side, numbers and locations of deflection recorders.

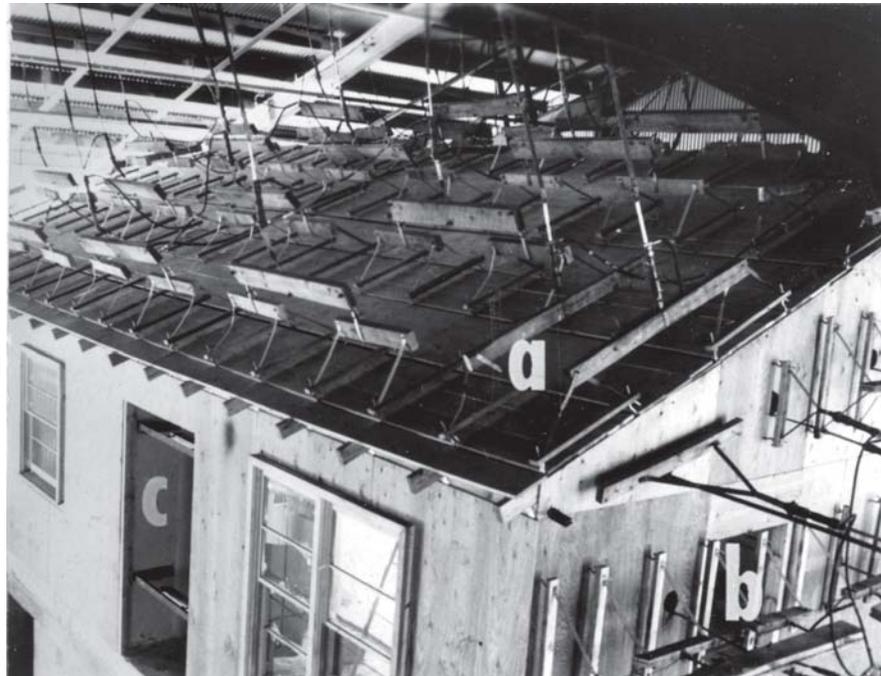
Figure 8.

The structurally complete house, showing (a) outward wind loading (suction) being applied to windward roof; (b) outward wind loading being applied to part of leeward end; and (c) the windward side which is being loaded inwardly by tension cylinders inside the test house.

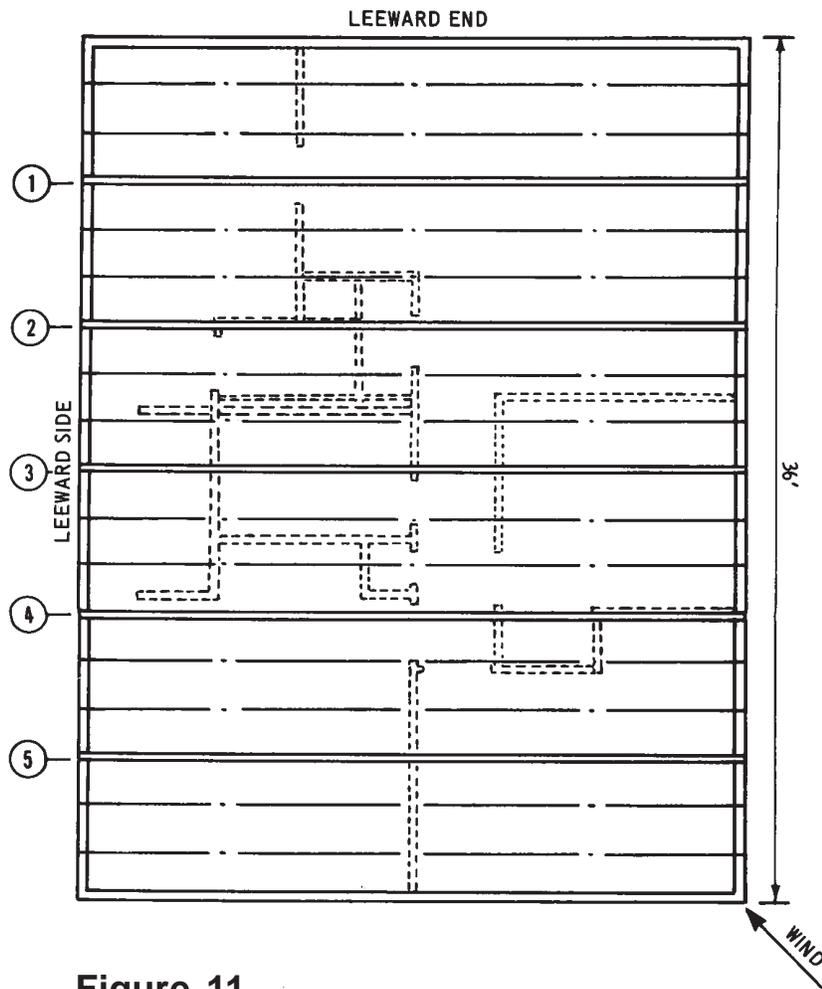
Figure 11.

Plan view, showing roof trusses, by number, for which chord and crown deflections were recorded.

Vertical movements also were recorded at the crown and at the center of the bottom chord of every third truss, as shown in Figures 11 and 12.

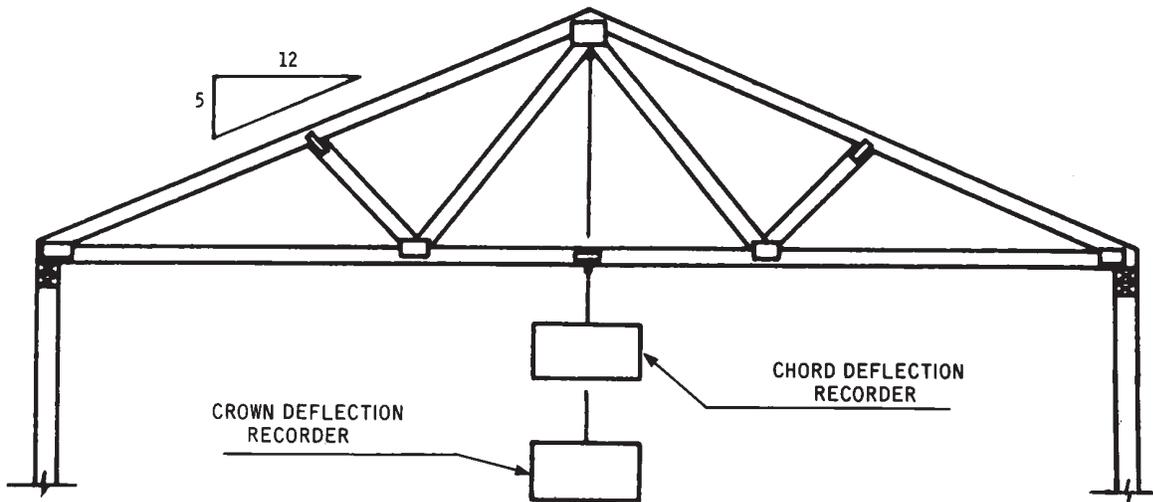
Figure 12. TECO plate truss, spaced 2 feet o.c. in test house.

Vertical movement of crown and chord was recorded for five trusses, as indicated in Figure 12. Vertical movements in both directions, at 12 psf, are plotted in Figures 33 and 34 for all seven stages of dismantling, except the 12 psf gravity load was inadvertently omitted after the wind-load failure in Stage 7.

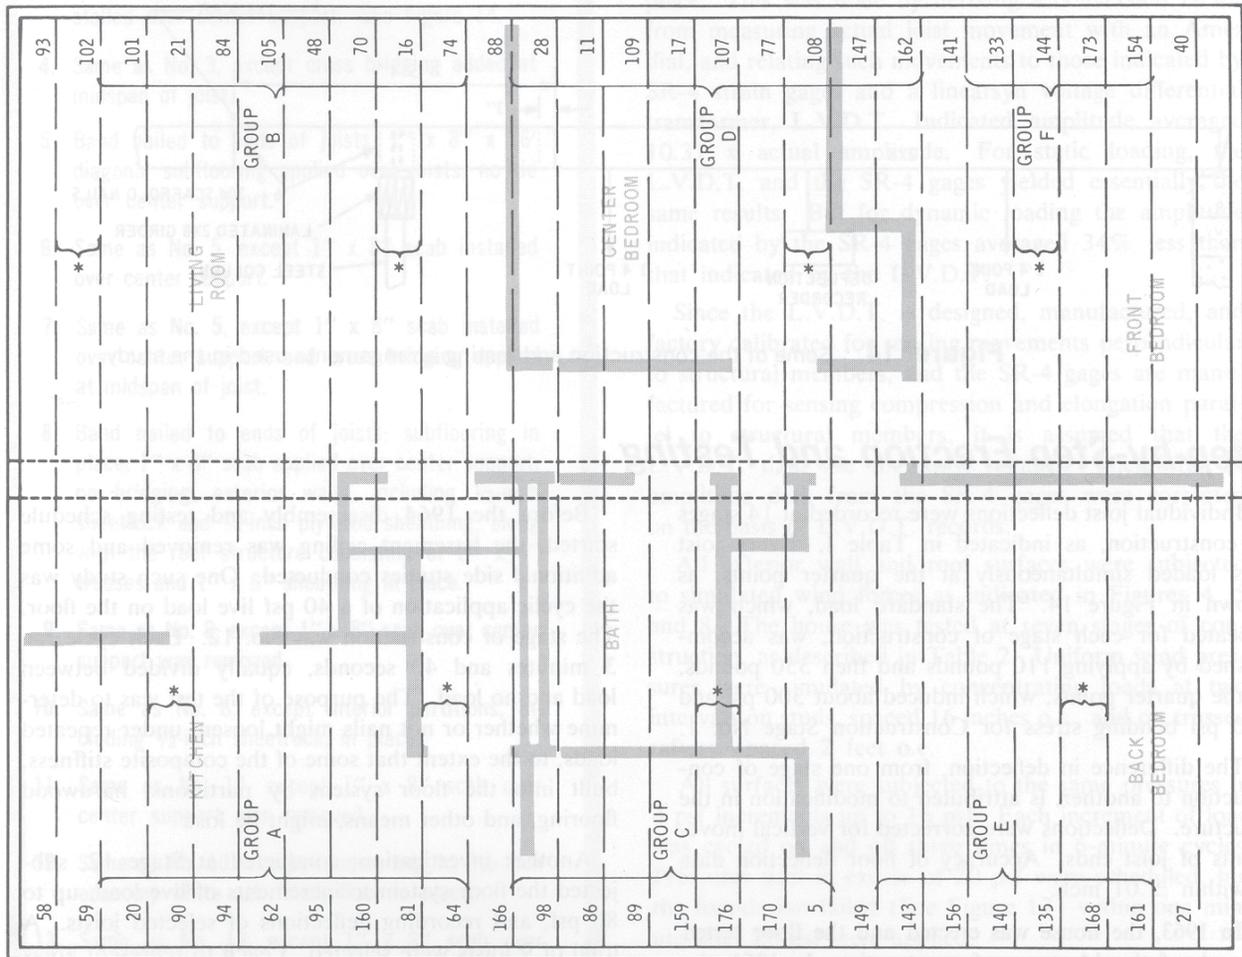
Floor plan showing joist numbers, locations and groups.

*Joists loaded to 344 pounds each at center, and suddenly released for vibration recording.

Selected joists were randomly located on the foundation, as shown in Figure 13, and allowed to stabilize in moisture content before conducting the final selection test. Moisture contents ranged from 10.1% to 12.4% except joist No. 28, which was 15.8%. The size of each joist was measured to determine moment of inertia, I, at the time of final selection.

recorded. Vibration was induced by suddenly releasing a 688-pound force, equally applied to two joists as indicated in Figure 13. Vibration was recorded for two joists each time the load was released, and a maximum of six joist records were taken for each load-releasing location.

The remaining 48 joists were treated as a single group until partitions were installed, at Stage 10. Then they were separated into six groups, A through F, as shown in Figure 13. All joists in each group were considered to be affected, in substantially the same manner, by the partition arrangement within each group, and the data were tabulated and analyzed accordingly.

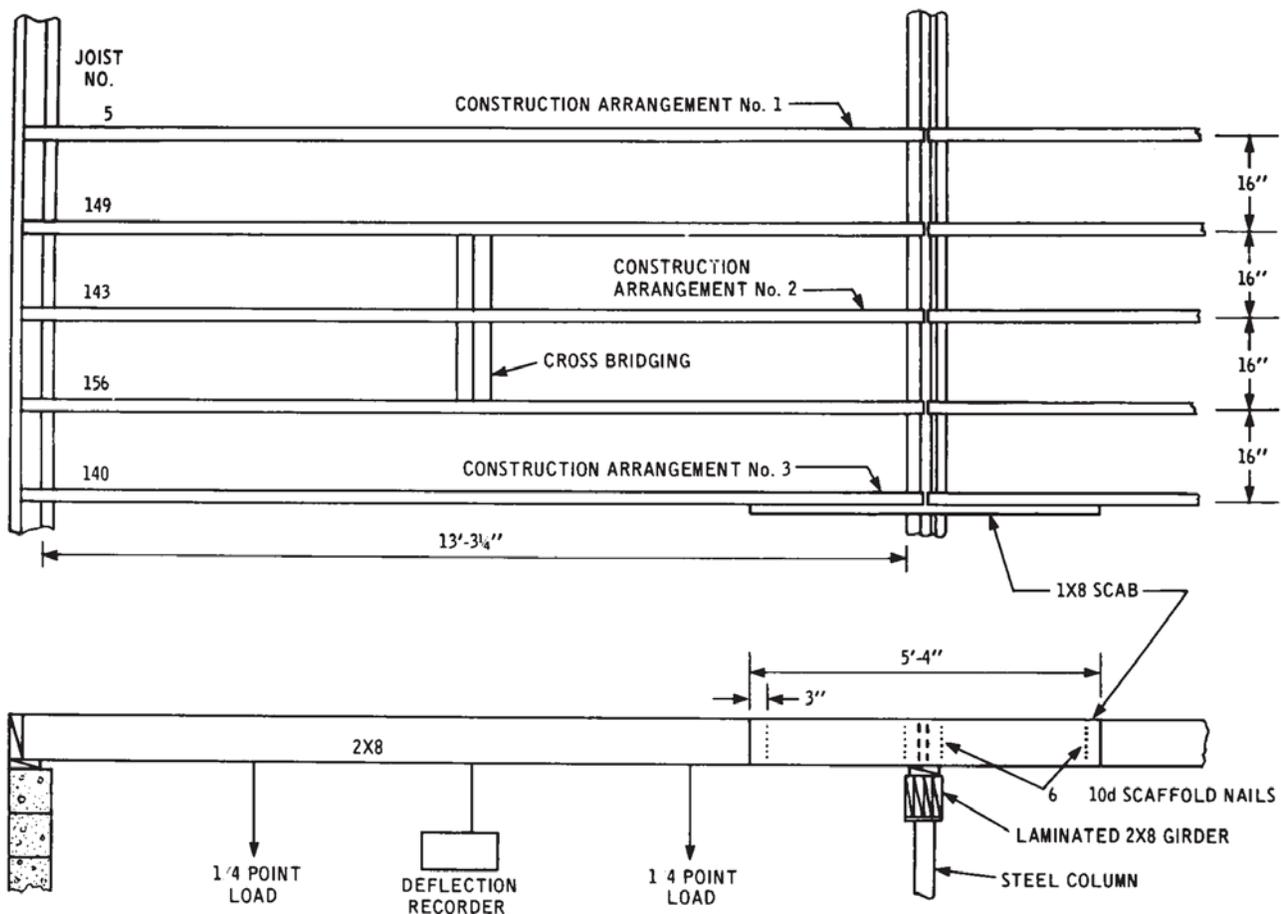
Figure 14. Some of the construction and testing arrangements used in the study.

Individual joist deflections were recorded at 14 stages of construction, as indicated in Table 1. Every joist was loaded simultaneously at the quarter points, as shown in Figure 14. The standard load, which was repeated for each stage of construction, was accomplished by applying 110 pounds and then 330 pounds, at the quarter points, which induced about 300 psi and 900 psi bending stress for Construction Stage No. 1.

Stage No.	Description
1.	Band fastened to ends of joists with three 16d nails, no tie over center support. See Figure 14.
2.	Same as No. 1, except cross bridging added at midspan of joist. See Figure 14.

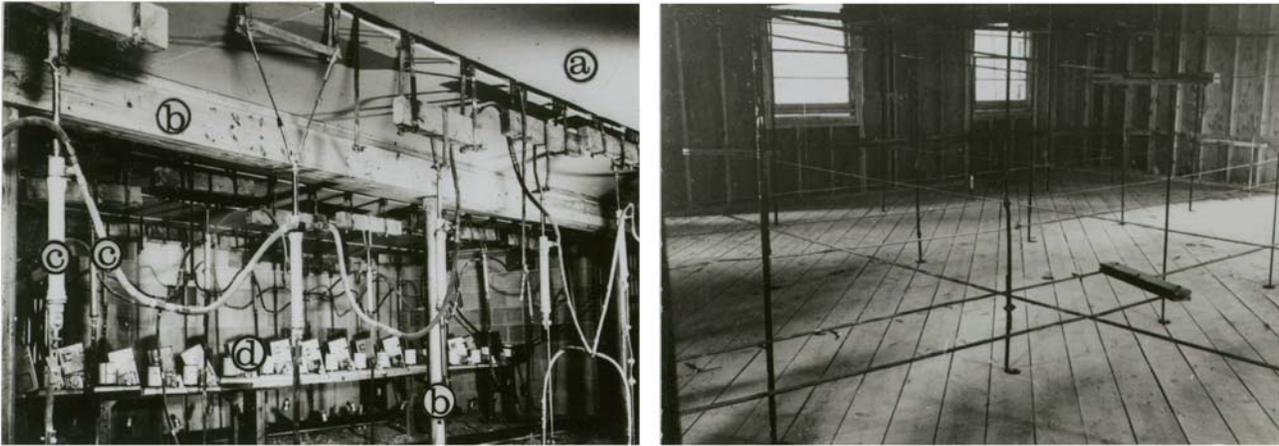
Figure 15. Basement Ceiling and Subfloor.

Photo at left shows: (a) ½-inch sheetrock ceiling with slot through which rigging passes to connect loading cylinders to joists; (b) center beam and steel columns; (c) hydraulic loading cylinders and flexible hose connections; and (d) deflection recorders. At right, a view of the interior after partitions and sheetrock finish were removed.

13.	Same as No. 12, except 1" x 8" scab over center support was removed.
14.	Same as No. 12, except ½-inch sheetrock ceiling was applied to bottom of joists. See Figure 15.

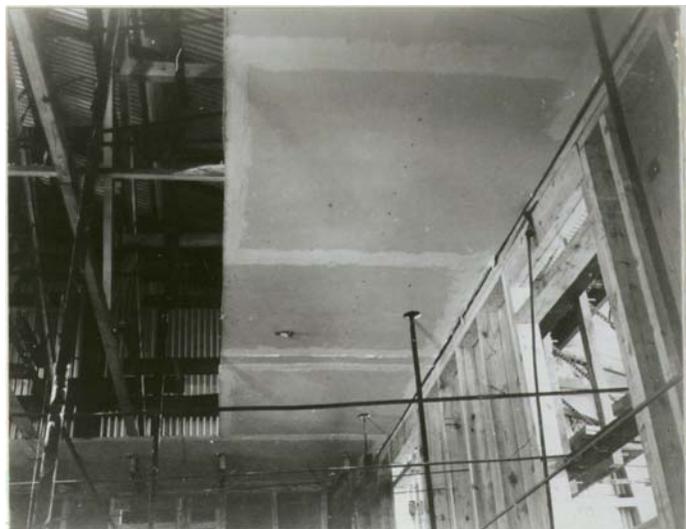
View of ceiling during Dismantling Stage No. 7, showing a 4-foot strip of ½-inch sheetrock adjacent to leeward end and side. As it was obvious that practically all resistance to outward movement, at the top plate, would be removed with the ceiling, the 4-foot strip of sheetrock was left in place, to see how effective it would be. The end wall pulled away from the sheetrock at 12 psf.

Stage No.	Description
1.	House structurally complete with $\frac{3}{8}$ -inch exterior plywood sheathing; 1" x 8" roof sheathing; $\frac{1}{2}$ -inch sheetrock on walls, partitions and ceilings.
2.	Same as No. 1, except sheetrock joints weretaped and plastered.
3.	Same as No. 1 and 2, except sheetrock was removed from partitions.
4.	Same as No. 1 and 2, except partitions were removed.
5.	Same as No. 1 and 2, except partitions and sheetrock on walls were removed.
6.	Same as No. 1 and 2, except partitions, wall sheetrock, and roof sheathing removed.
7.	Same as No. 6, plus removal of all sheetrock ceiling, except a 4-foot strip adjacent to the leeward end and side wall. See Figure 16.

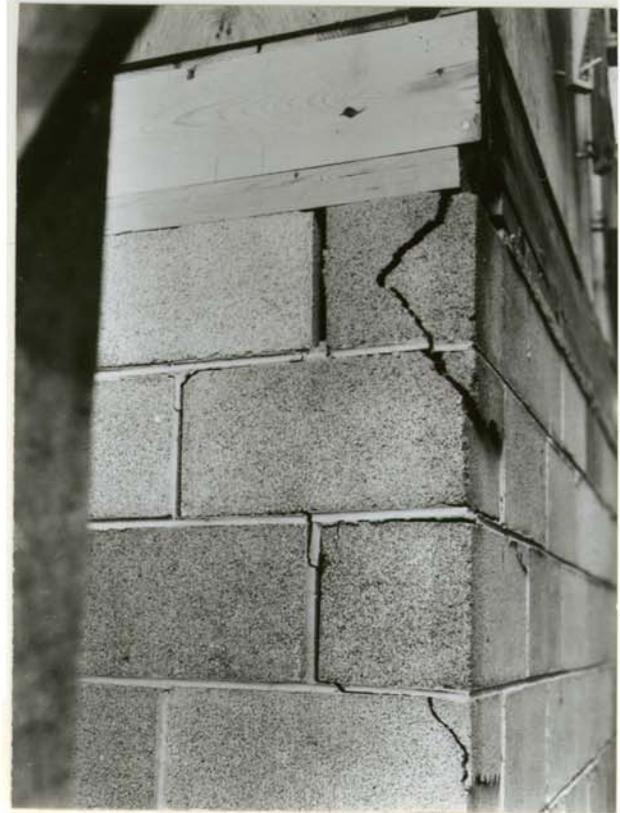
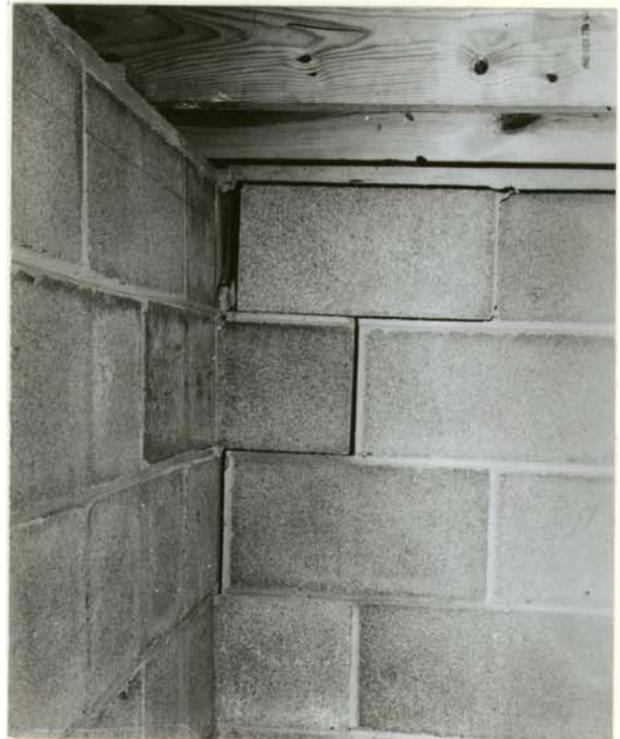
Figure 17. Foundation Failure.

All four corners and both side walls cracked within one minute after 20 psf were applied to the four walls and two roof surfaces. Photos, above, show foundation failure at the outside and inside corner of leeward side and end.

A foundation failure, within one minute after 20 psf were applied to all exterior surfaces, complicated this part of the study because the house could move on its foundation, in spite of strong anchorage and guys on the "up-wind" side. The ½-inch sheetrock ceiling, in combination with ¾-inch plywood wall sheathing, appeared to be very effective in resisting horizontal movement. However, other combinations, such as ¾-inch plywood wall sheathing and partitions with sheetrock in place, could be expected to show more resistance if the ceiling had been removed first.

All surfaces were subjected to the same pressures in 4 psf increments up to 16 psf. Each increment of load was cycled on and off three times in 6-minute cycles. Pressures well in excess of 20 psf were scheduled, but the foundation failed (See Figure 17) within one minute after 20 psf were applied.

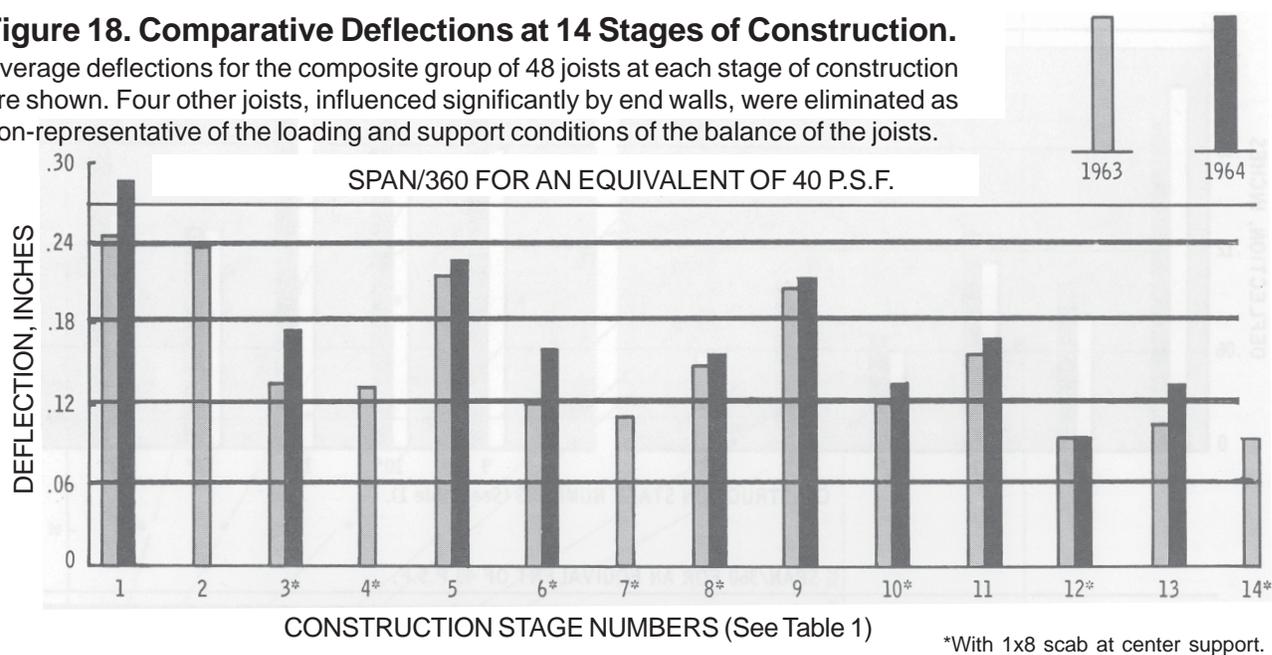
Figure 18. Comparative Deflections at 14 Stages of Construction.

Average deflections for the composite group of 48 joists at each stage of construction are shown. Four other joists, influenced significantly by end walls, were eliminated as non-representative of the loading and support conditions of the balance of the joists.

Average deflection for the composite group of 48 joists, at each stage of construction, is shown in Figure 18. A better comparison of average deflections is provided by Figure 19, which considers the five groups after partitions were installed. Construction Stage No. 9 is included in Figure 19 to emphasize the significant reduction of deflection in groups under partitions, while deflections usually increased slightly for those groups without partitions.

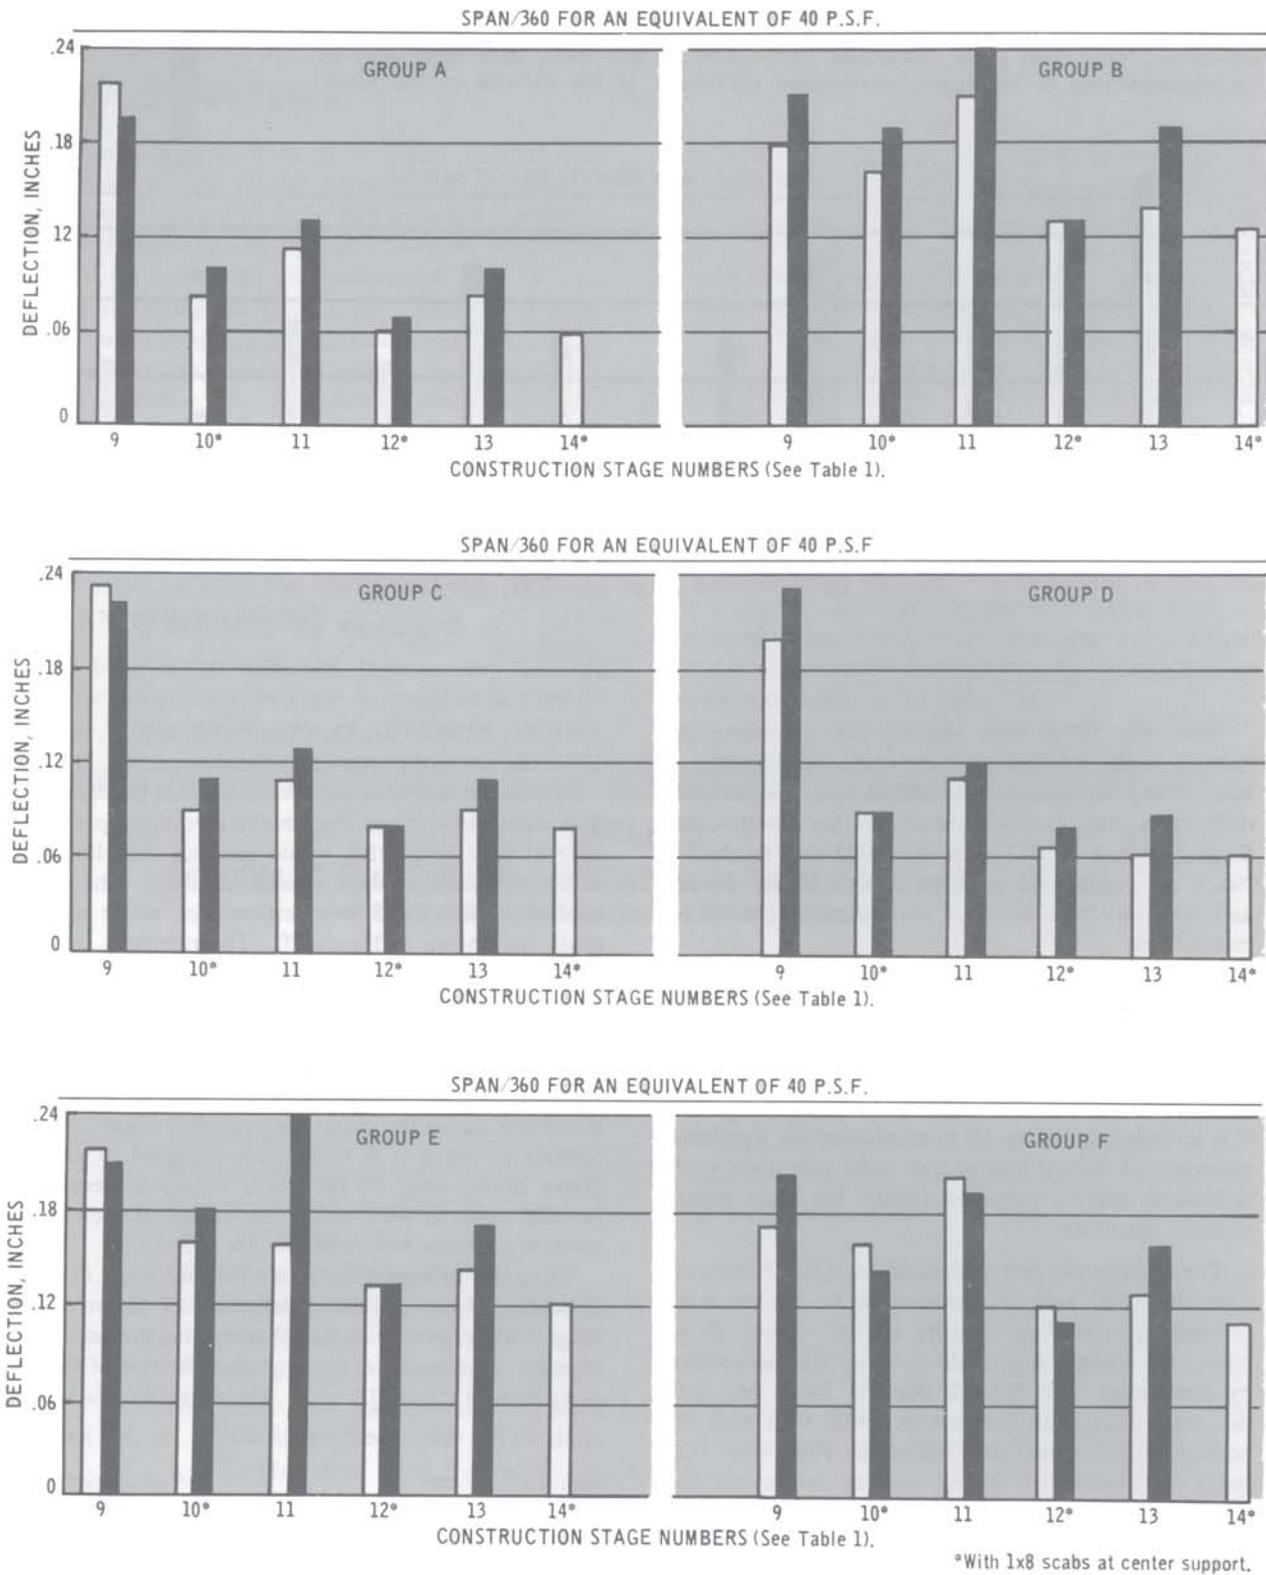
Figure 19. Comparative Deflections by Groups.

Average deflections for six groups, in the last six stages of construction, are shown by the open bars for 1963, the solid ones for 1964.

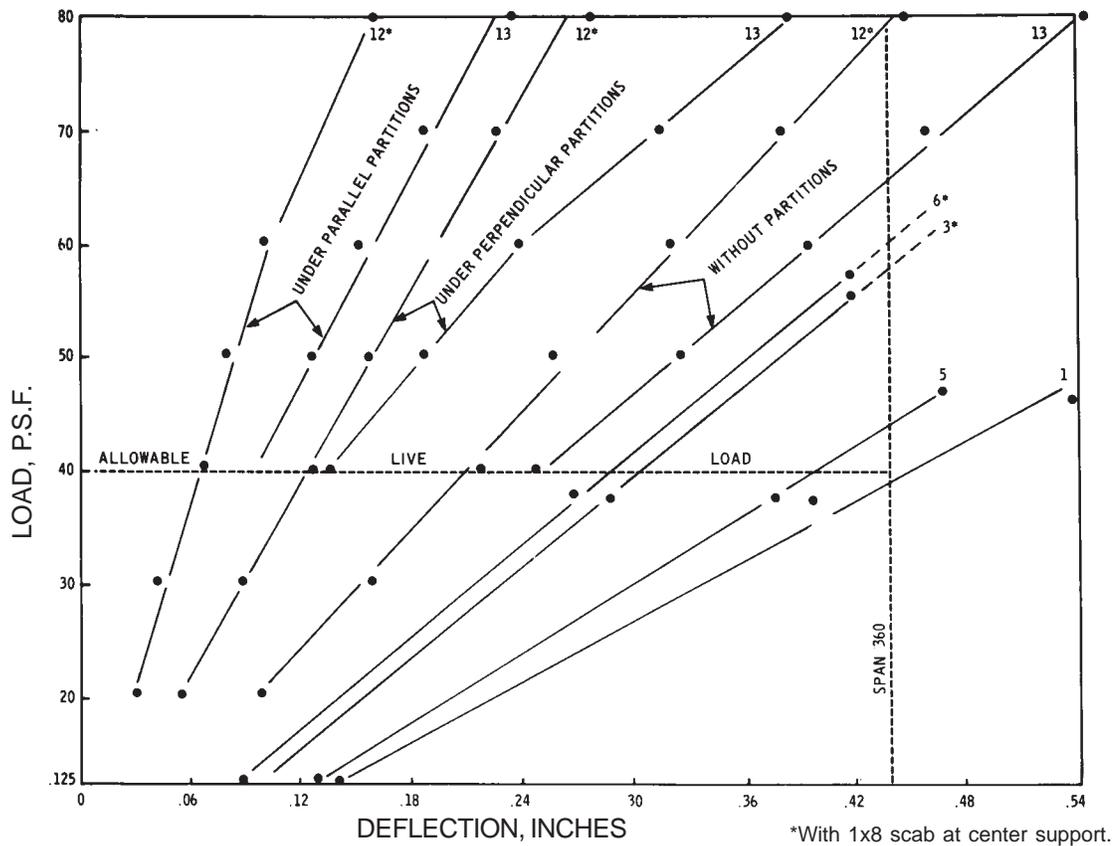
Figure 20. Floor Joist Deflections at Selected Stages of Construction.

The cyclic application of 40 psf on the floor, in 1964 at Stage 12, produced no creep, set, or change in deflection at the end of 529 cycles. Since the 1964 deflections were slightly more than in 1963, and cyclic loading had no effect, aging may be more important to structural performance than repetitive loads within the elastic limits.

Referring again to Figure 20, it can be seen that partitions parallel to and over joists are the most effective

in reducing deflections. This is because partitions, when connected to the floor by a bottom plate, tend to act as deep beams, and as cantilever beams if fastened to a wall. Partitions also act as suspension supports from the ceiling, if fastened to bottom chord of roof trusses.

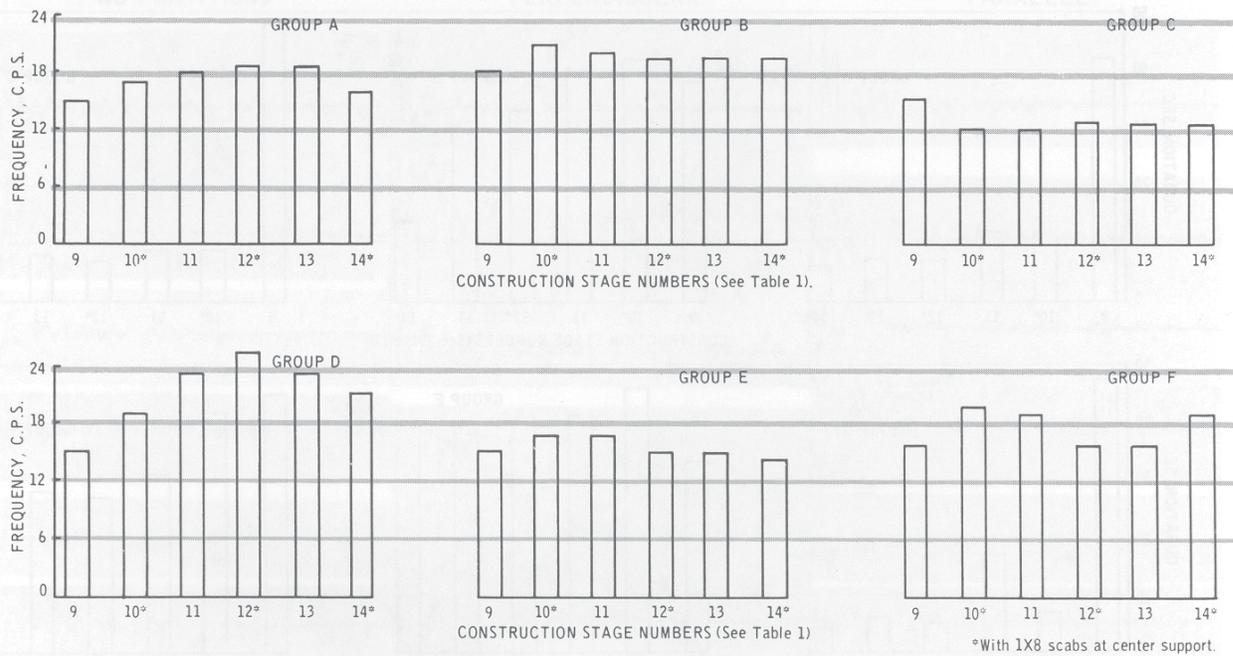
Figure 22. Comparative Vibration Frequencies by Groups.

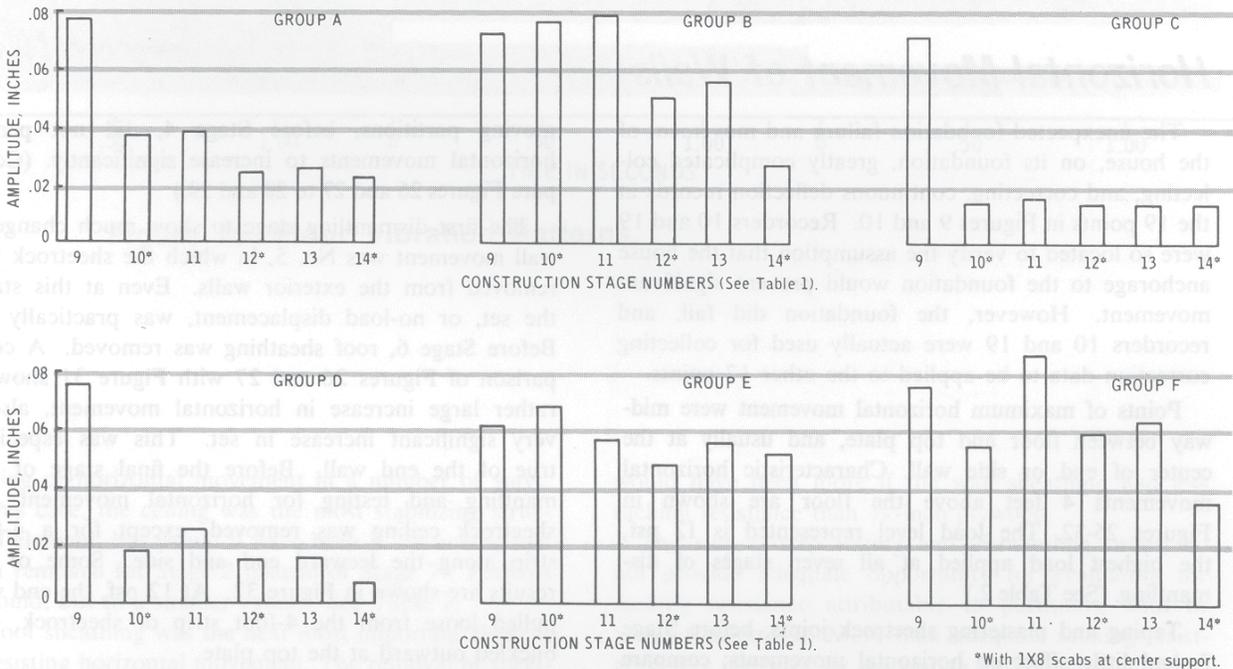
Figure 23. Comparative Vibration Amplitude by Groups.

Vibration amplitude does not seem to be affected by bridging, but scabbing reduced it slightly. Hardwood flooring and 1/2-inch sheetrock ceiling were also quite effective in reducing amplitude; but partitions were, by far, the most effective of all modifications.

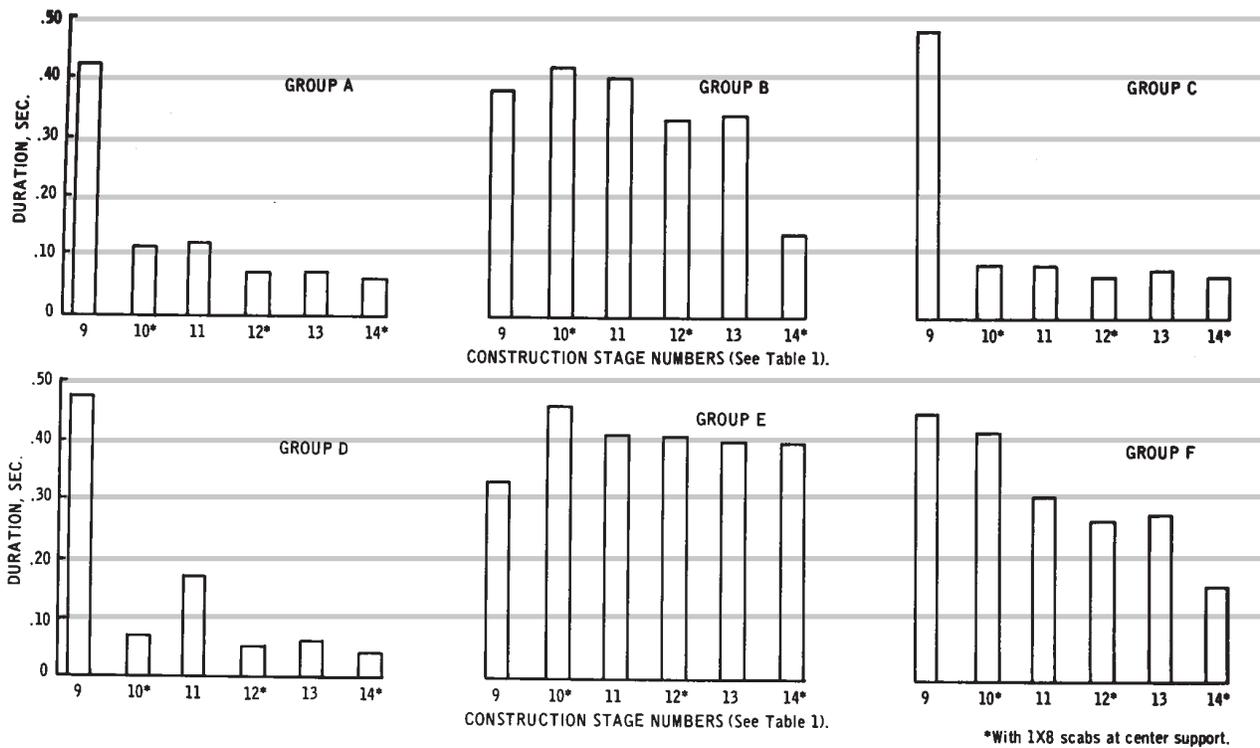
Figure 24. Comparative Duration by Groups.

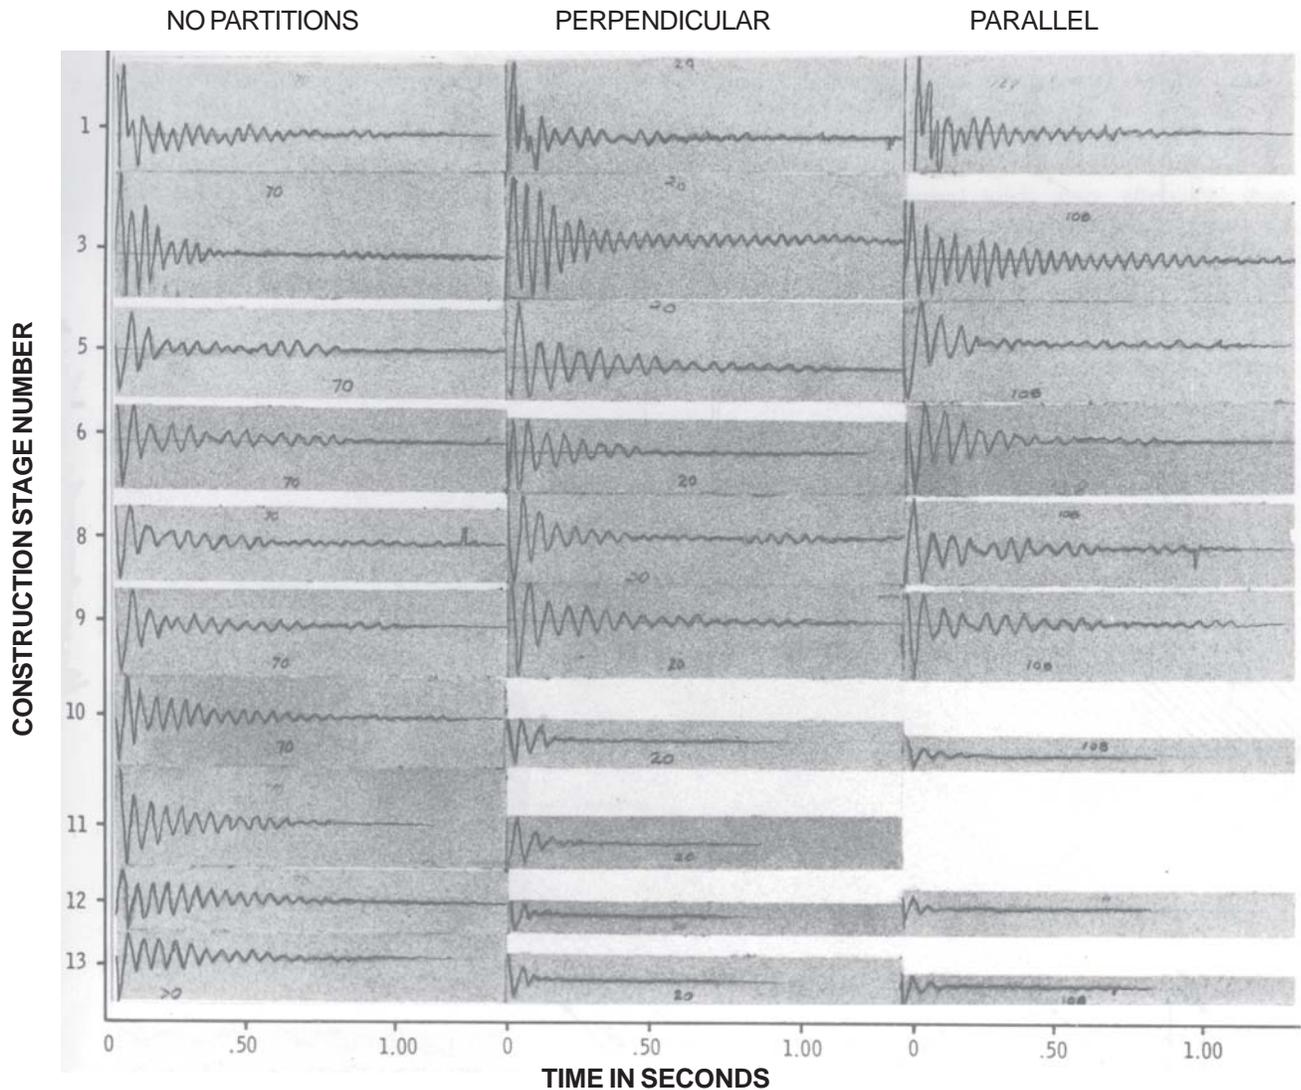
FLOOR VIBRATIONS WITH JOISTS AND PARTITIONS

Figure 25. Floor Vibration Patterns.

Duration does not seem to be affected by bridging or scabbing, but Figure 25 shows how very effective are partitions in practically stopping floor vibrations. Finish flooring and 1/2-inch sheetrock ceiling also reduced duration, significantly, in non-partitioned areas.

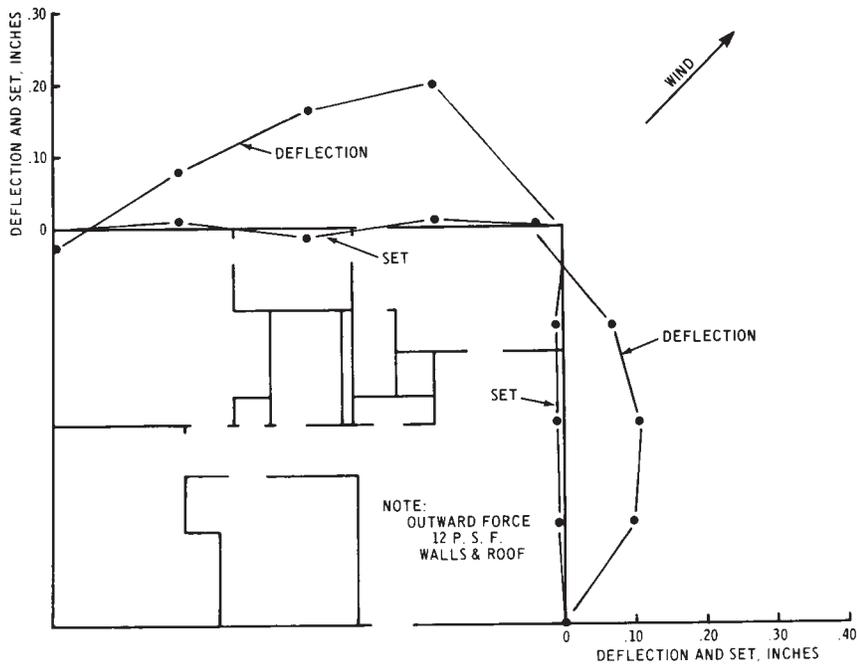
Figure 26. Stage No. 1.

WALL MOVEMENT
4 feet above floor
 (See Table II)

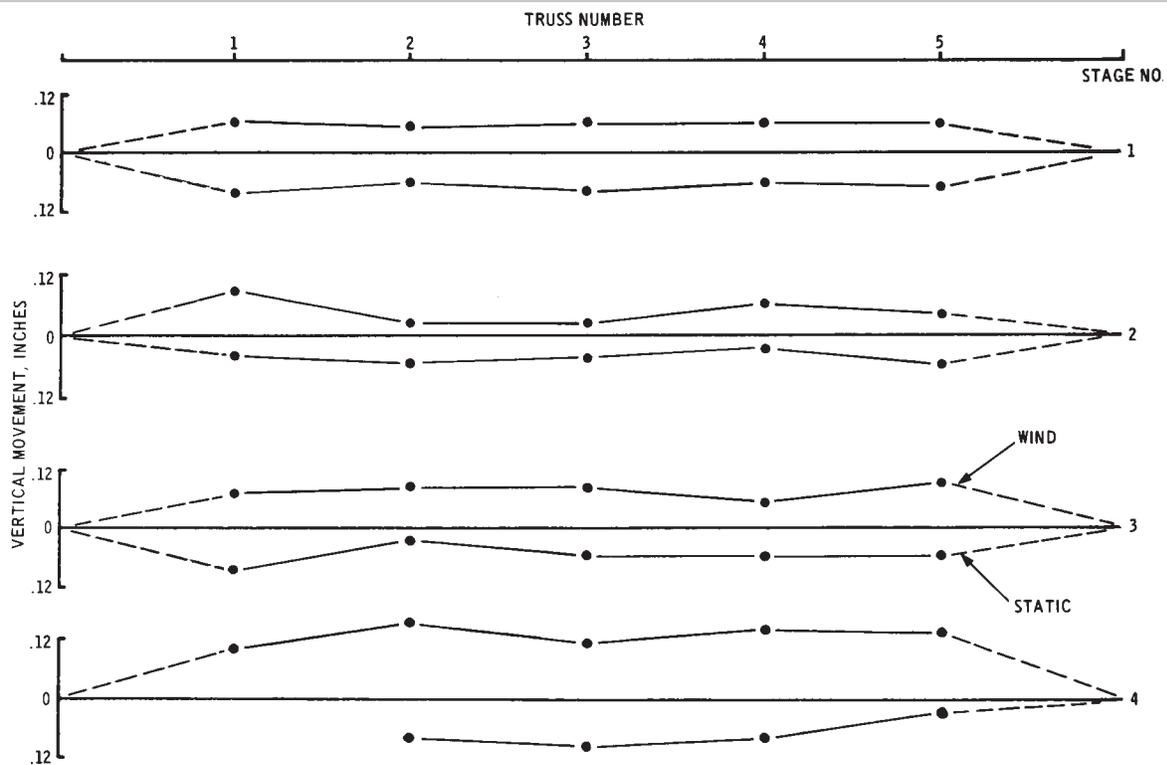
Figure 33. Vertical movement at the crown for dismantling stages 1-4, loaded to 12 psf. (See Table 2 and Figure 11.)
