The Wood-Frame House as a Structural Unit

Presented at the 1965 Meeting
of the Wood Engineering Division
of the
FOREST PRODUCTS RESEARCH SOCIETY
New York, New York
June 26 - July 1

A full-scale house, 28' x 36', was structurally evaluated as a unit, by subjecting it to various combinations of simulated wind and gravity loads while continuously recording deflections at 29 points. Rigidity, attributable to members, components, and such structural elements as sheathing, flooring, and sheetrock, was also evaluated. Floor deflections and vibrations were recorded for 14 stages of construction, and racking tests were conducted at 7 stages of dismantling.

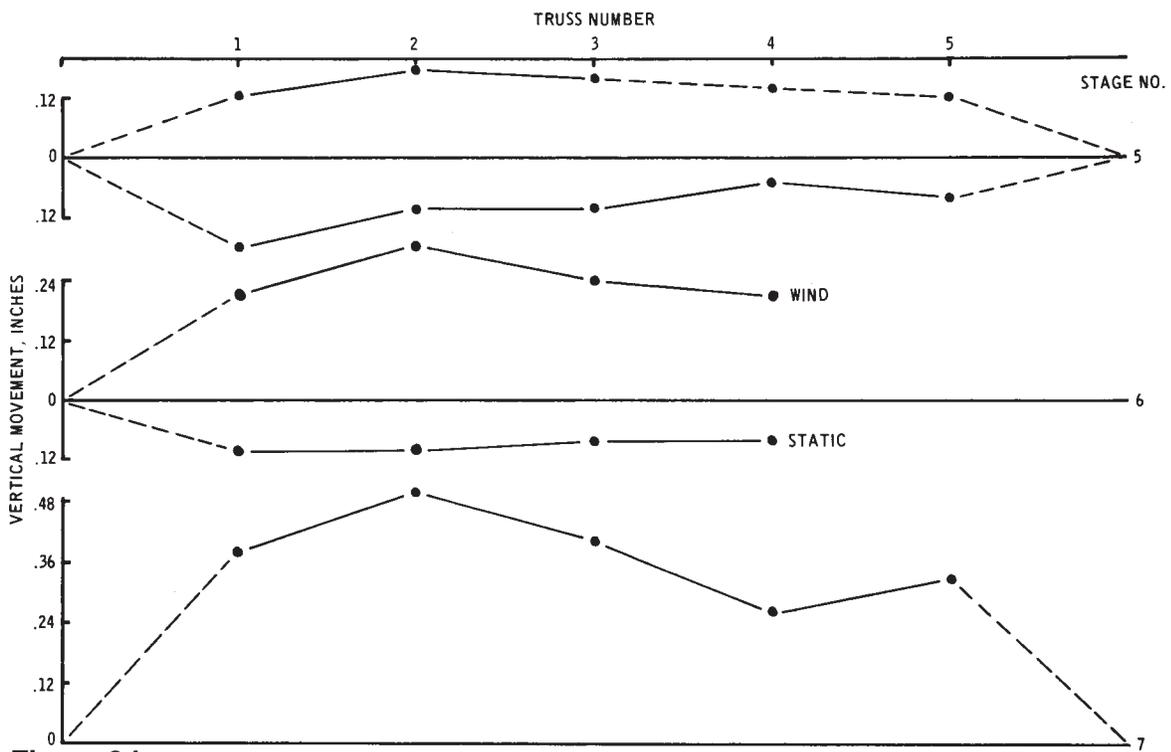
Figure 34. Vertical movement at the crown for dismantling stages 5-7, loaded to 12 psf. (See Table 2 and Figure 11.)

Vertical movement of crown and chord was recorded for five trusses, as indicated in Figure 12. Vertical movements in both directions, at 12 psf, are plotted in Figures 33 and 34 for all seven stages of dismantling, except the 12 psf gravity load was inadvertently omitted after the wind-load failure in Stage 7.

The roof structure appeared to be more resistant to gravity load than to wind load, as indicated in Figure 34. A possible reason is that the metal-plate-connected truss resists downward loads more effectively than upward loads. Another reason is that the same live loads were repeated for each stage. No adjustments were made for the decrease in dead load from one stage to another. Originally, adjustments in live load to compensate for changing dead load seemed unnecessary, since all loading was intended to be well within the elastic limit.
