# Energy Conservation Study

A PERFORMANCE  
COMPARISON OF  
A WOOD-FRAME  
AND A  
MASONRY STRUCTURE

American Forest & Paper Association

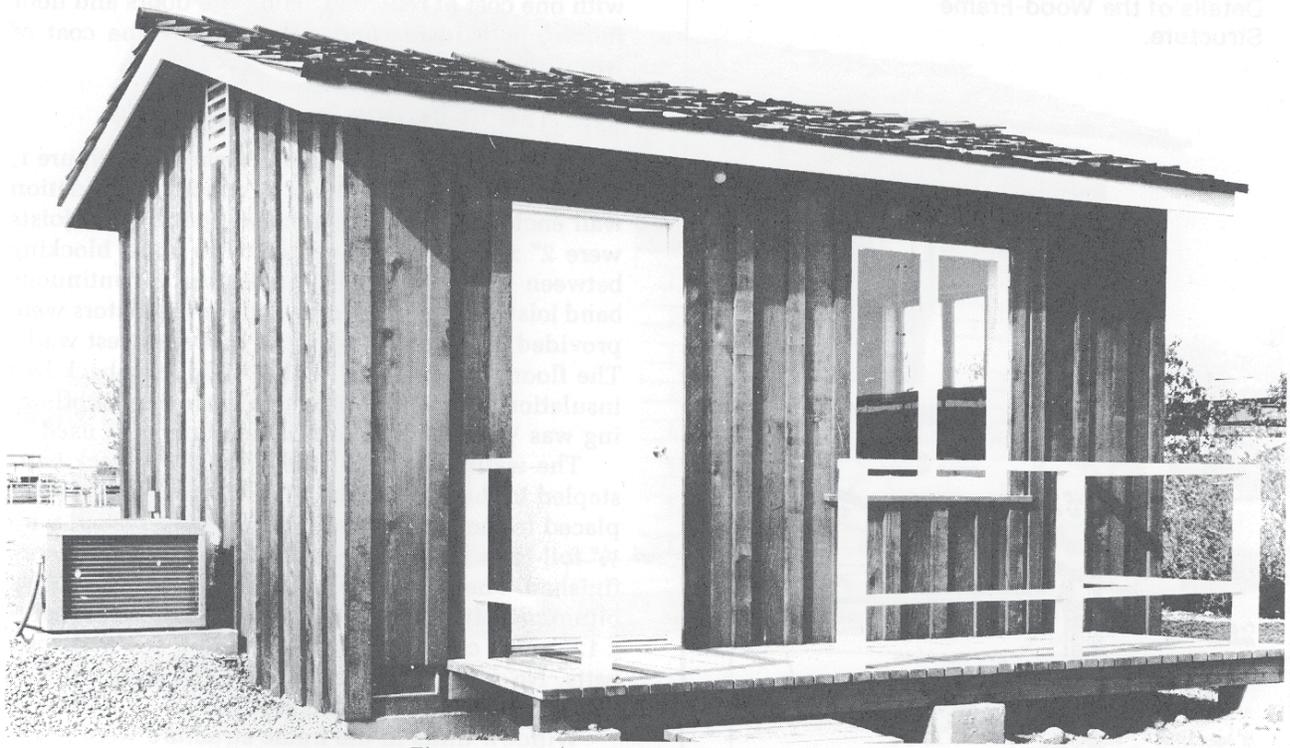
**Figure 1— Wood- Frame Test Structure**

The wood-frame test structure, shown in Figure 1, was erected on a continuous 8" concrete foundation wall enclosing an 18" deep crawl space. Floor joists were 2" x 8" at 16" on center, with solid blocking between the ends of joists instead of a continuous band joist. Four 4" x 14" crawl space ventilators were provided, divided between the east and west walls. The floor was insulated with 2" thick foil-back batt insulation with the foil placed to the inside. Subflooring was 1/2" plywood. No finished floor was used.

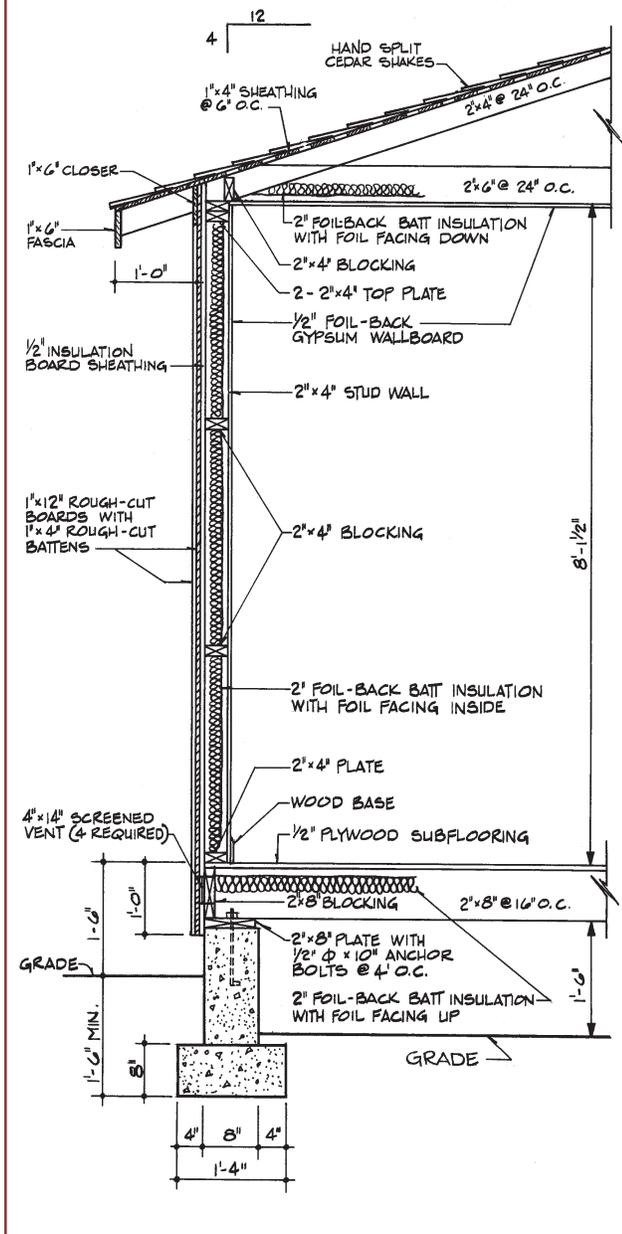
**Figure 2—Construction Details of the Wood-Frame Structure**

The walls were insulated with 2" foil-back batts stapled to the sides of the 2" x 4" studs with the foil placed to the inside. The interior was finished with 1/2" foil-back gypsum drywall; joints were taped and finished. The exterior wall covering consisted of 1/2" bituminous fiberboard sheathing clad with vertical 1" x 12" rough cut redwood boards and 1" x 4" redwood batts. No coating was applied to the exterior wall surfaces of the frame structure.

Window units in the frame structure were of the casement type, with wood sash and frames. Special frame units were needed to provide the same glass area as in the masonry building. A wooden porch 13' long by 4' 3" wide was installed on the east side of the structure.

Construction details for the wood-frame test structure are shown in Figure 2.

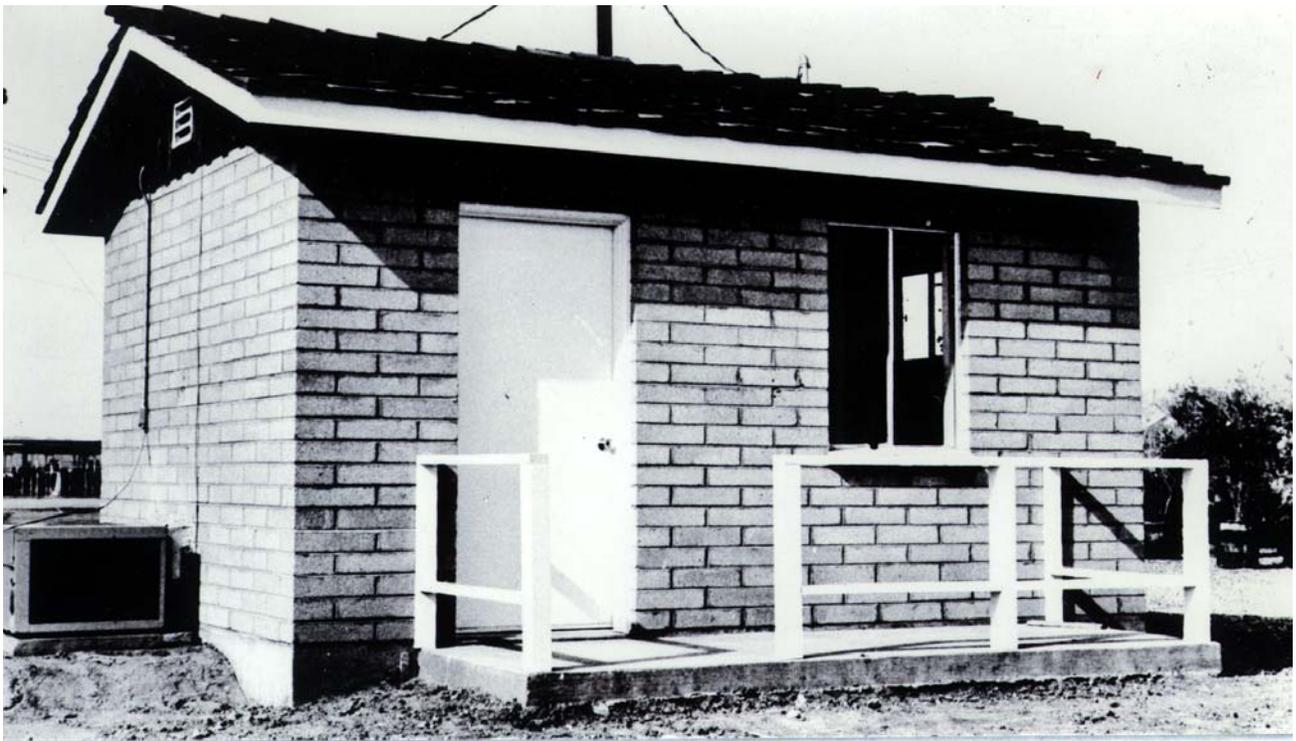
Figure 3—Masonry Test Structure

The masonry test structure, shown in Figure 3, was erected on a 4" concrete slab. The slab was placed over compacted earth fill topped by 4" of gravel and a 6 mil polyethylene vapor barrier. No finish floor was installed on the slab.

Walls were constructed of 4" x 8" x 16" two-core, three-web scoria building block. This block, a typical and common building material for the Arizona region, utilizes quarried volcanic cinders as the coarse aggregate. Loose vermiculite fill was placed in the core voids to insulate the masonry block. Although the majority of block homes in the Phoenix region do not utilize core insulation, the vermiculite was added to provide a *better*

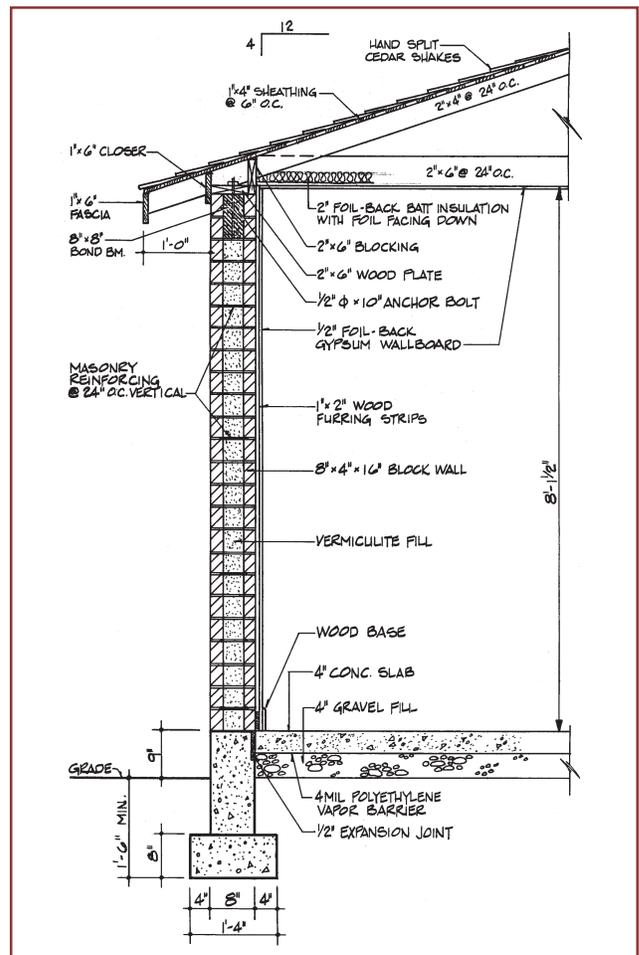
Figure 4—Construction Details of the Masonry Structure

The interior of the masonry structure was finished with ½" foil-back gypsum drywall nailed to 1" x 2" vertical furring strips placed 2' on center. Drywall joints were taped and finished.

The gable ends of the masonry structure were framed and clad with the same materials as the walls of the wood-frame structure. A 4" concrete slab porch 12' 8" long and 4' wide was provided on the east side of the masonry structure. Wood railings and posts were installed.

Construction details of the masonry test structure are given in Figure 4.

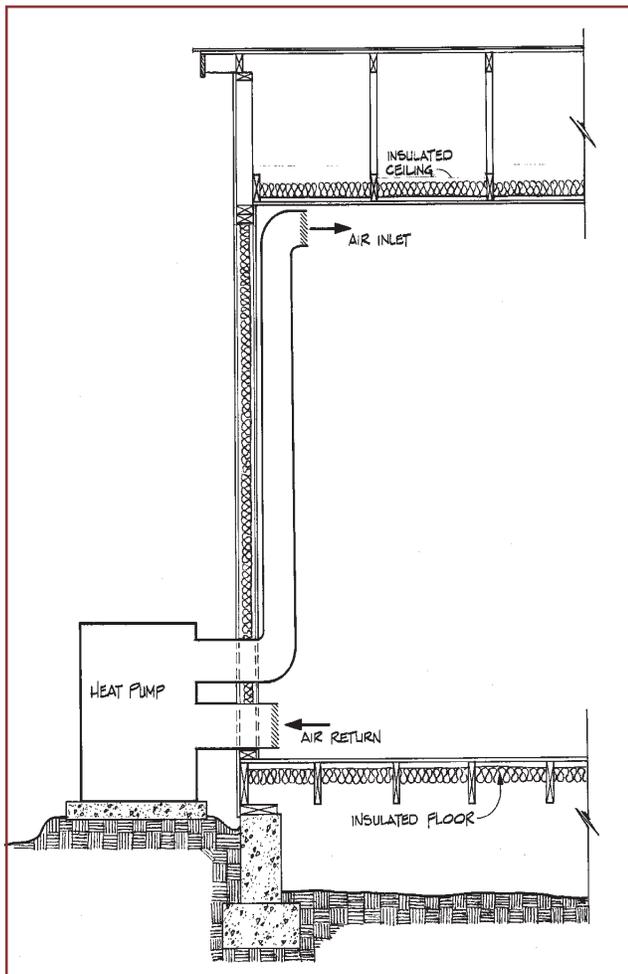
**Figure 5—Schematic of Heat Pump and Ductwork Installation**

Each structure was equipped with a heat pump rated at 17,000 British thermal units per hour (BTU/hour) to provide appropriate interior temperature regulation during periods requiring heating or air-conditioning or both. The heat pump capacity was determined by calculating theoretical heat losses and heat gains through the various elements of each building. Figure 5 illustrates the heat pump and ductwork installation for the test structures.

The heat pumps were installed on concrete slabs adjacent to the south wall of each structure. The metal ductwork entered the structure above the floor level with the exposed ductwork extending to approximately 18" below the ceiling and containing an adjustable register. The return air opening was placed at floor level and adjacent to the incoming duct.

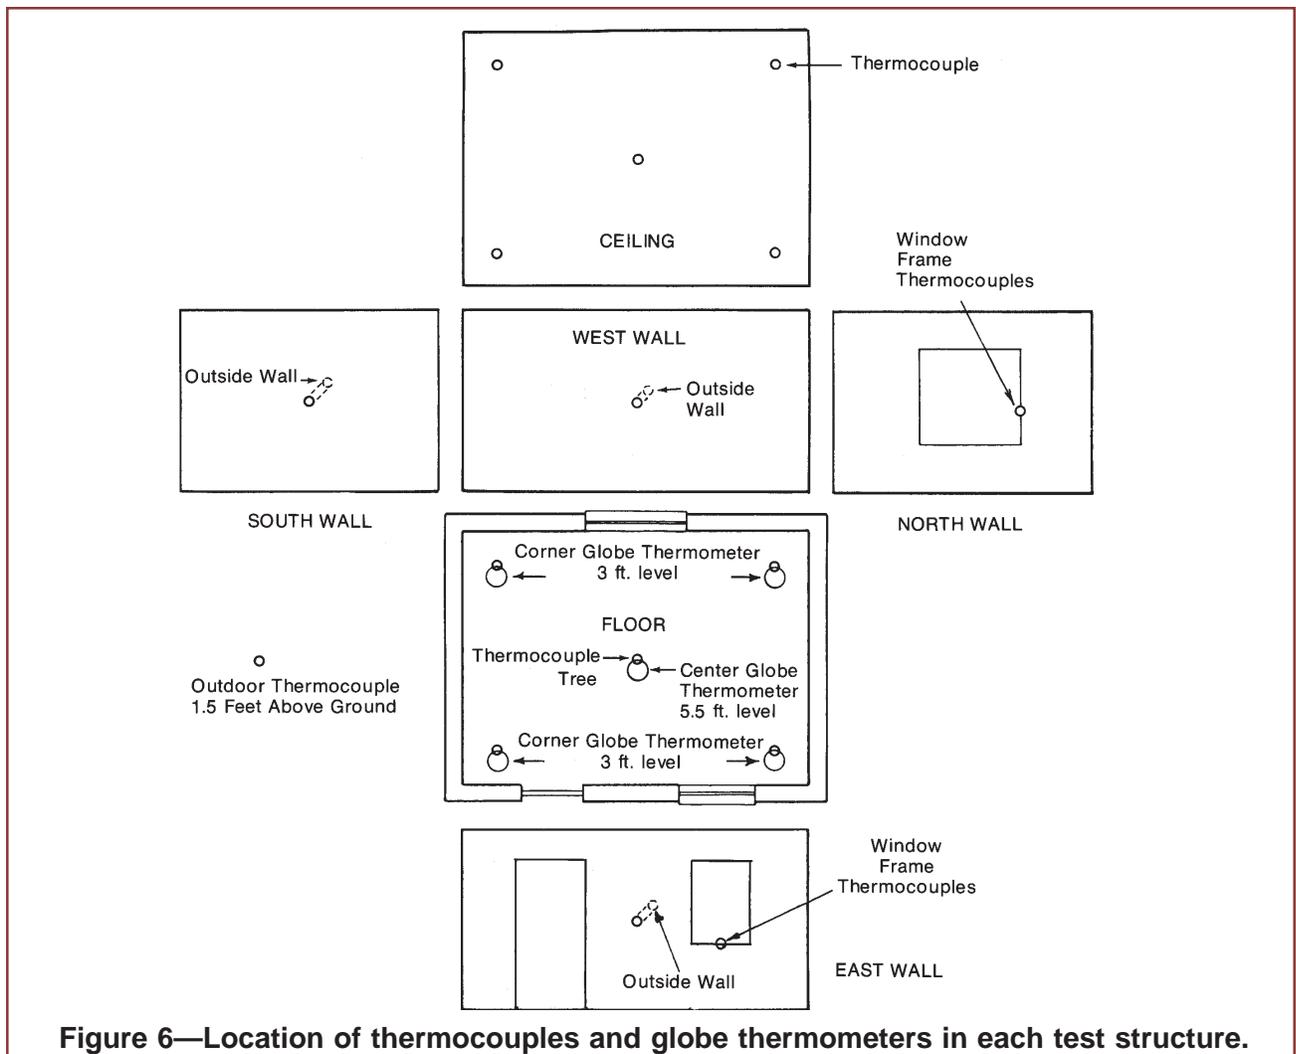
Figure 6—Location of thermocouples and globe thermometers in each test structure.

Figure 6 shows the locations of the thermocouples and globe thermometers used in both test structures.

Temperatures of the exterior wall surfaces at the center of the wall were measured by thermocouples on the surface of the wood siding or the masonry exterior. These were located directly opposite the thermocouples at the center of the interior wall surfaces to determine the temperature differential between the outside and the inside surfaces.

Window frame temperatures were also recorded. Thermocouples were fastened to the interior and the exterior surfaces of each wood and aluminum window frame.

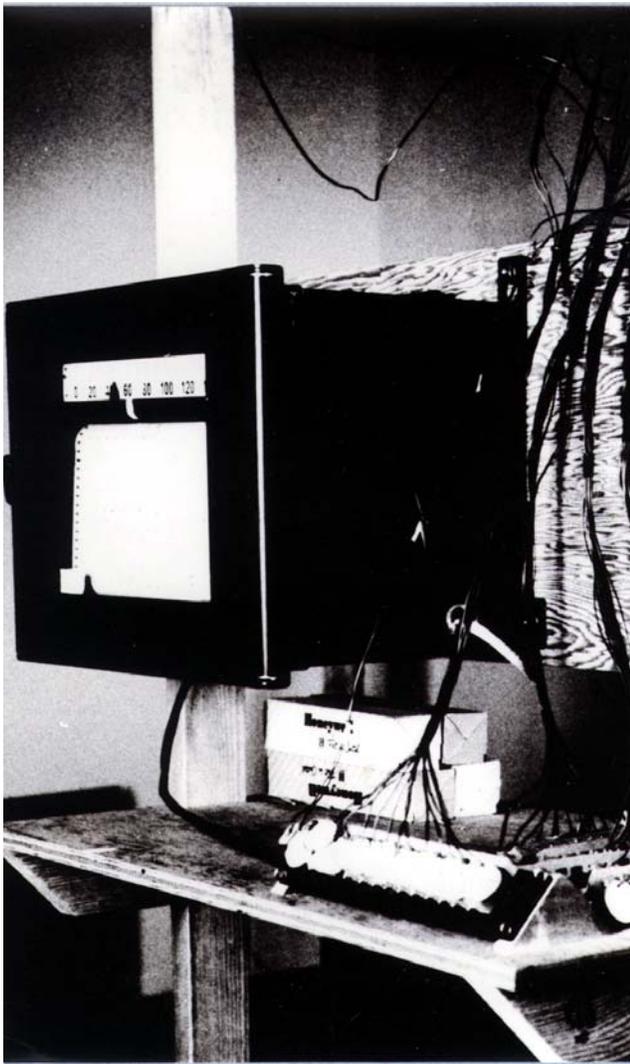
Figure 7—Recording Potentiometer.

Each test structure was equipped with a Honeywell type 153 ELECTONIK 16 point recording potentiometer. It was equipped with a 16 point print wheel and provisions for continuous recording on paper rolls. The recording cycle produced one recording every two minutes. An illustration of one potentiometer with connecting attachment appears in Figure 7. The instruments were regulated to simultaneously record the temperatures of identical thermocouples in each test structure, resulting in an accurate comparison of conditions in both structures. Both instruments were serviced and calibrated for accuracy by certified technical representatives.

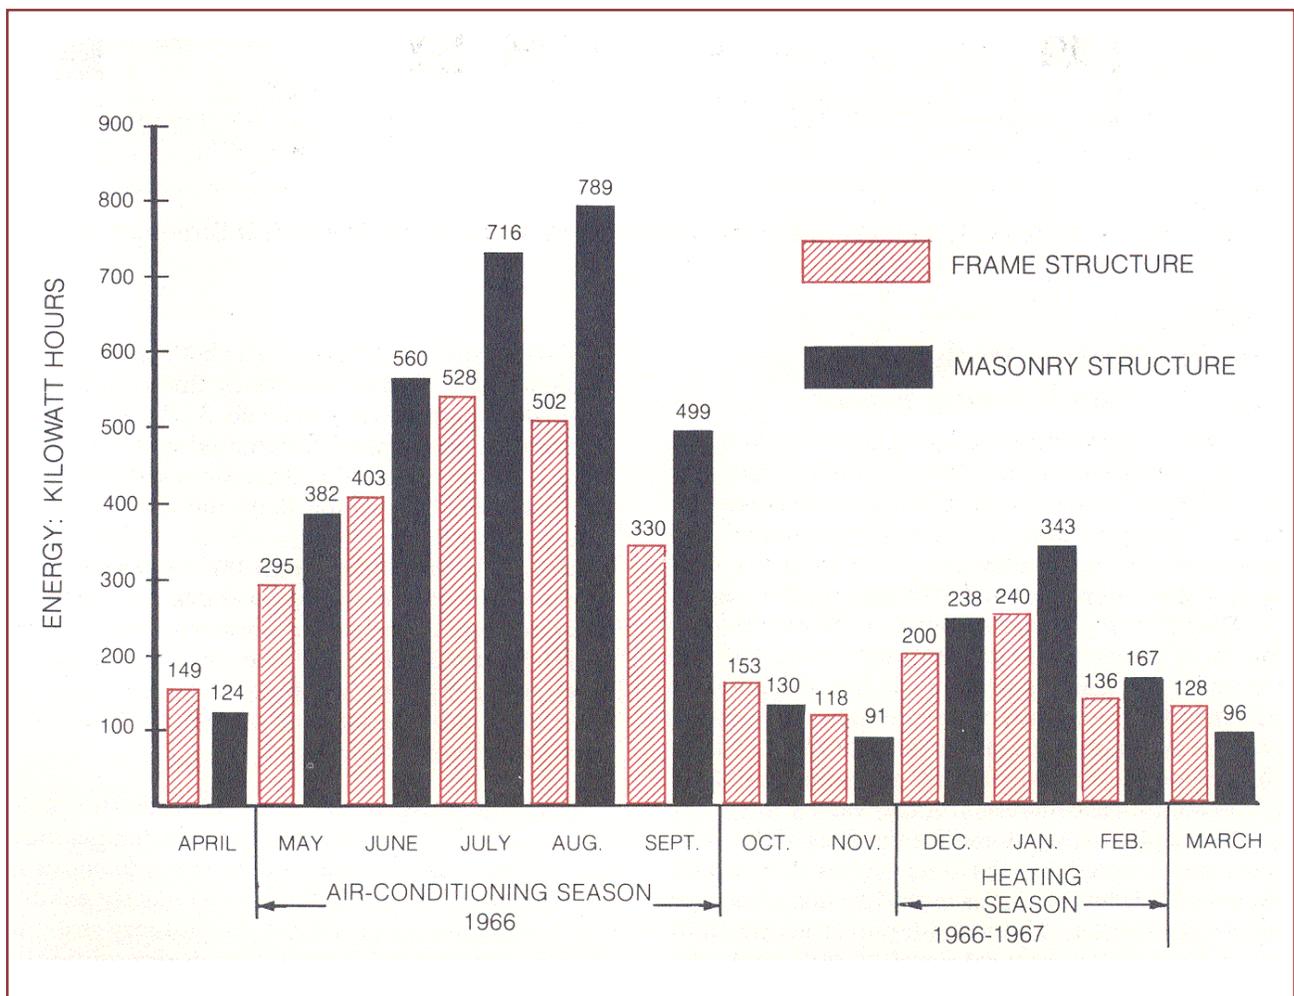
Figure 8—Monthly Power Consumption.

The quantities of electricity required to maintain a constant temperature in both the frame structure and the masonry structure during the 12 month test period, April 1, 1966 through March 31, 1967, are shown in Figure 8. Kilowatt hours of fuel consumption are tallied for each calendar month. For the total test period the masonry block building consumed 4,135 kilowatt

hours of electricity, while in the same period the wood-frame structure consumed 3,182 kilowatt hours.

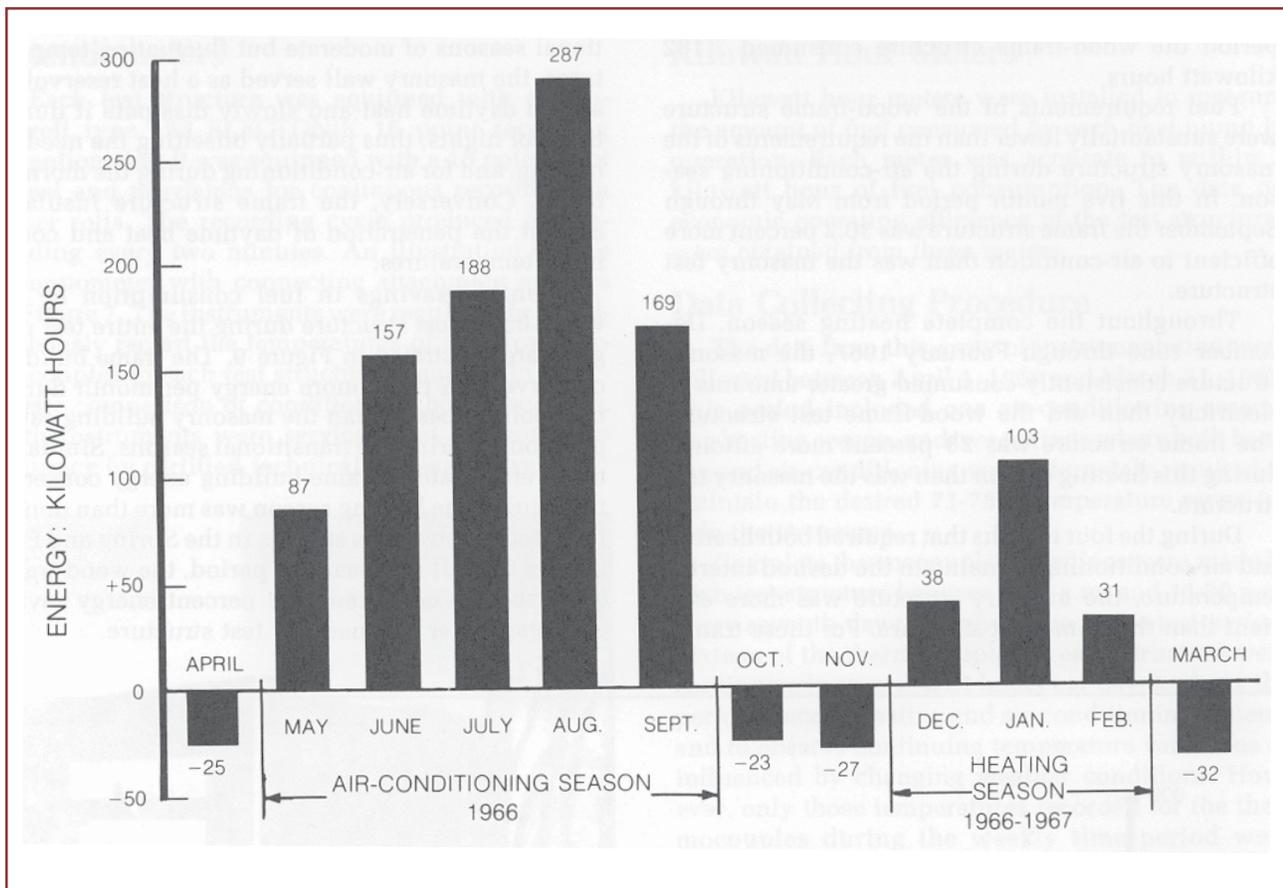
**Figure 9—Monthly Savings in Energy Consumption by the Wood-Frame Test Structure.**

Monthly savings in fuel consumption by the wood-frame test structure during the entire test program are illustrated in Figure 9. The frame building conserved 6½ times more energy per month during the cooling season than the masonry building saved per month during the transitional seasons. Similarly, the average rate of frame building energy conservation during the heating season was more than double the masonry structure savings in the Spring and Fall. During the full one-year test period, the wood-frame test structure exhibited a 23 percent energy saving advantage over the masonry test structure.
