FULL-SCALE TESTS IN A FURNISHED LIVING ROOM TO EVALUATE THE FIRE PERFORMANCE OF PROTECTED CROSS-LAMINATED AND NAIL LAMINATED TIMBER CONSTRUCTION

FINAL REPORT

SwRI® Project No.: 01.21428.01.001

American Wood Council
222 Catocin Circle SE
Leesburg, VA 20175

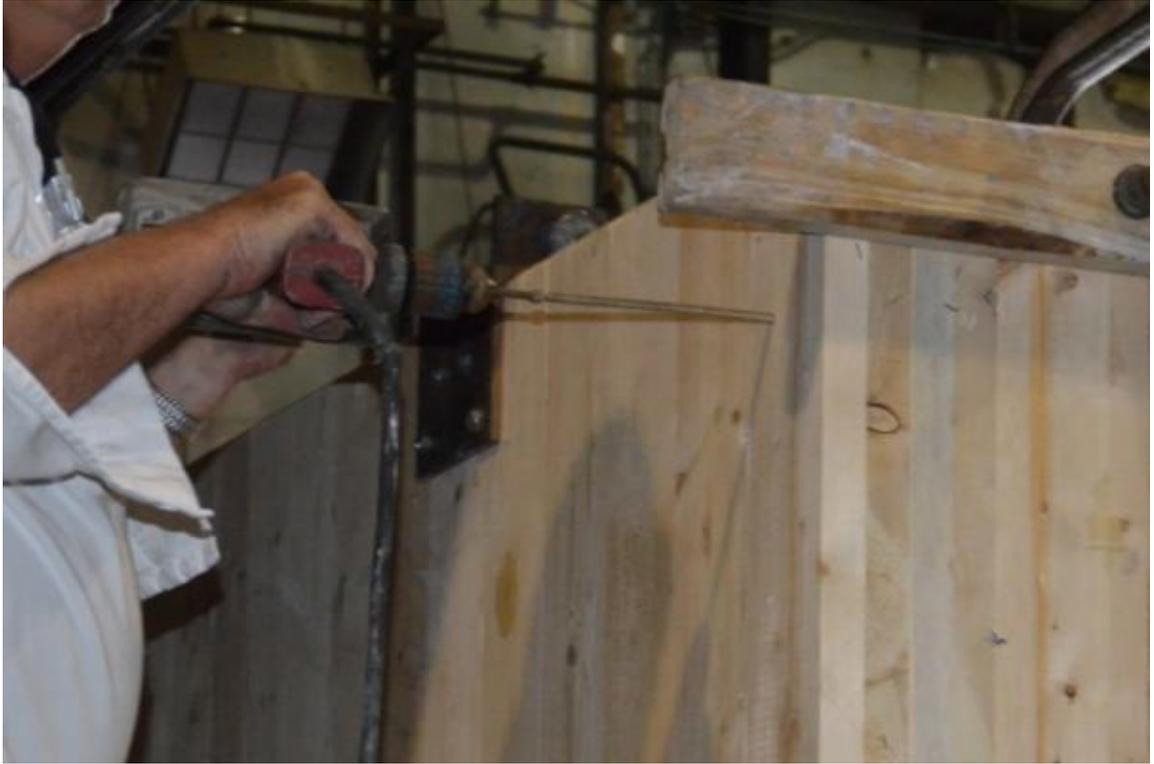
Figure B-1. CLT Connection.

The walls of the test room were constructed from CLT panels (CrossLam™) made by StructurLam, located in Penticton, BC, Canada. The CLT panels consisted of five layers of spruce-pine-fir (SPF) lumber stacked at right angles and glued together into 7-in. (175-mm) thick panels. The front wall, back wall, and each side wall of the compartment consisted of a single continuous panel (see Figures A-1 through A-3). The panels were connected with $\frac{5}{16} \times 11\frac{3}{4}$ -in. (8 × 300-mm) screws with a $\frac{7}{8}$ -in. (200 mm) spacing, as shown in Figure B-1. A schematic and picture of the CLT wall assembly are shown in Figures 1 and B-2, respectively. The dimensions in Figure 1 are the interior dimensions of the compartment after attaching the two layers of gypsum board.

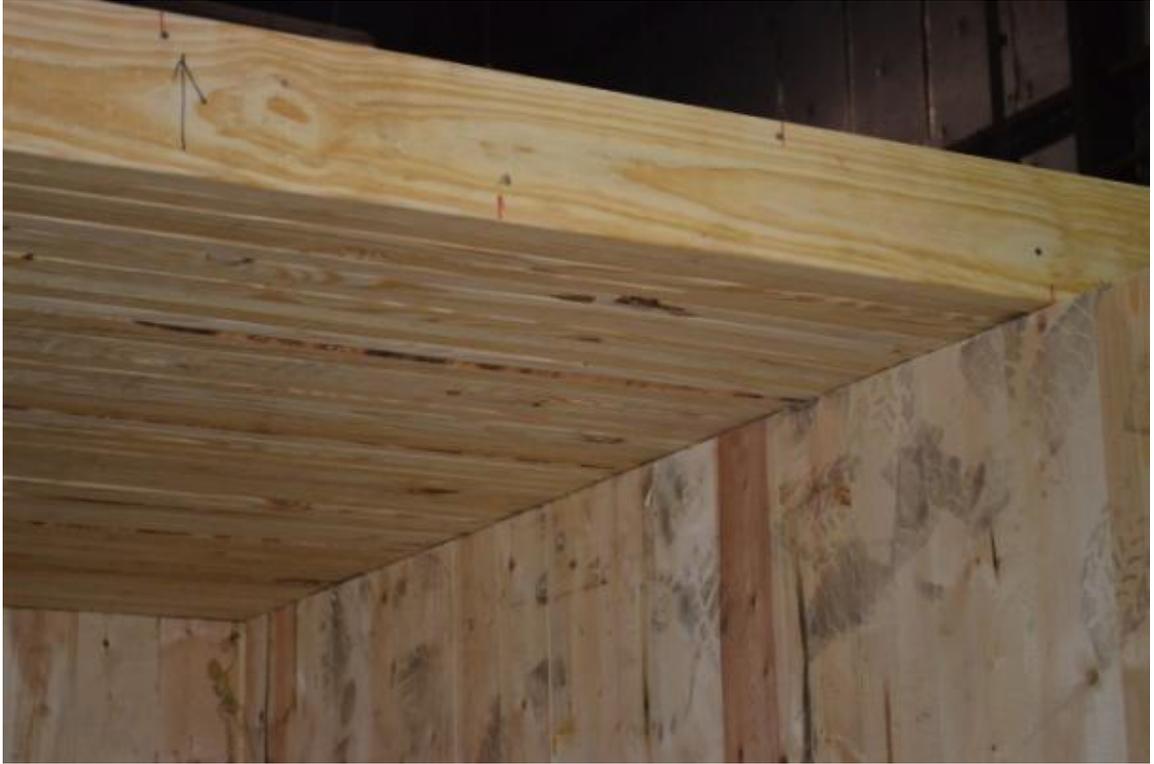
Figure B-3. NLT Ceiling under Construction.

The ceiling consisted of 14-ft (4.27-m) long by 2 × 6-in. (38 × 140-mm) Southern pine floor joists nailed together one-by-one using $0.131 \times 3\frac{1}{2}$ -in. (0.7 × 89-mm) nails as shown in Figure B-3. The nail schedule is shown in Figure 2 and a schematic of the finished NLT ceiling is shown in Figure 3. Small gaps around the perimeter at the wall-ceiling interface were sealed with 3M Fire Barrier Sealant (CP 25WB+ Red).

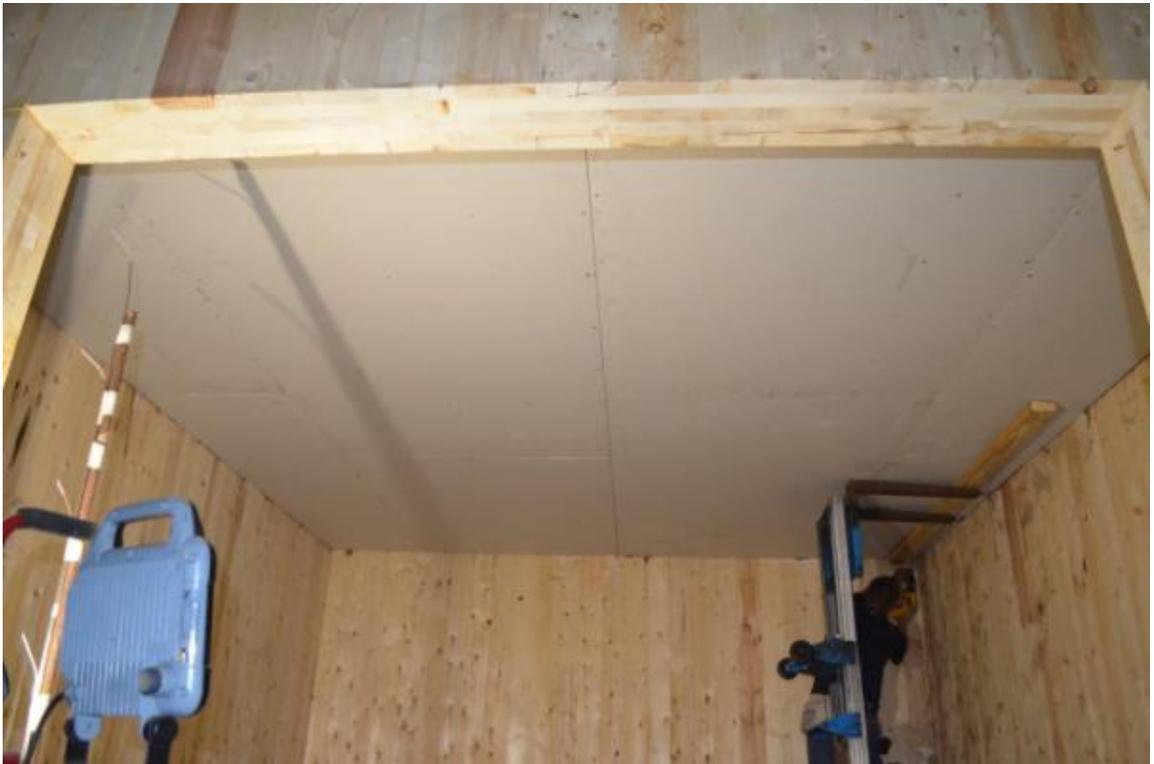
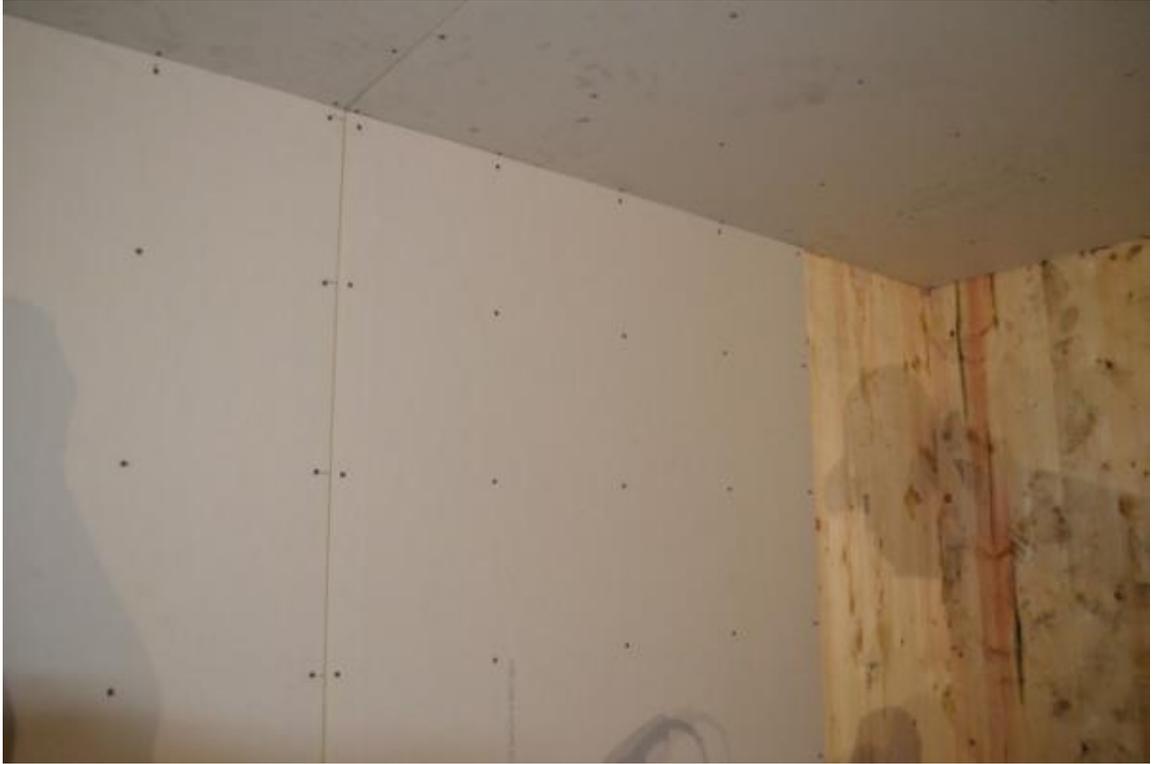
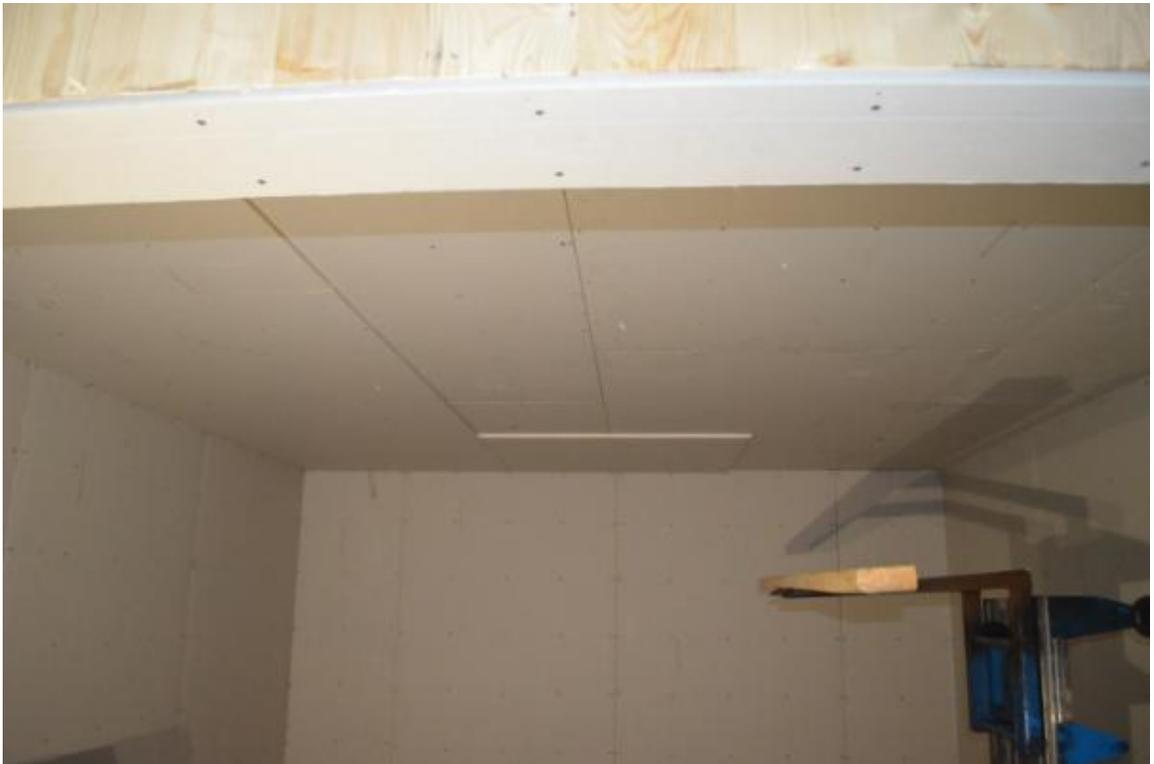
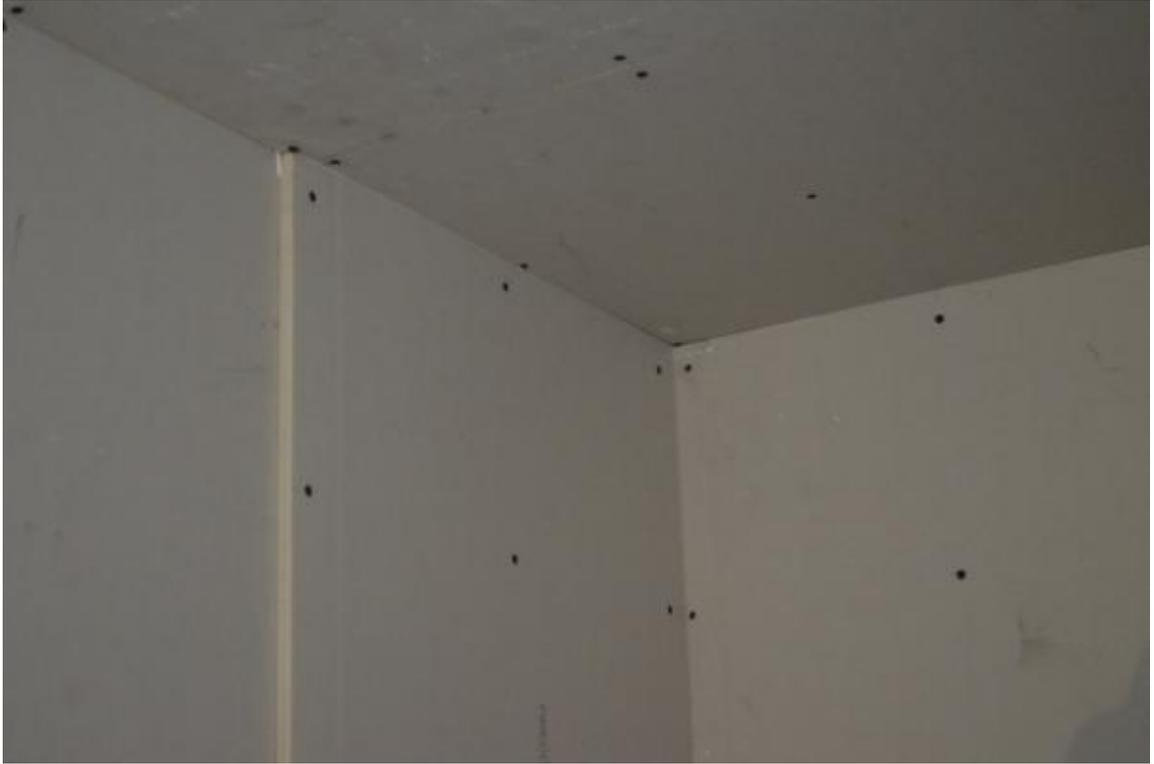
Figure B-4. Base Layer of Gypsum Board on Ceiling.

Figure B-5. Base Layer of Gypsum Board on Walls.

Figure B-6. Face Layer of Gypsum Board on Ceiling.

Figure B-7. Face Layer of Gypsum Board on Walls.

The walls and ceiling were covered with two layers of $\frac{5}{8}$ -in. (16-mm) type X gypsum board so that the joints were staggered (see Figures B-4 through B-7). The base layer of gypsum board was

attached to the CLT walls and NLT ceiling with #6 1⁵/₈-in. (41-mm) type “S” (fine thread) screws, spaced 12 in. (0.305 m) apart in the field, and 1 in. (25 mm) from the edges around the perimeter. The face layer of gypsum board was attached with #6 2¹/₄-in. (57-mm) type “S” (fine thread) screws, spaced 12 in. (0.305 m) apart in the field and 1 in. (25 mm) from the edges around the perimeter. The joints of the face layer were taped and floated using Durabond 90 joint compound (see Figure B-8). Two layers of off-white latex paint were applied to the walls and ceiling the day before the test (see Figure B-9). The floor of the laboratory was covered with two layers of 5/8-in. (16-mm) type X gypsum board.

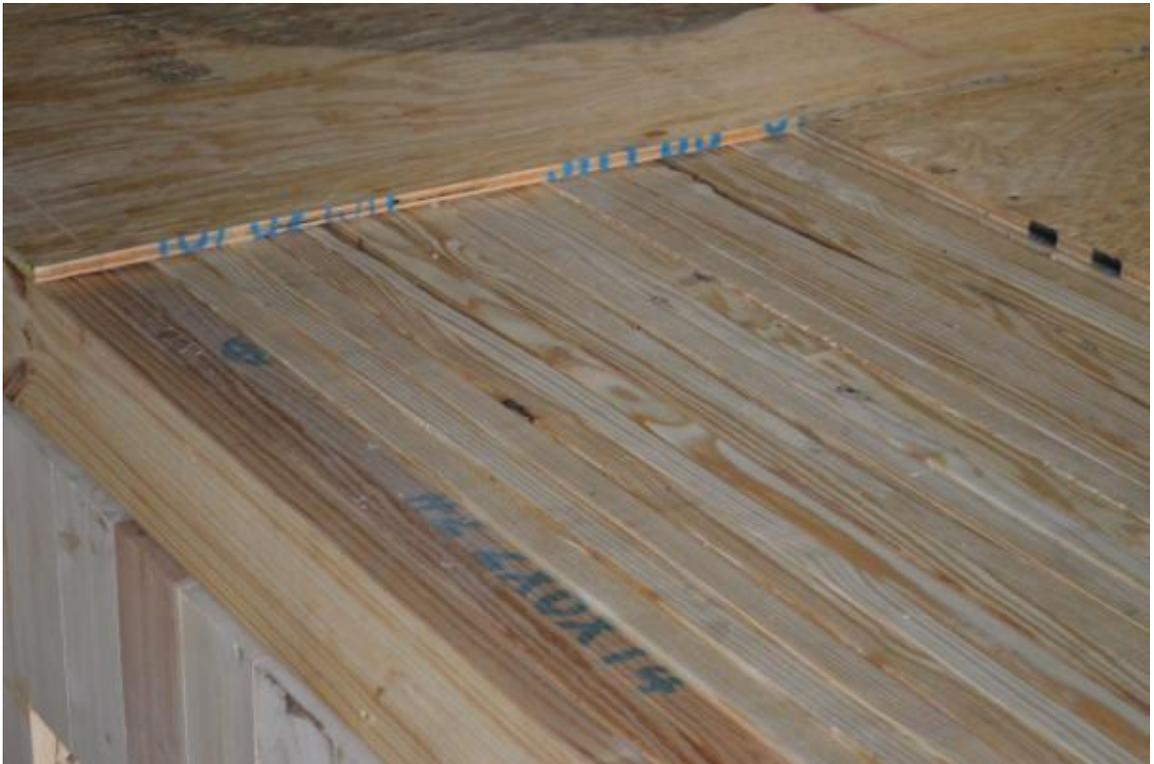
Figure B-10. Plywood on NLT Ceiling.

19/32-in. (15-mm) thick plywood was fastened to the top of the NLT ceiling using #8 2¹/₄-in. (57-mm) coarse thread wood screws (see Figure B-10). Concrete blocks were placed on the plywood to impose a distributed structural load of 40 psf (1.9 kN/m²) as shown in Figure B-11.

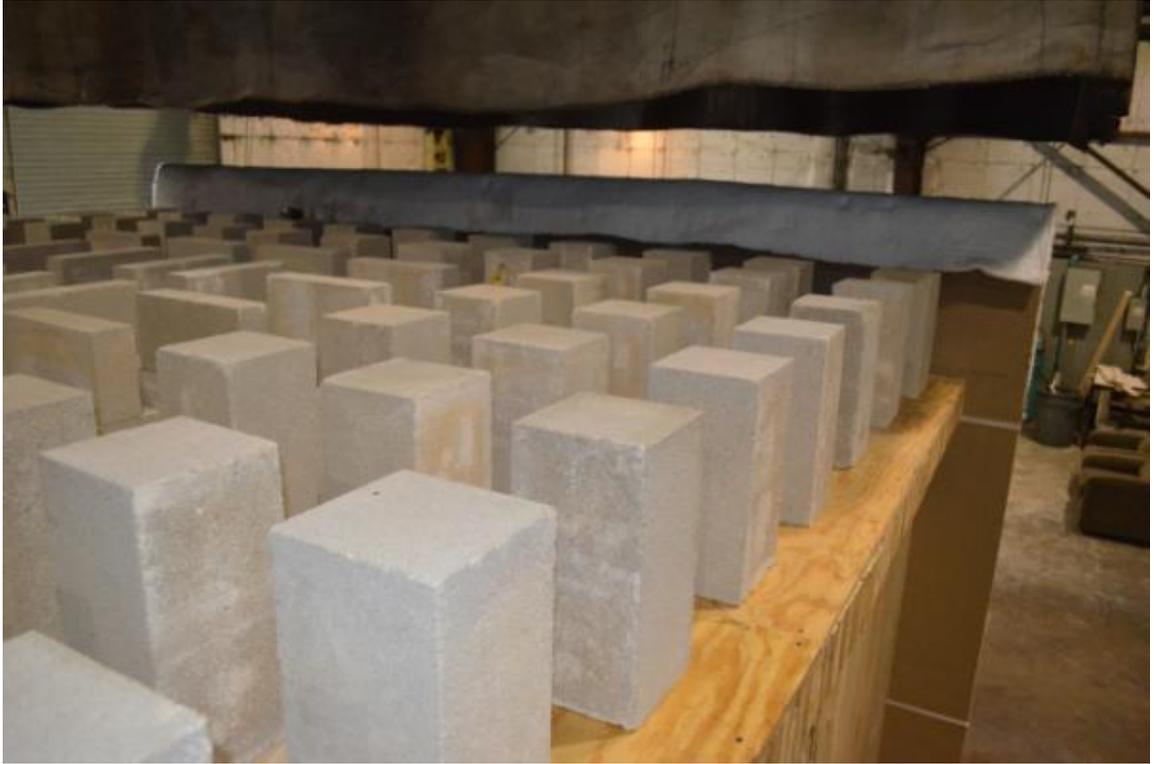
Figure B-11. Load Applied.

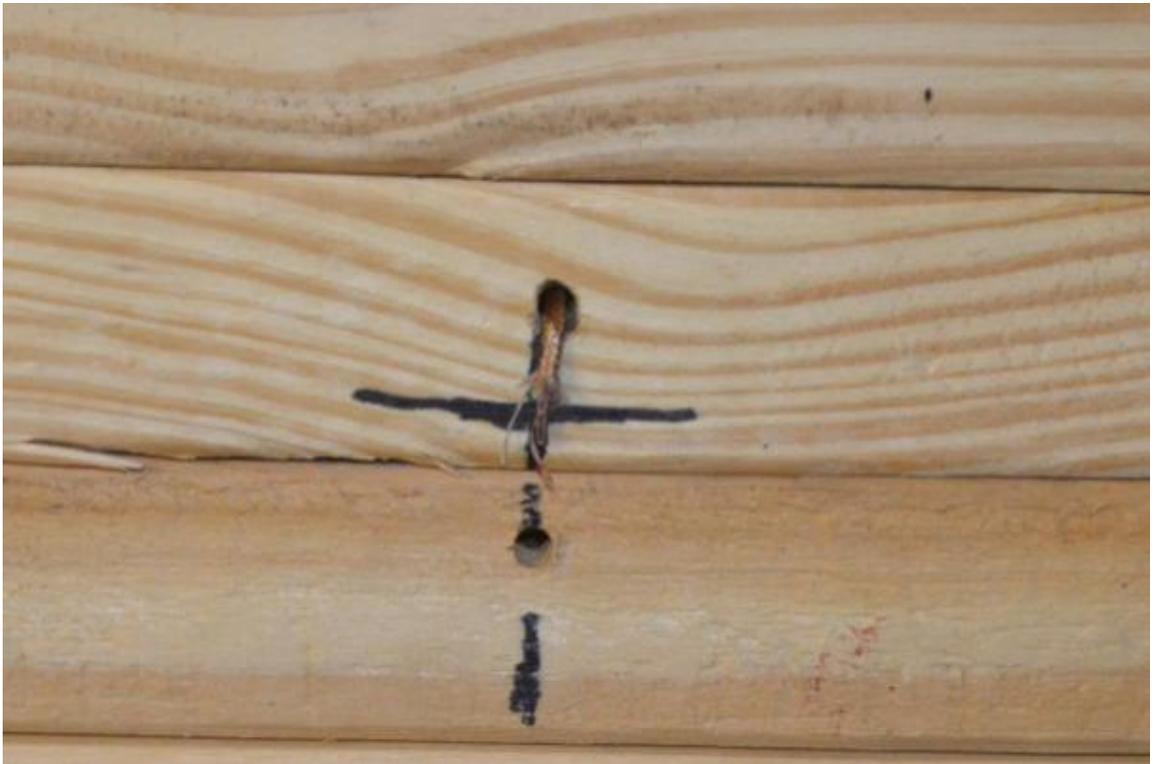
Figure B-12. Thermocouple on Floor Joist.

The room walls and ceiling were instrumented with 20 AWG (0.812 mm diameter) type K TC wire that was placed between the two sheets of gypsum board and between the gypsum and the interior wood surface. The locations of the TCs are shown in Figure 4. The hot junction of the TCs was stapled to the wood or gypsum board, as shown in Figure B-12.

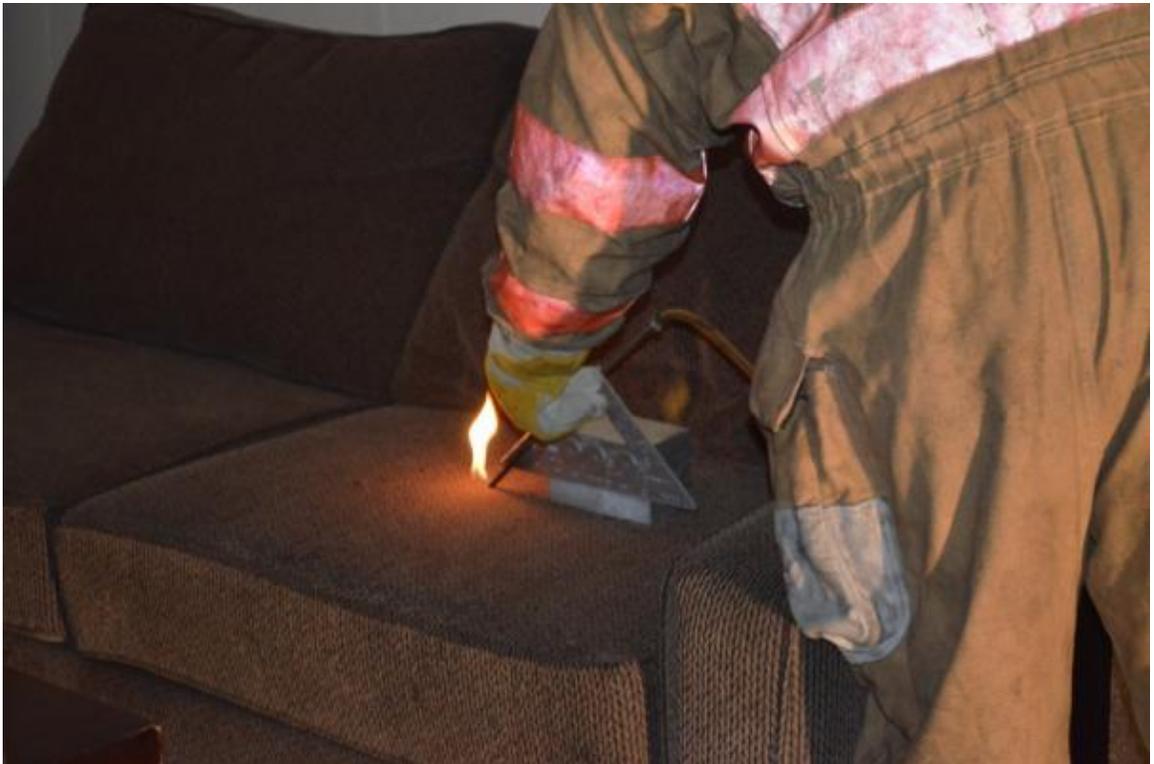
Figure B-16. Start of Test (Application of BS5852 Ignition Source 2).

After a 5-minute baseline, a small butane flame (BS 5852 Source 2) was applied for 40 seconds in the center of the sofa seat cushion closest to doorway (see Figure B-16). The fire quickly developed (see Figures B-17 through B-19) and reached flashover in about four minutes (see Figure B-20). The fire reached peak intensity between five and six minutes (see Figures B-21 and B-22).

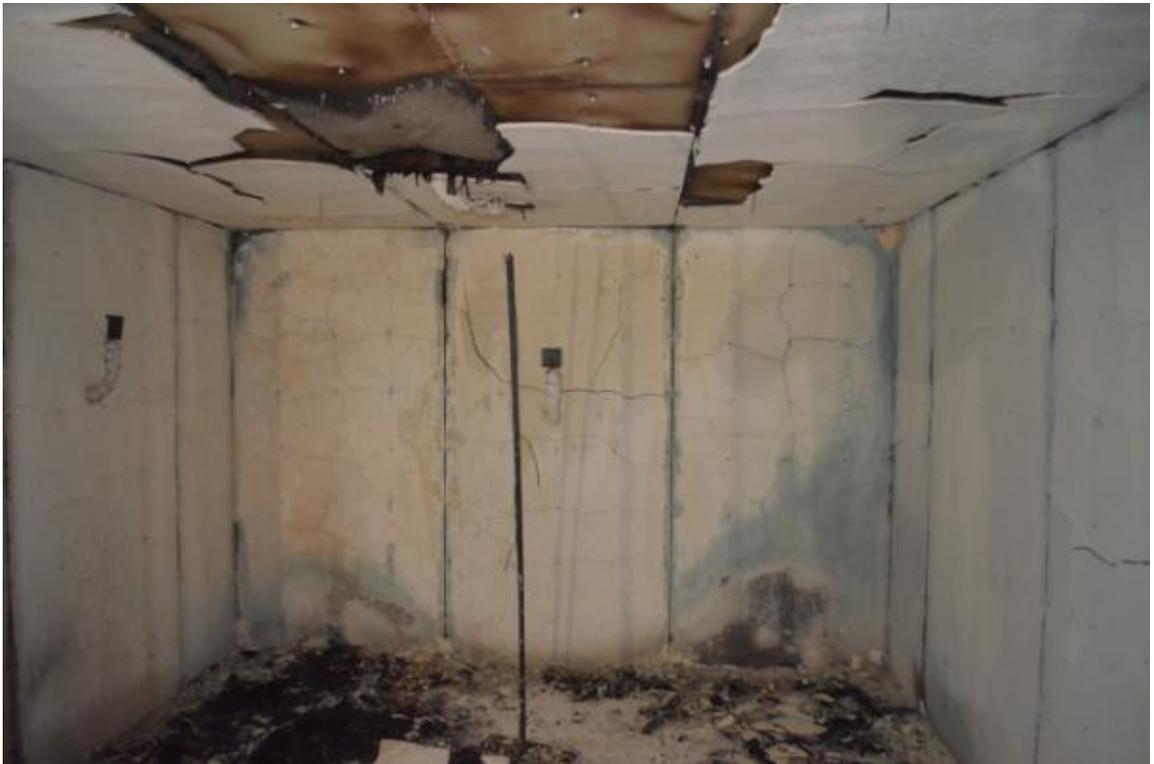
Figure B-32. Room Post-Test.

The gypsum board face layer sustained limited damage, except for the pieces that fell from the ceiling during the test and some additional pieces that fell down during cool-down (see Figure B-32). The base layer remained largely intact although there was some noticeable damage in the three corners where solid furniture items burned for a long time (see Figures B-33 and B-34). The wood structure was also intact except for the same three corners (see Figure B-35). Some superficial charring was observed in the back corners (see Figures B-36 and B-37), while a maximum char depth of ¼ in. (6 mm) was measured in the front corner where the heavier bookcase was located (see Figure B-36).

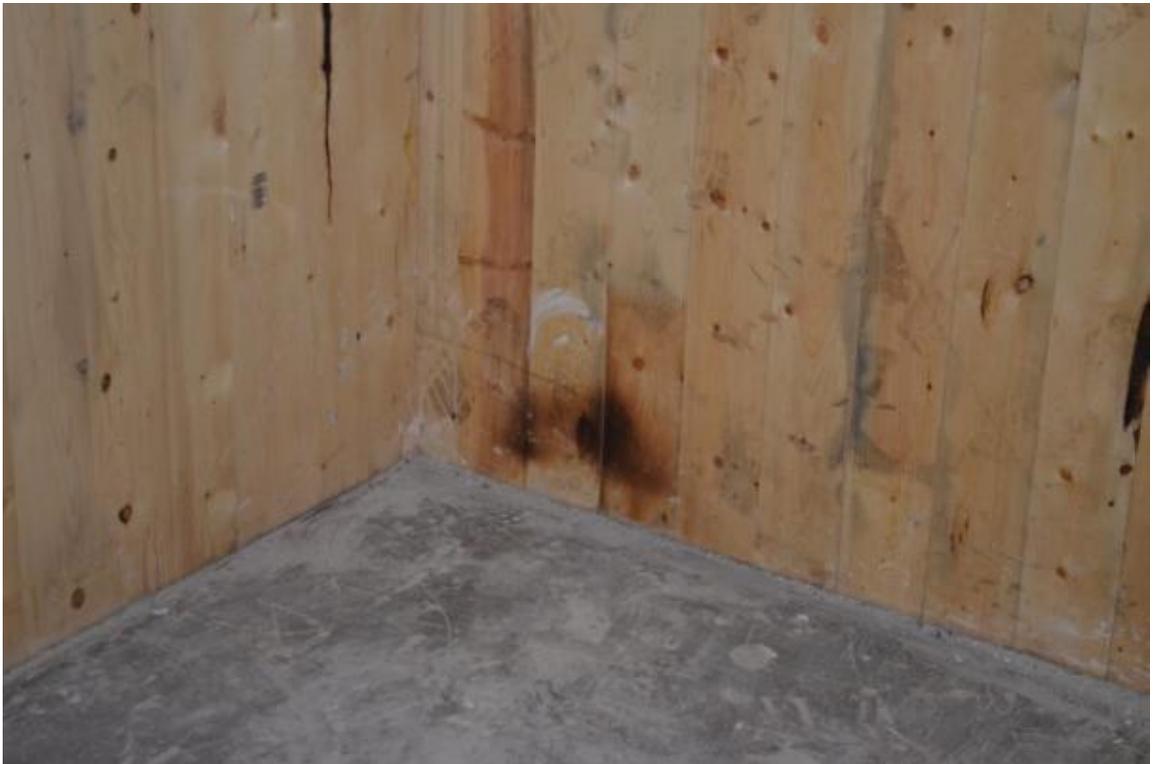
Figure B-36. Charring in Back Right Corner Post-Test.

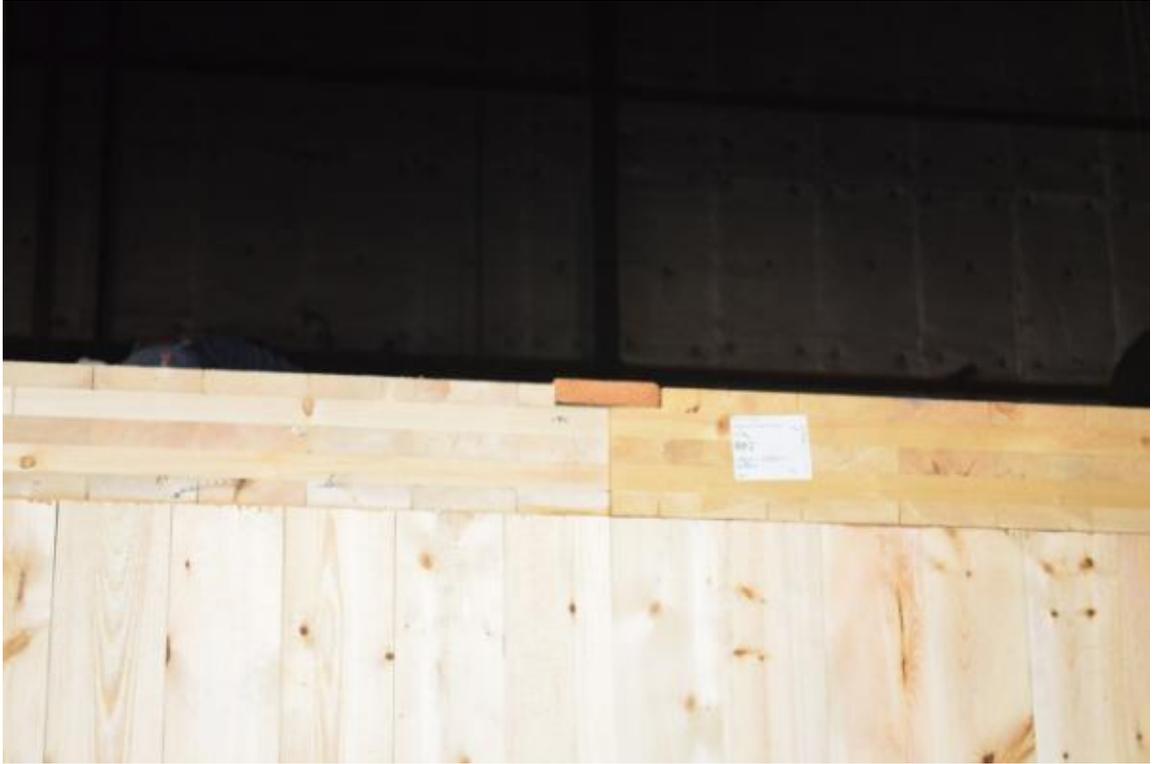
Figure D-3. Spline Covering Joint between CLT Ceiling Panels.

The walls of the compartment were constructed from a second set of CLT panels that were identical to those used in the construction of the compartment for the first test (see Figure D-1). However, the sidewalls in this case were inside the front and back panels as shown in Figure 8. The ceiling consisted of two CLT panels (see Figures A-4 and A-5) that were connected to the walls with 5/16 × 11-in. (8 × 280-mm) partial thread screws with a 5/8-in. (150-mm) spacing. Figure D-2 shows placement of the first ceiling panel on the walls of the compartment. A spline was attached with #8 2¼-in. (57-mm) coarse thread wood screws to connect the two ceiling halves (see Figure D-3). The assembled CLT compartment is shown in Figure D-4. The joint around the perimeter at the wall-ceiling interface was sealed with 3M Fire Barrier Sealant (CP 25WB+ Red) as shown in Figure D-5.

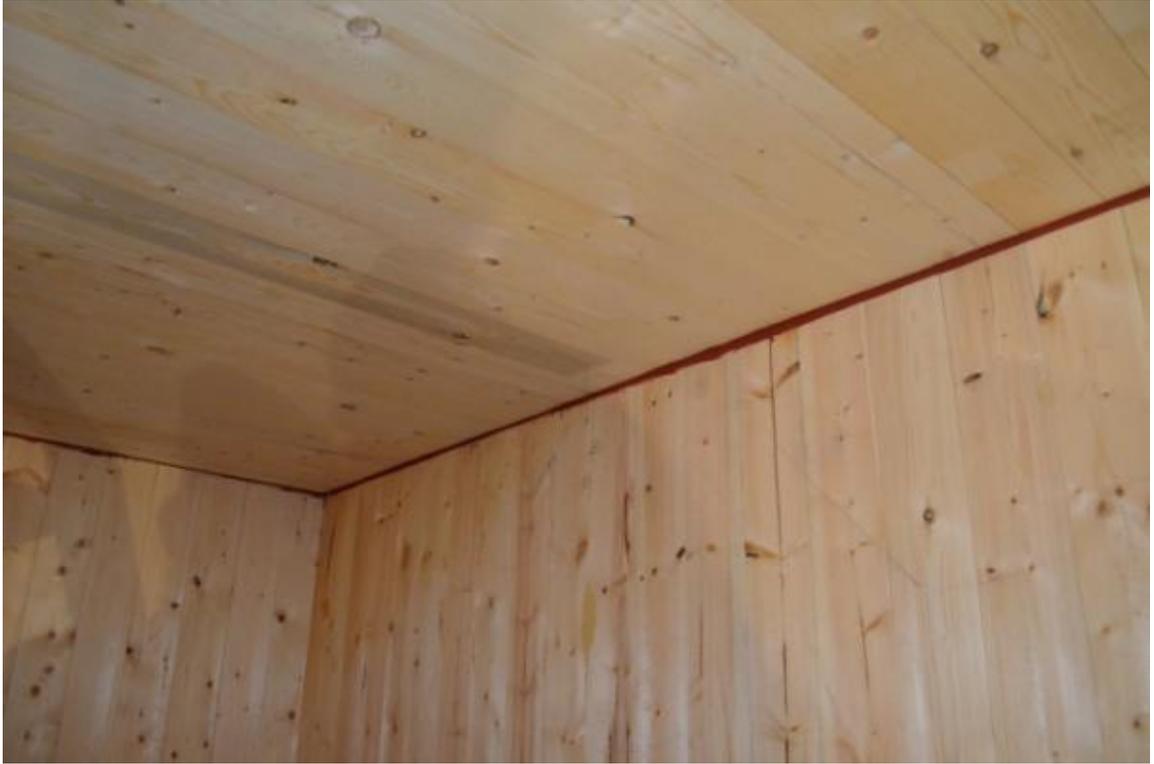
Figure D-5. Fire Sealant around Room Perimeter at Wall-Ceiling Interface.

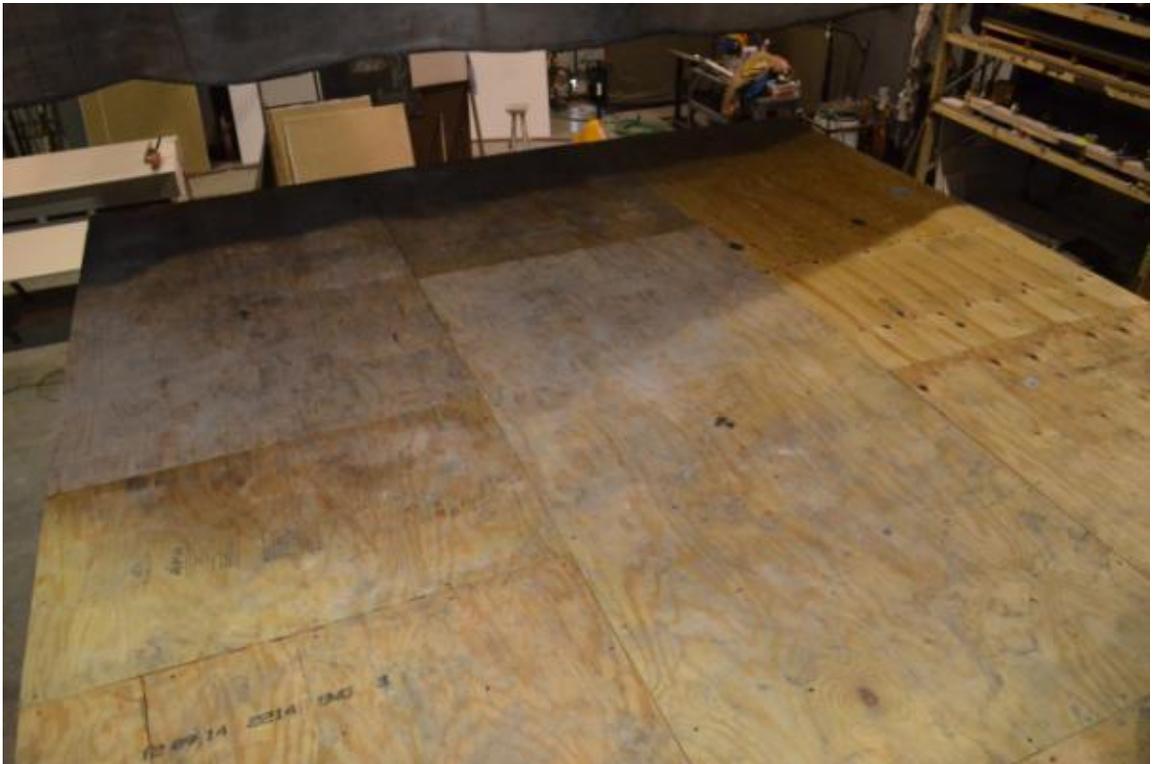
Figure D-12. Plywood on CLT Ceiling.

19/32-in. (15-mm) thick plywood was fastened to the top of the CLT ceiling using #8 2¼-in. (57-mm) coarse thread wood screws (see Figure D-12). Concrete blocks were placed on the plywood to impose a distributed structural load of 40 psf (1.9 kN/m²) as shown in Figure D-13.

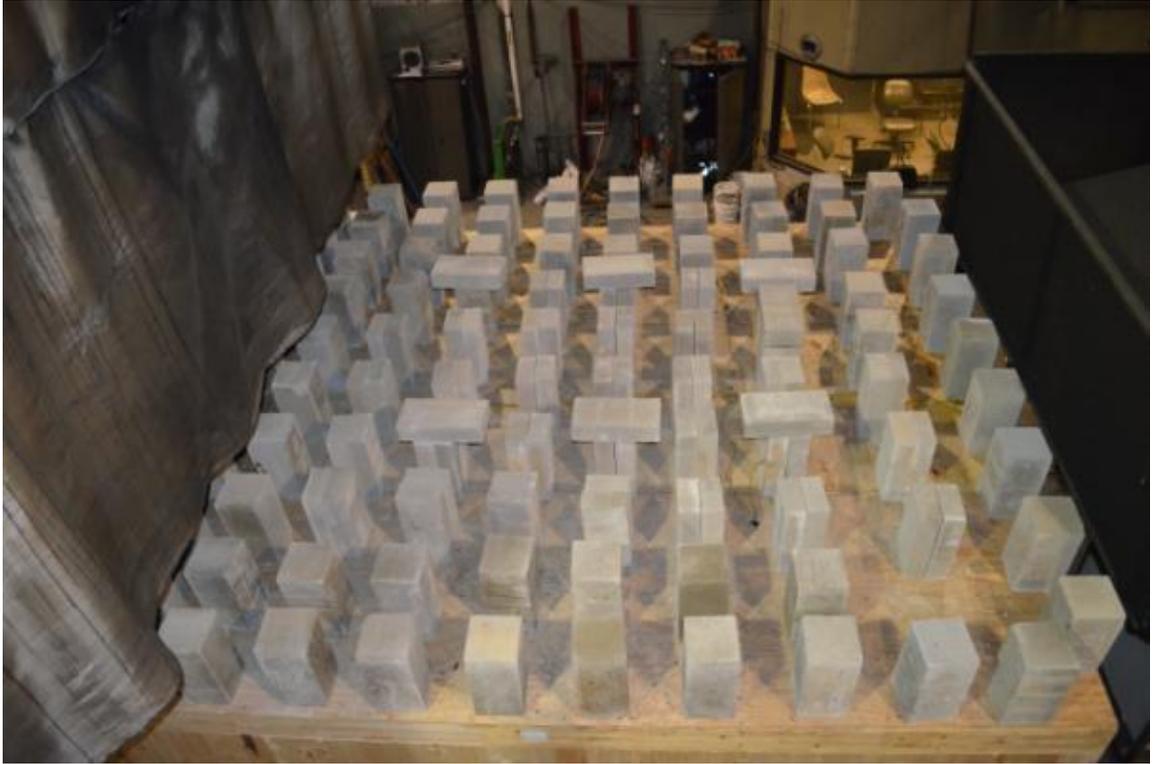
Figure D-13. Load Applied.
