RESEARCH FOUNDATION

Fire Safety Challenges of Tall Wood Buildings – Phase 2: Task 5 – Experimental Study of Delamination of Cross Laminated Timber (CLT) in Fire

March 2018

Report number: FPRF-2018-05

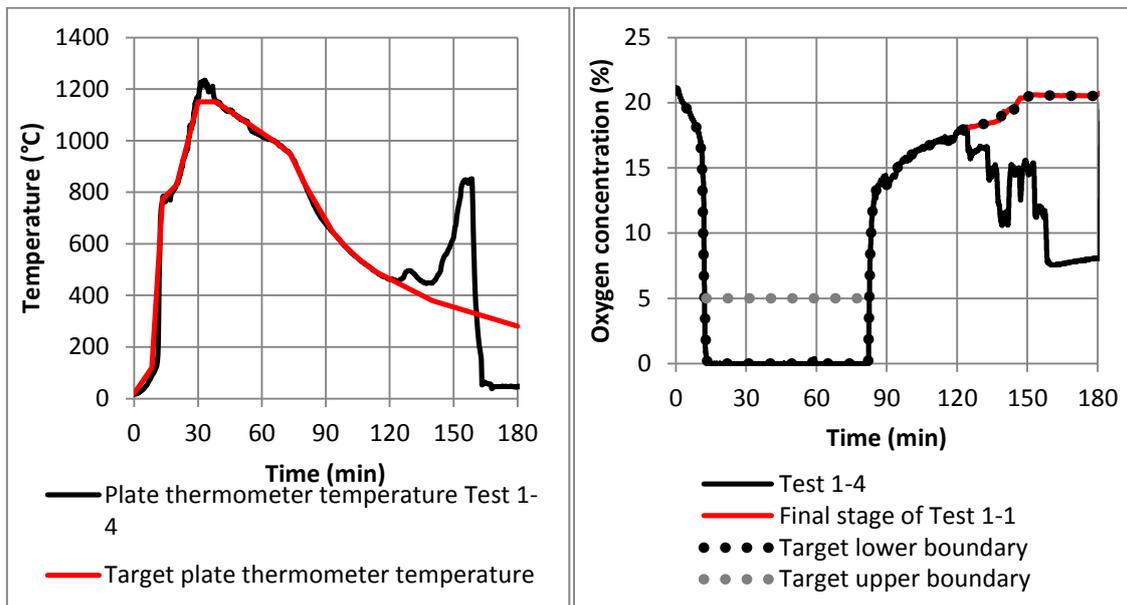
Figure 1: Target temperature and oxygen content and the original measurements of compartment tests

The exposure within the furnace is controlled by aiming for similar plate thermometer temperatures as measured in compartment fire test 1-4. Additionally, the oxygen concentration measured under the ceiling in the full scale compartment fire test is replicated in the furnace. In test 1-4 delamination of the second layer of lamellas caused the temperature to rise and the oxygen content to drop between 120 minutes and the end of the test at 160 minutes after ignition. In order to assess whether delamination would occur, with other CLT specimens, the effects of delamination of the second layer of lamellas in the original test were ignored and the target temperature and oxygen curve were extrapolated to resemble that of a decaying fire without delamination (Figure 1). In the fully developed stage the oxygen content of the compartment test was approximately 0% for the majority of the time. In the furnace this oxygen content is difficult to achieve. As it was recently shown that there is no significant char contraction due to oxidation at oxygen concentrations under 5% (Schmid et al., 2016), it was chosen to allow the oxygen content to be in between 0 and 5% during the fully developed phase of the intermediate scale furnace test.

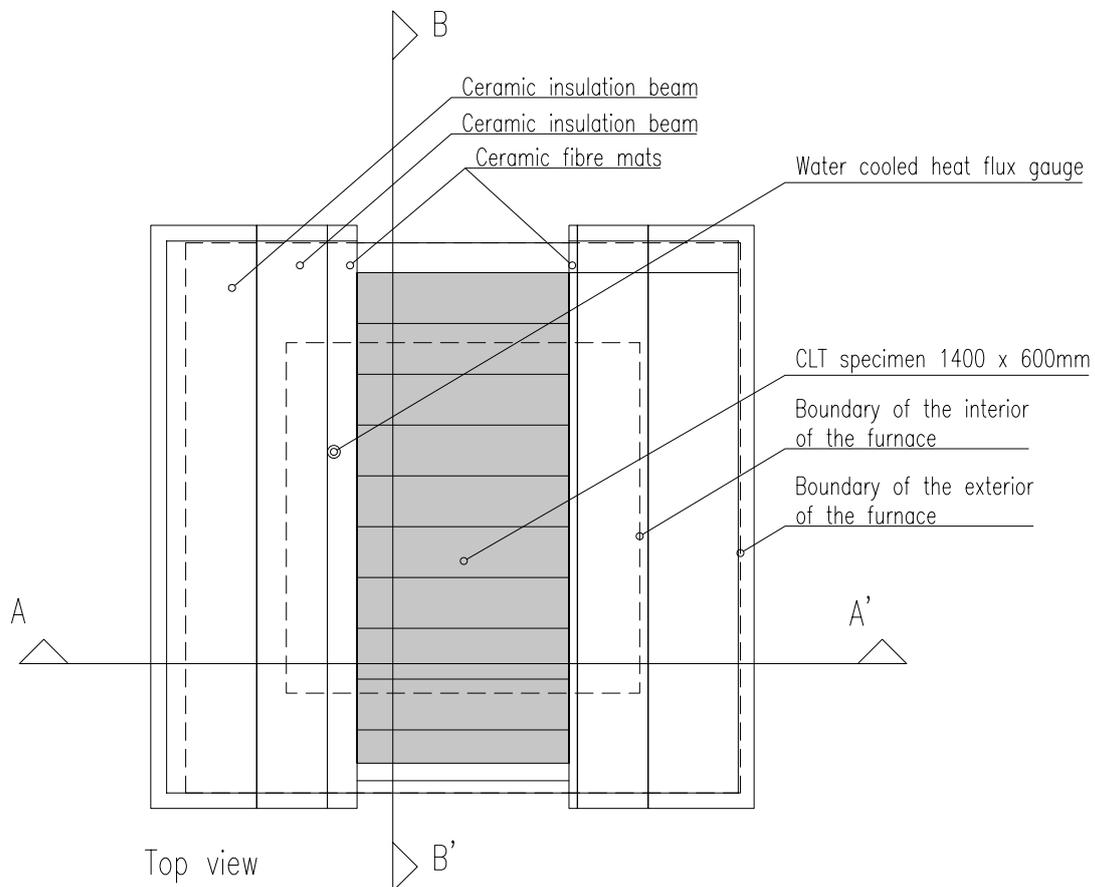
Figure 2: Top view of the test setup

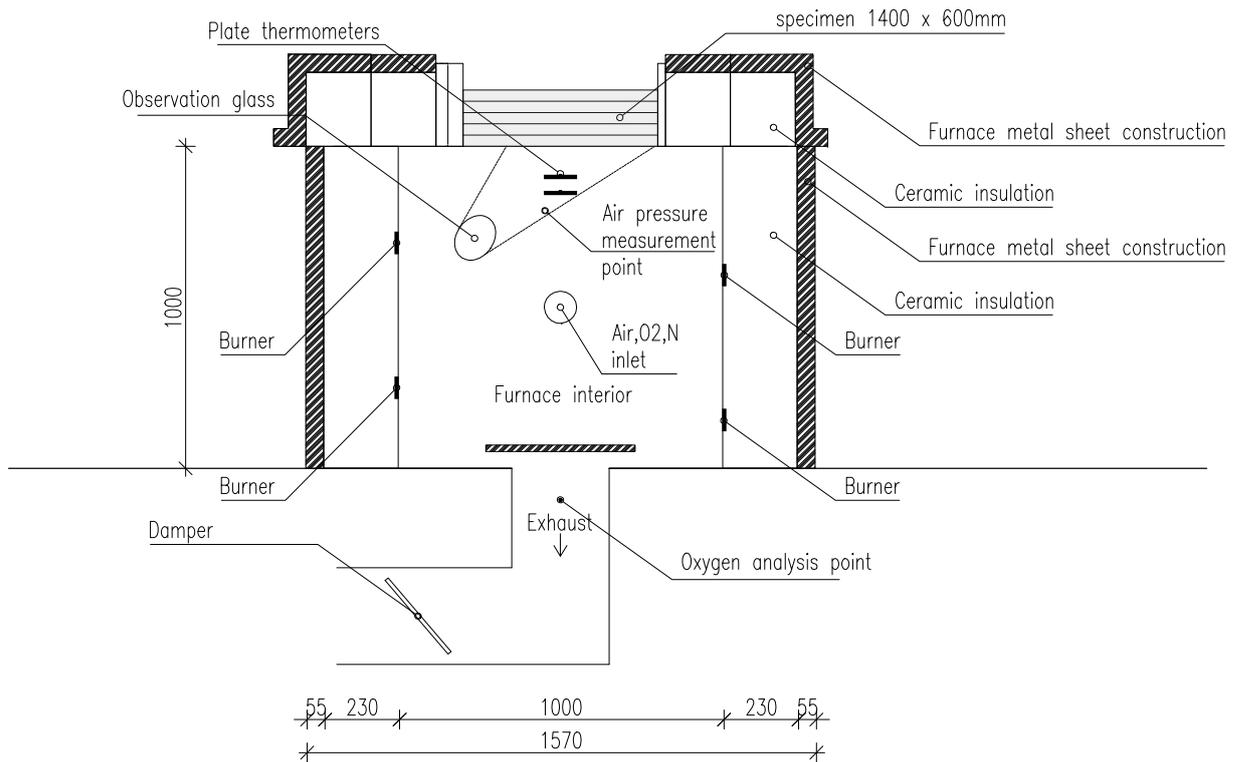
Figure 3: Section A-A' of the test setup

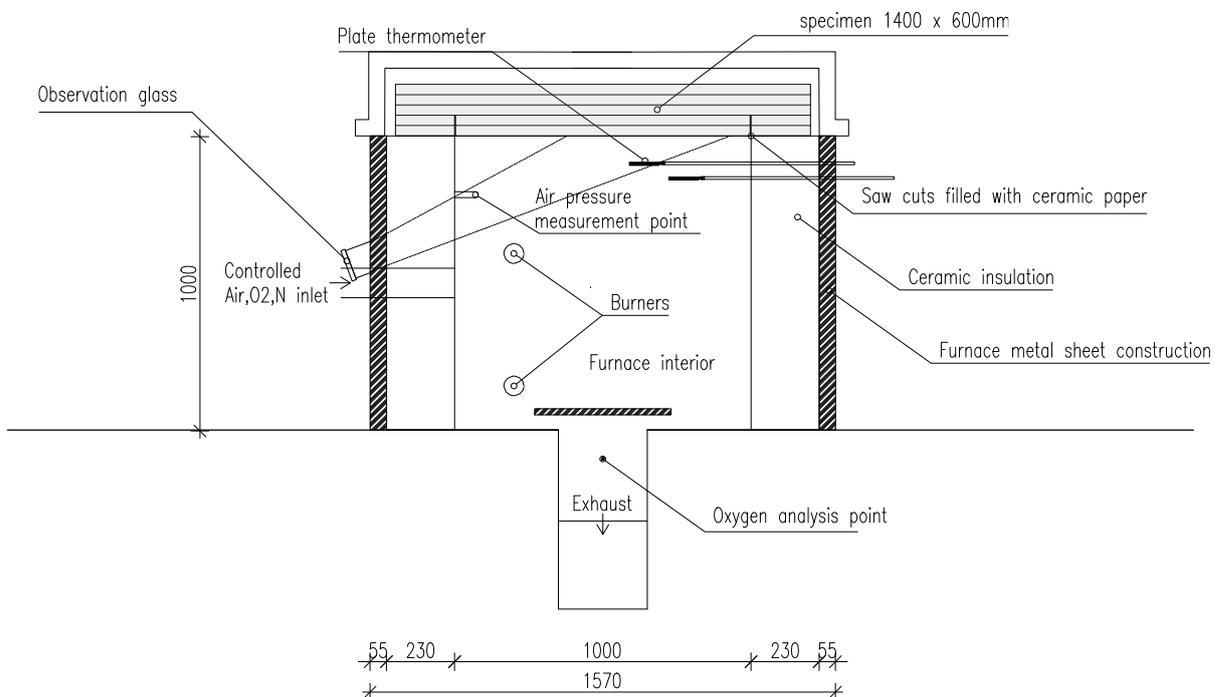
Figure 4: Section B-B' of the test setup

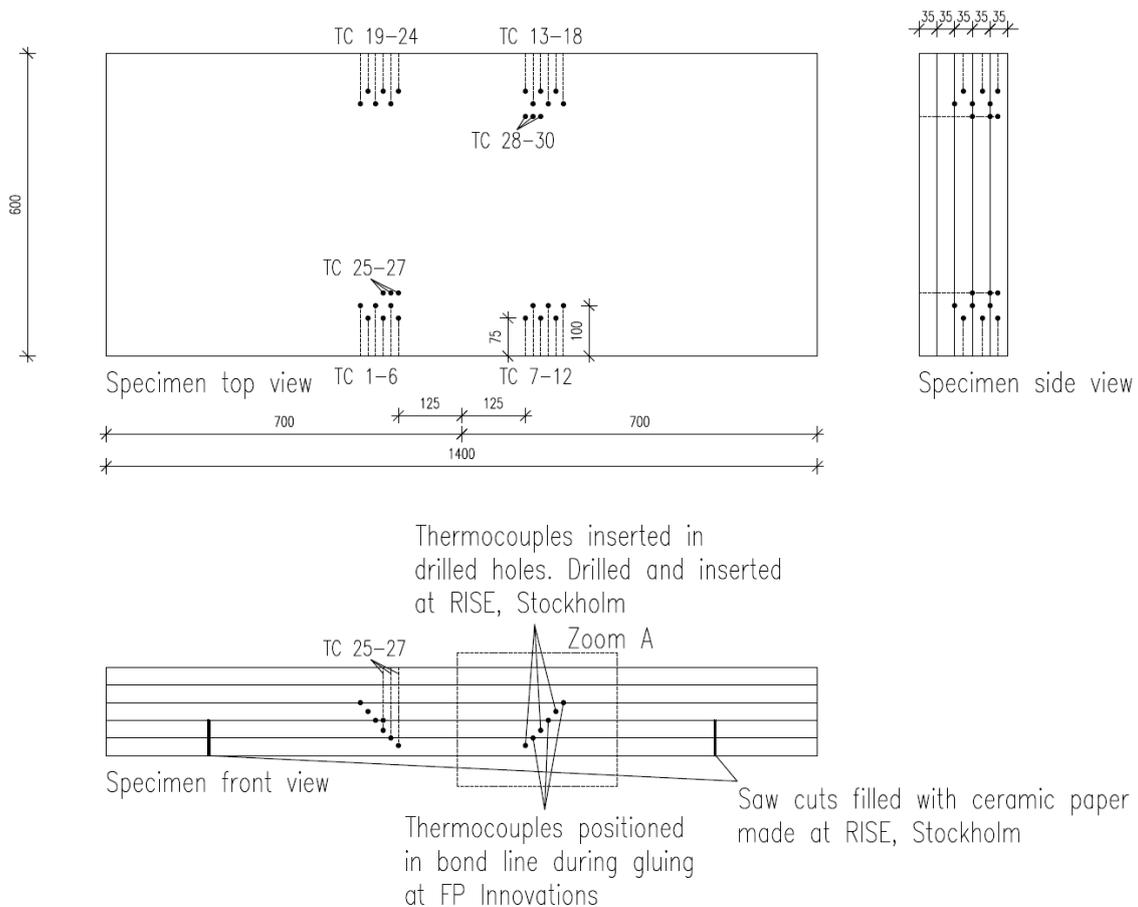
Figure 5: Top view, front view and side view of the specimens with indicated locations of thermocouples

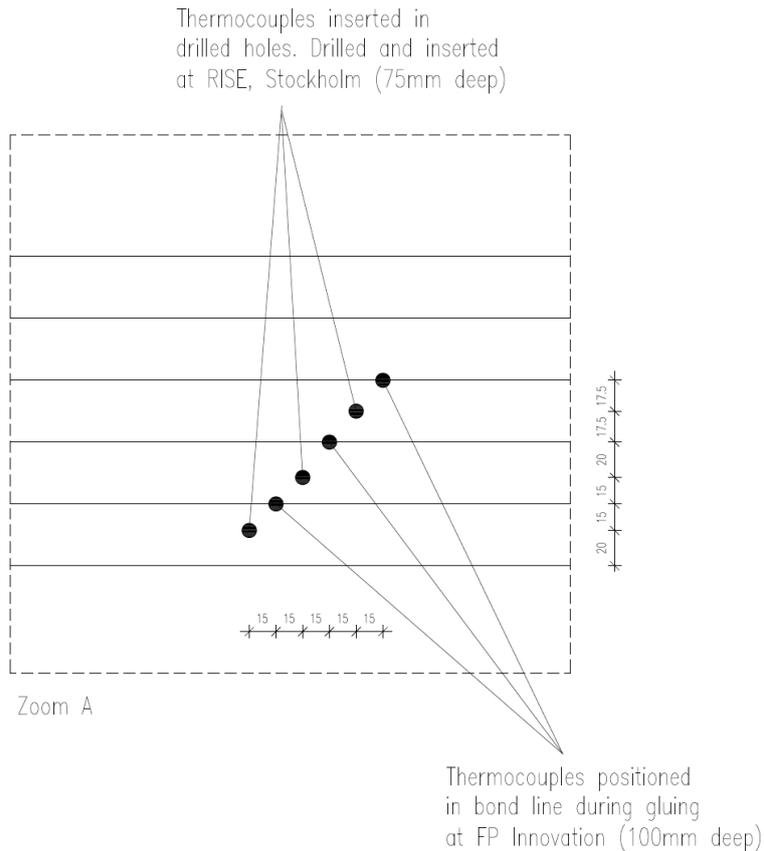
Figure 6: Locations and distances of thermocouples.

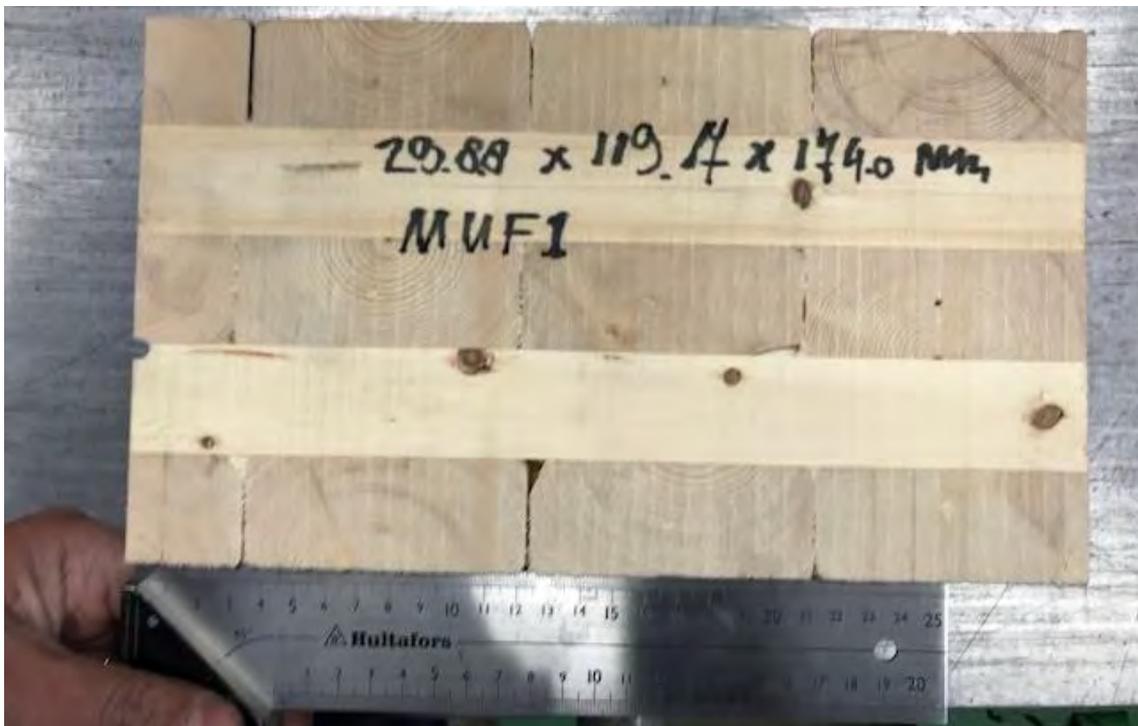
Figure 8: typical cross section of the CLT specimens

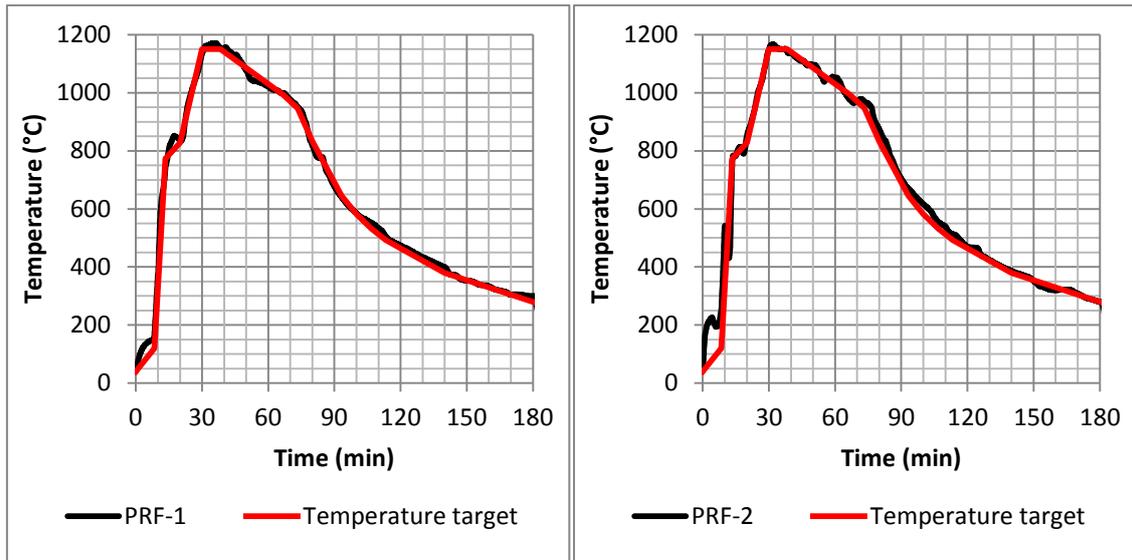
Figure 9: Average temperature measured by the plate thermometers of PRF-A (left) and PRF-B (right)

This sub-section summarizes the main results of tests PRF-A and PRF-B. Figure 9 shows the average plate thermometer temperature together with the target temperature. Figure 10 shows the measured oxygen concentration together with the target oxygen concentration for the duration of the test. No complications arose for the control of the temperature and oxygen content.

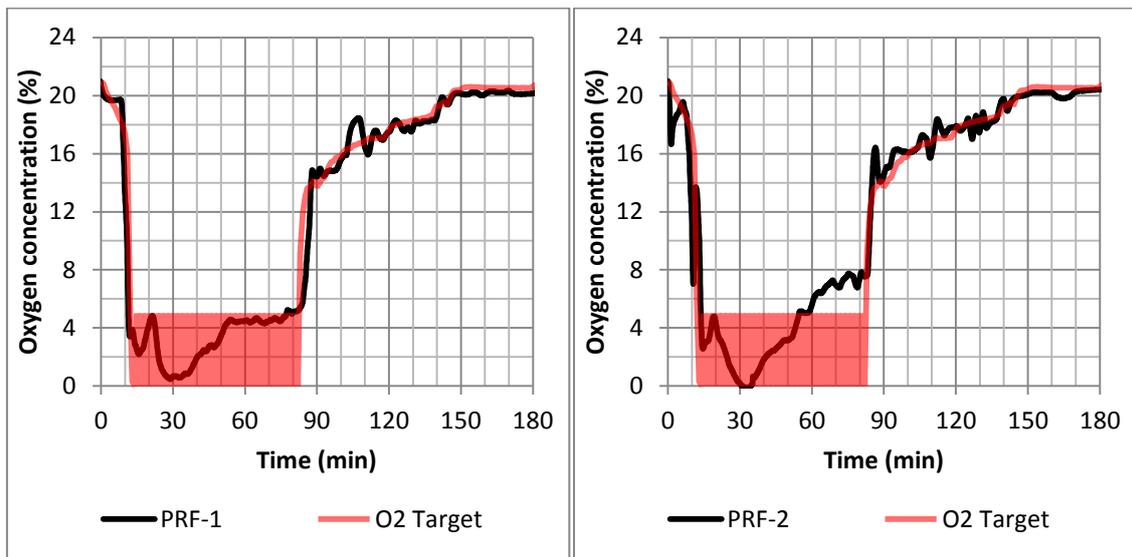
Figure 10: Oxygen concentration of PRF-A (left) and PRF-B (right)

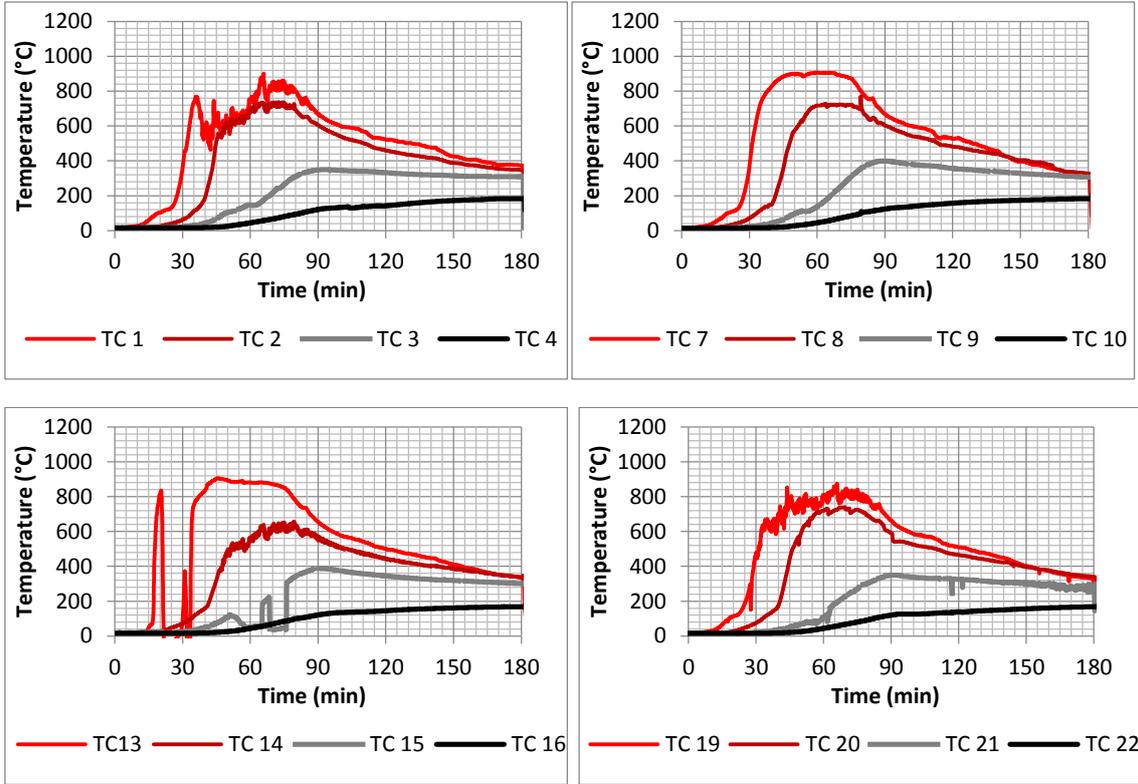
Figure 11: CLT temperatures at 20, 35, 50 and 70mm depth at four locations PRF-A

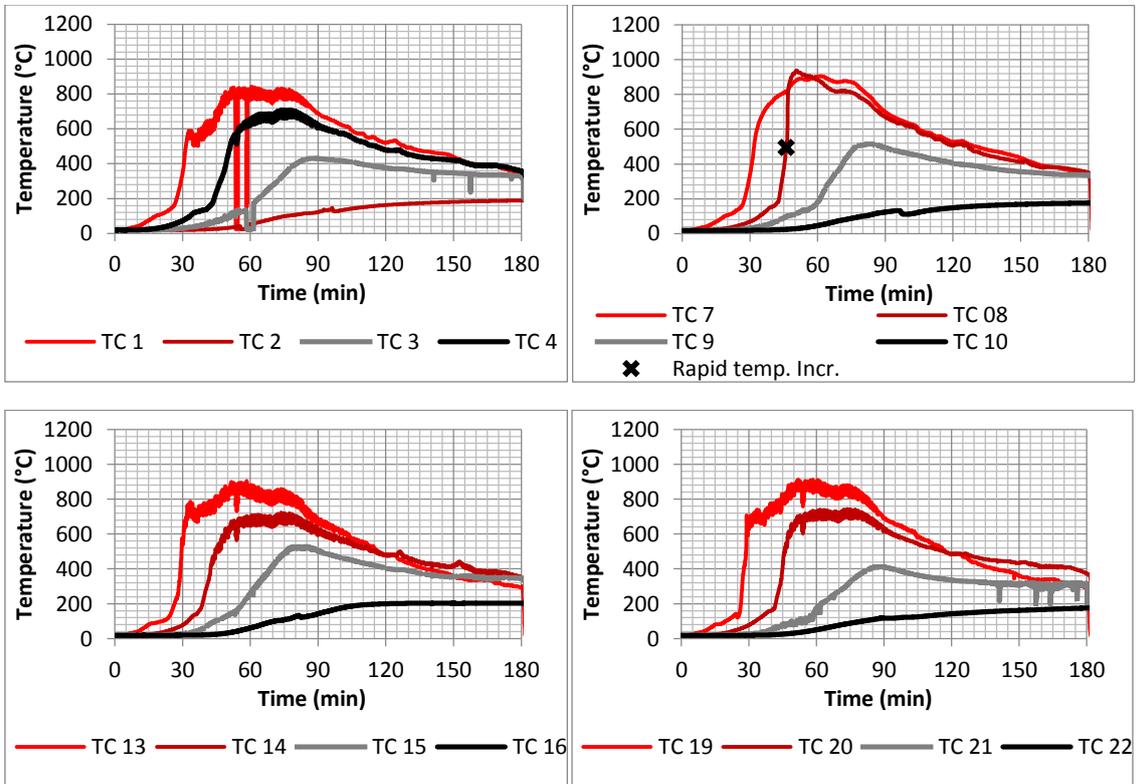
Figure 12: CLT temperatures at 20, 35, 50 and 70mm depth at four locations PRF-B

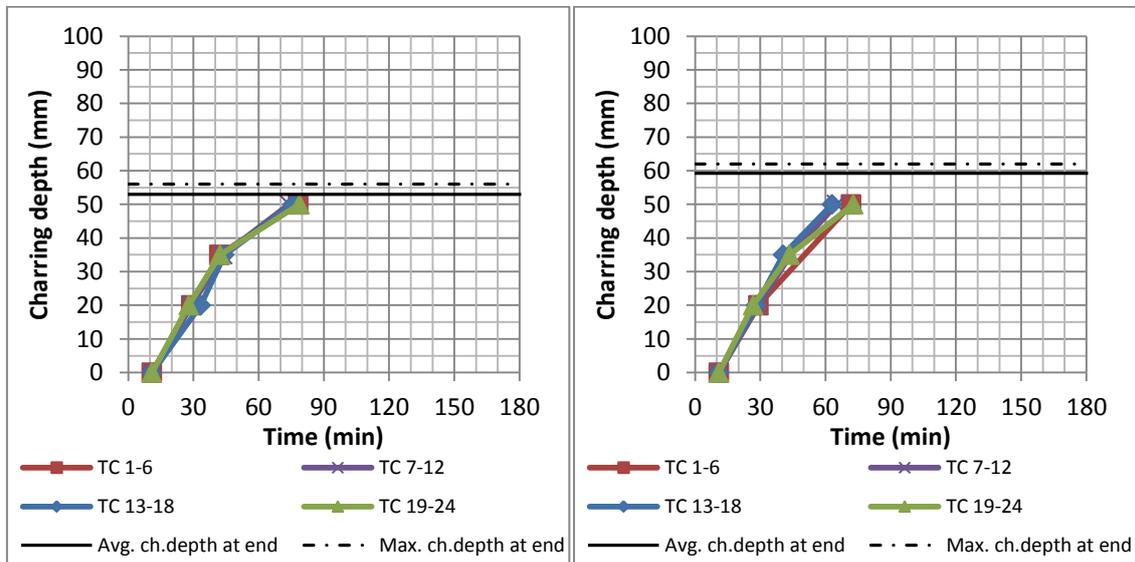
Figure 13: Charring depth during and at the end of PRF-A (left) and PRF-B (right)

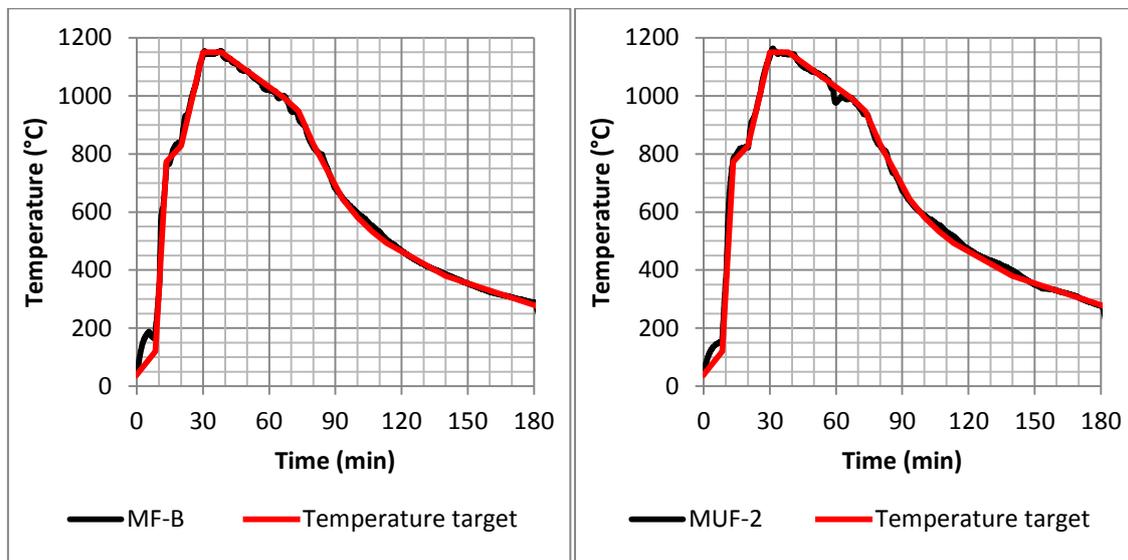
Figure 14: Average temperature measured by the plate thermometers of MF-A (left) and MF-B (right)

Figure 14 shows the average plate thermometer temperature together with the target temperature. Figure 15 shows the measured oxygen concentration together with the target oxygen concentration for the duration of the test. No complications arose for the control of the temperature and oxygen content.

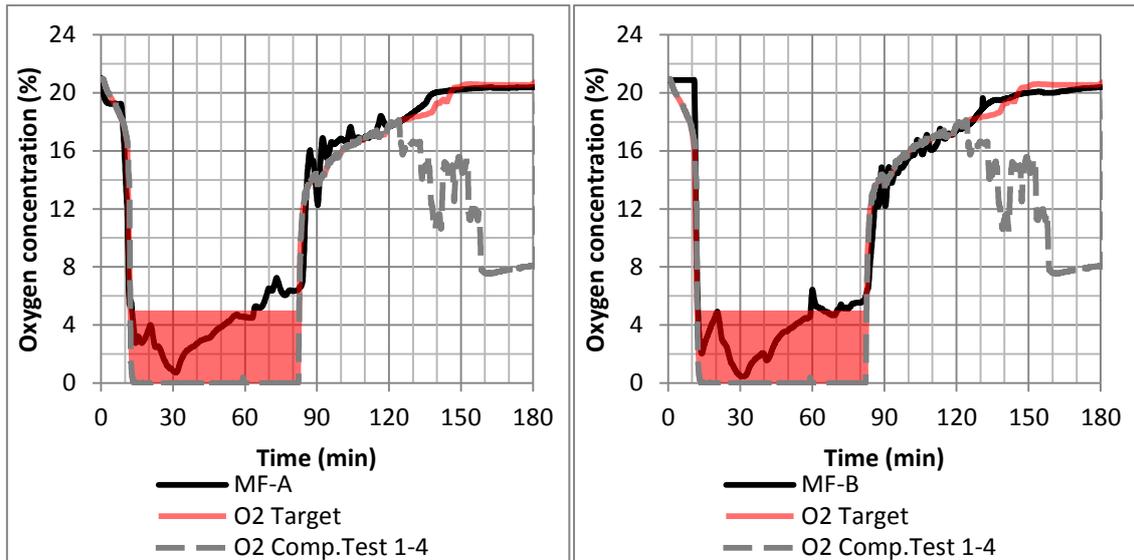
Figure 15: Oxygen concentration of MF-A (left) and MF-B (right)

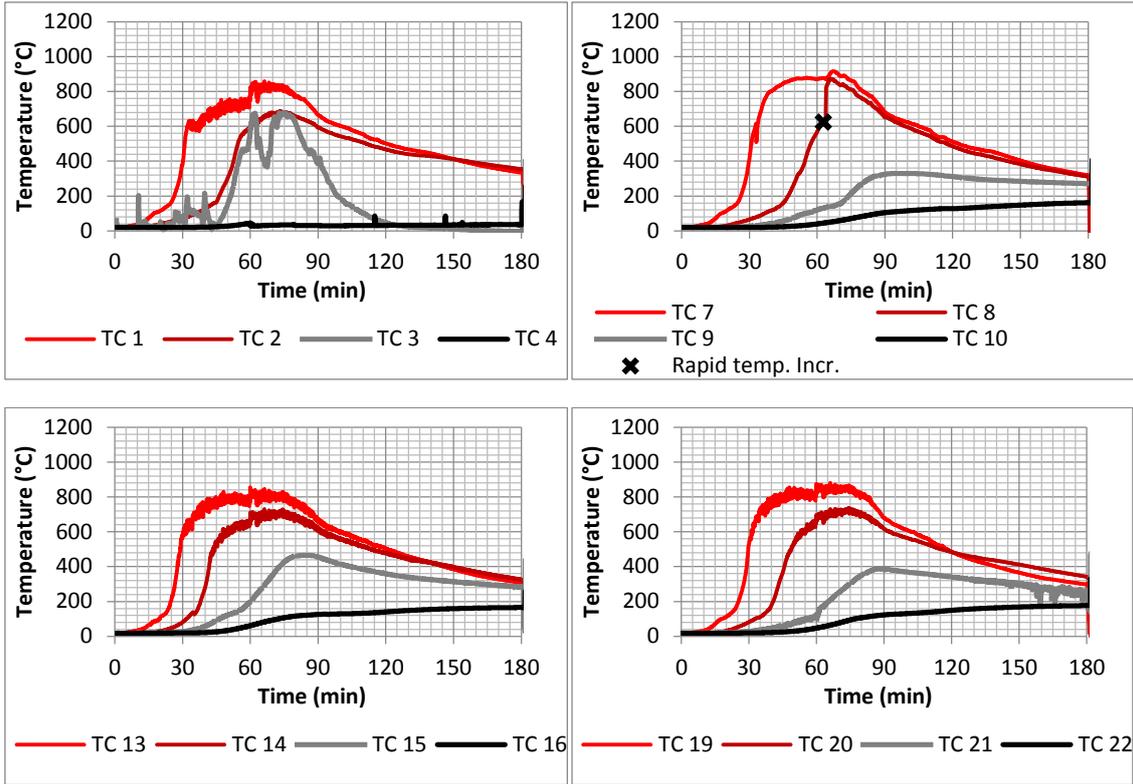
Figure 16: CLT temperatures at 20, 35, 50 and 70mm depth at four locations MF-A

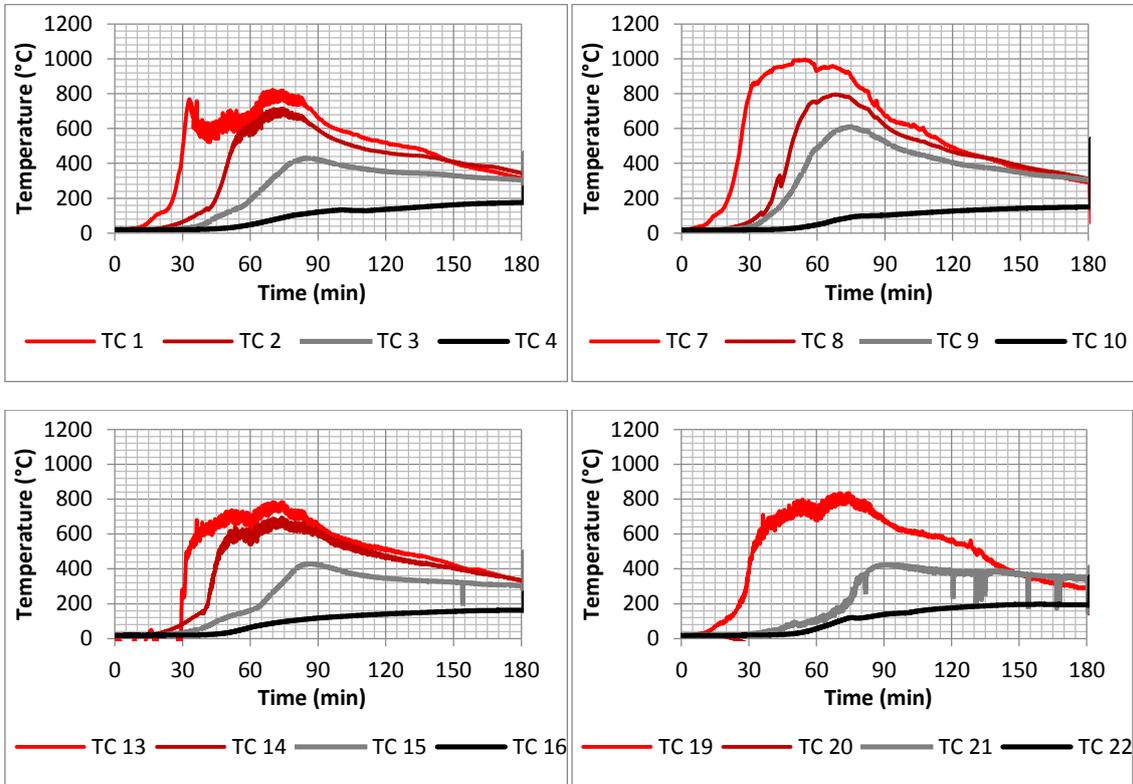
Figure 17: CLT temperatures at 20, 35, 50 and 70mm depth at four locations MF-B

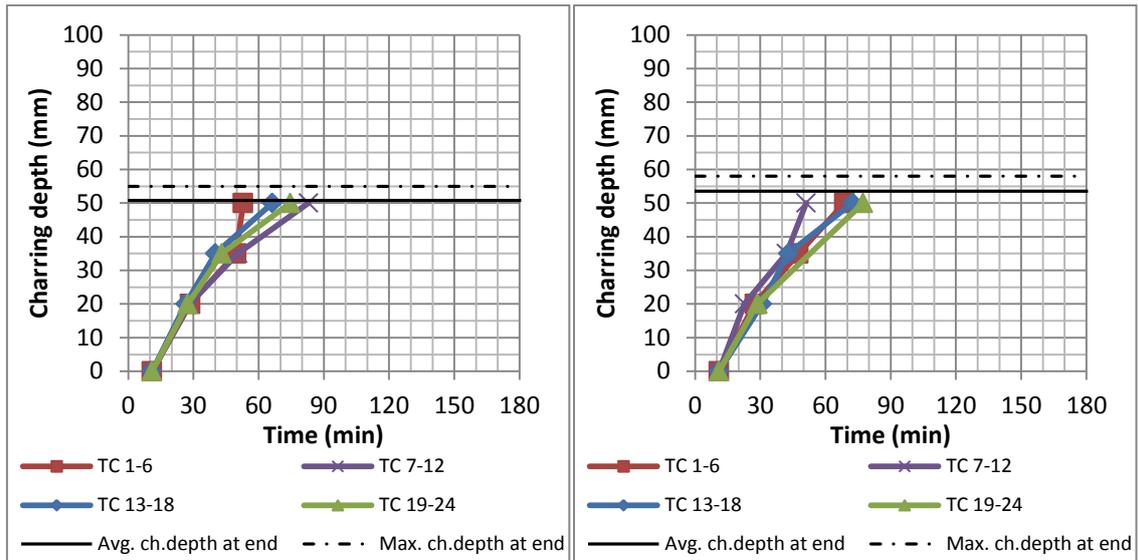
Figure 18: Charring depth during and at the end of MF-A (left) and MF-B (right)

Charring rates were determined in a similar way as was done for tests that were already discussed in sub-section 2.6.1. 300°C was measured in all thermocouples at 50mm depth, but it was not measured at 70mm depth. Figure 18 shows the depth of the char layer during the test based on temperature measurements. Additionally, the average and the maximum char depths measured after the test are indicated. The measured char depth suggests that the charring rate sharply reduces after approximately 70 minutes, which is approximately when the decay phase starts. The results of the four char depth measurements with a resistograph are shown in Table 6.

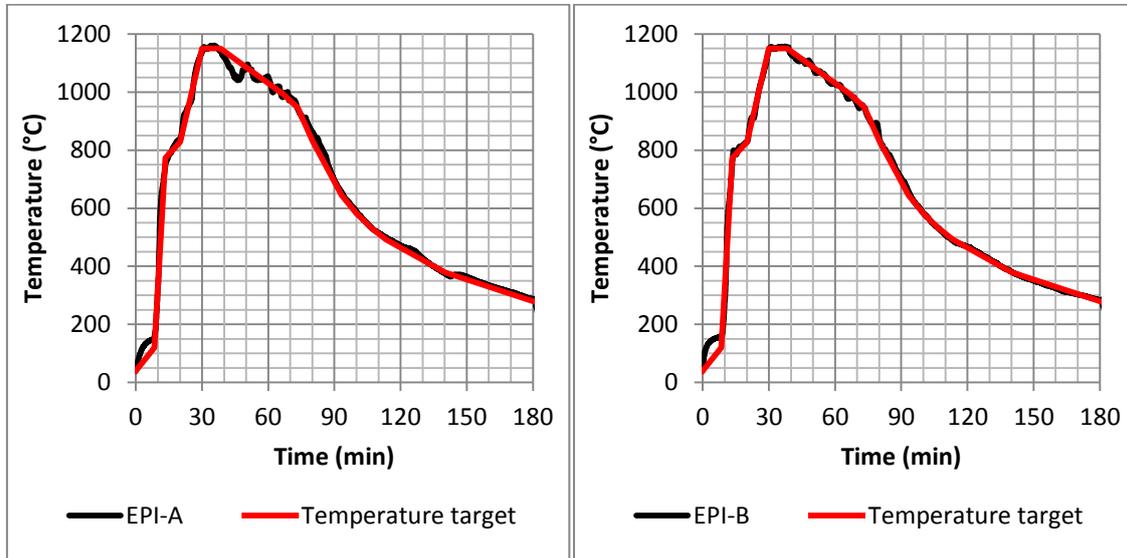
Figure 19: Average temperature measured by the plate thermometers of EPI-A (left) and EPI-B (right)

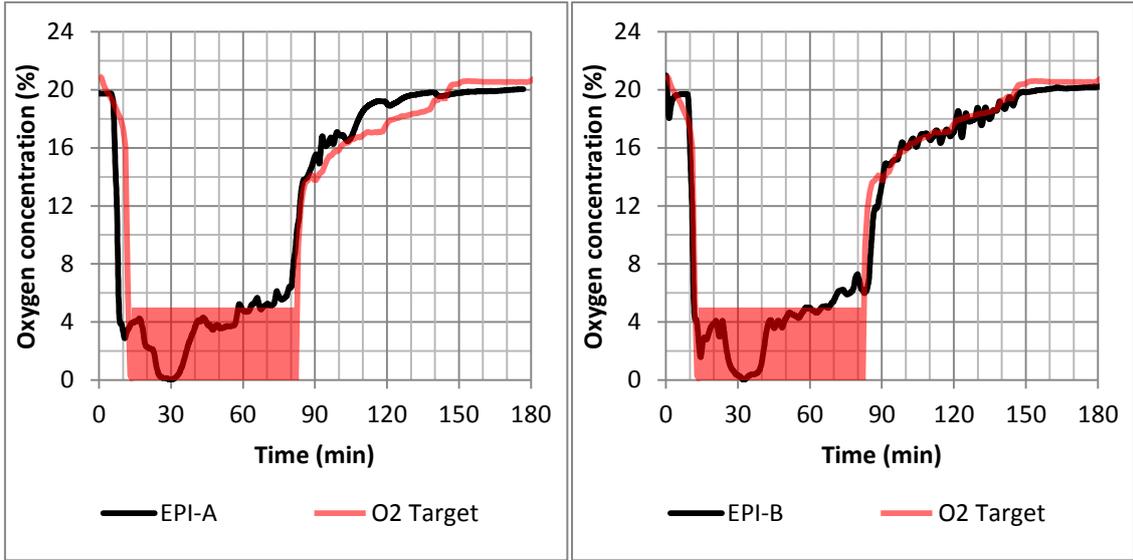
Figure 20: Oxygen concentration of EPI-A (left) and EPI-B (right)

Figure 14 shows the average plate thermometer temperature together with the target temperature. Figure 20 shows the measured oxygen concentration together with the target oxygen concentration for the duration of the test. No complications arose for the control of the temperature and oxygen content.

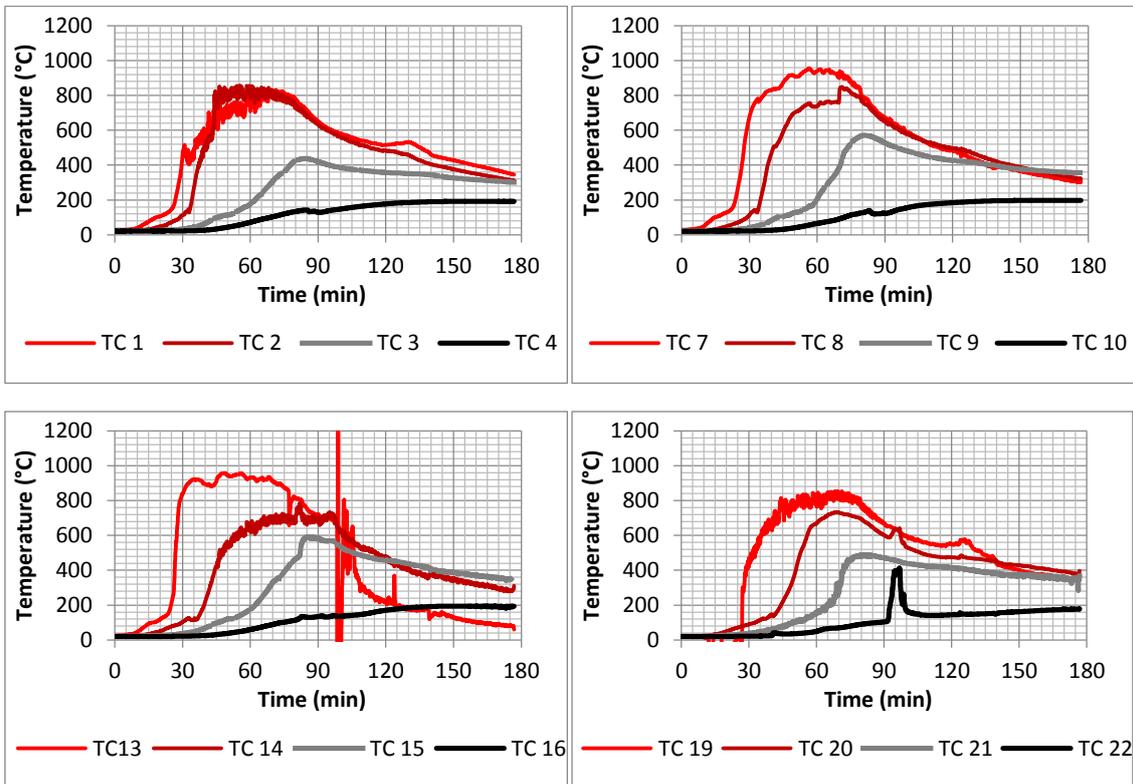
Figure 21: CLT temperatures at 20, 35, 50 and 70mm depth at four locations EPI-A

Figure 21 and Figure 22 show the CLT temperatures at 20, 35, 50 and 70mm from the exposed surface, measured using thermocouples that were positioned parallel to the isotherms. According to the criteria specified in 2.3, there is no indication of delamination given by the thermocouples of EPI-A and EPI-B. However, char fall-off was seen in the video of EPI-B at a relatively late stage. First, falling of small parts of a charred lamella was observed between 68 and 90 minutes into the test. After approximately 90 minutes, a significant part of a charred lamella fell into the furnace, as can be seen in the frames of the video in Figure 23. This char fall-off, however, did not seem to influence the temperatures in the furnace significantly and no adjustments had to be made to follow the target oxygen concentration and temperature. The char fall-off took place 40 to 60 minutes after the char line had surpassed the bond line, thereby distinguishing it from a delamination, in which a bond line fails before the char front surpasses it. At this stage the 300°C isotherm had surpassed all thermocouples at 50mm depth, indicating that there was a char layer with a thickness of at least 15mm in the second lamella. The bond line temperature was approximately 600°C, which was less than 100°C lower than the fire temperature at that point. Therefore, surface temperatures of the newly exposed second lamella did not increase as rapidly as seen in other tests of this study. The video of EPI-A showed only minor falling of char at approximately 1:13 h. Frames of that video can be found in Appendix I.

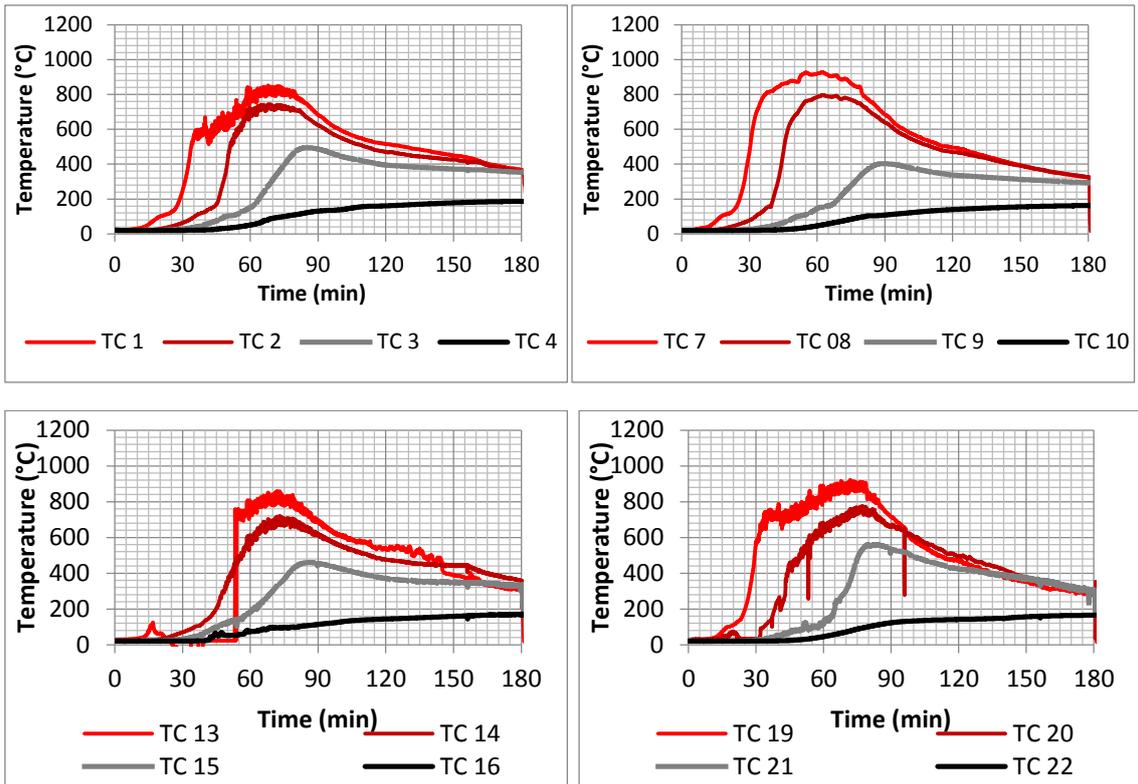
Figure 22: CLT temperatures at 20, 35, 50 and 70mm depth at four locations EPI-B

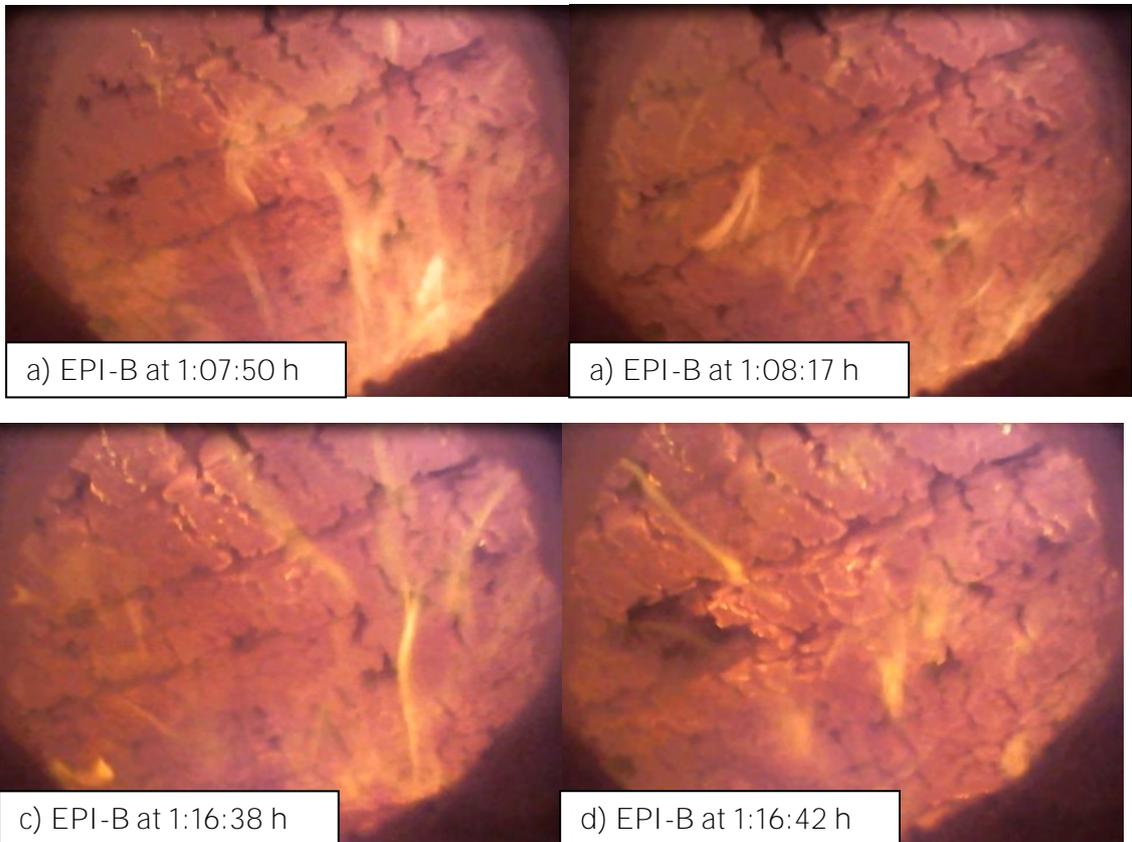
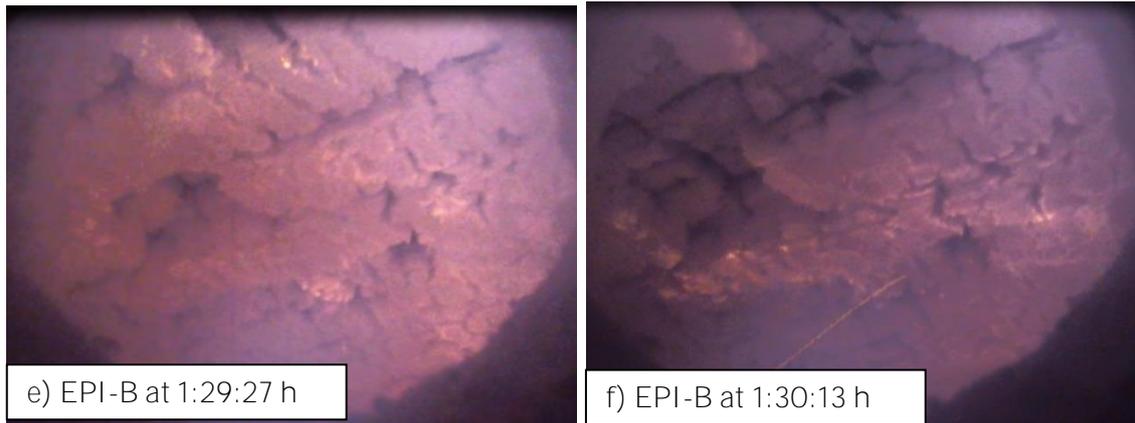
Figure 23: Frames of the video showing times and locations of falling parts.

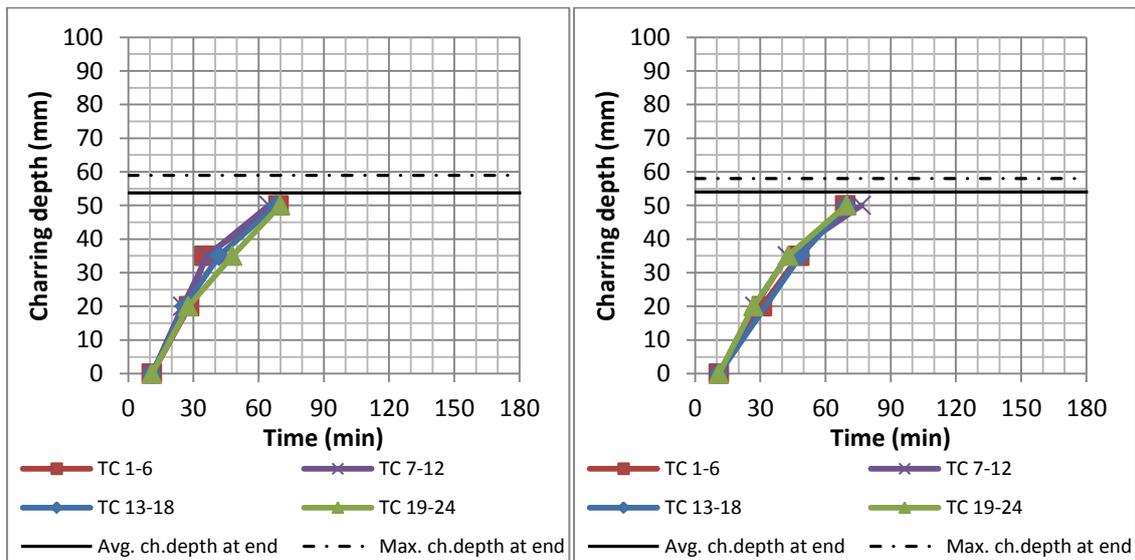
Figure 24: Charring depth during and at the end of EPI-A (left) and EPI-B (right)

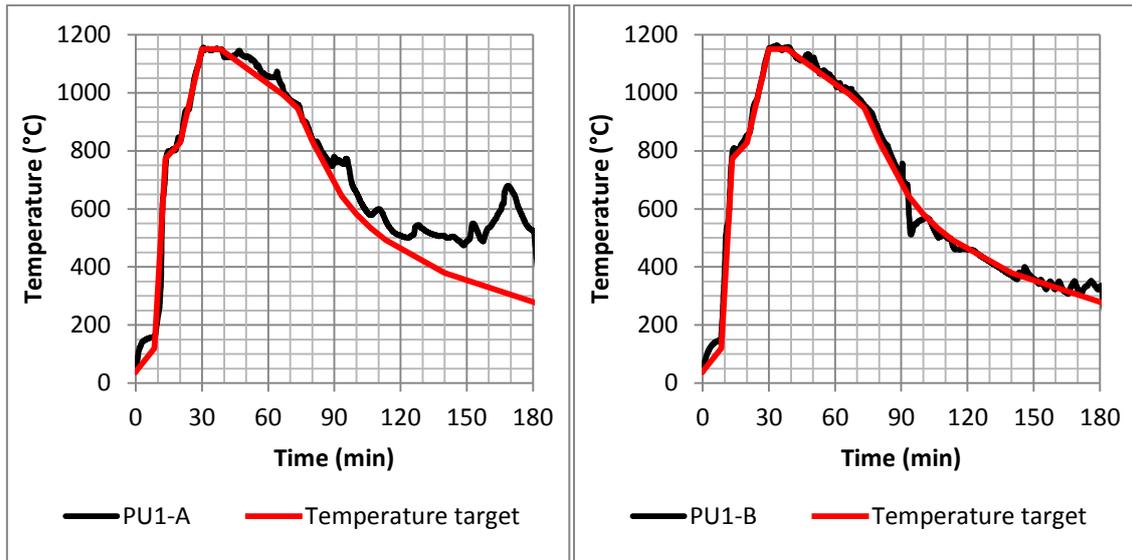
Figure 25: Average temperature measured by the plate thermometers of PU1-A (left) and PU A2 (right)

The plate thermometer temperatures of test PU1-A and PU1-B are shown in Figure 25. The oxygen measurements of both tests are shown in Figure 26. In both tests delamination of the exposed layer occurred during the fully developed phase of the fire. As a consequence of this, the oxygen concentration dropped to zero percent after approximately 50 minutes. Similar to the other tests discussed in this section, the burners were shut off during the decay phase. However, due to delamination of the second layer of lamellas, the temperatures increased naturally in PU1-A at approximately 2:30h. After delamination of the exposed layer, the oxygen content could not be controlled to the same level of accuracy, as was done in the tests of other specimens.

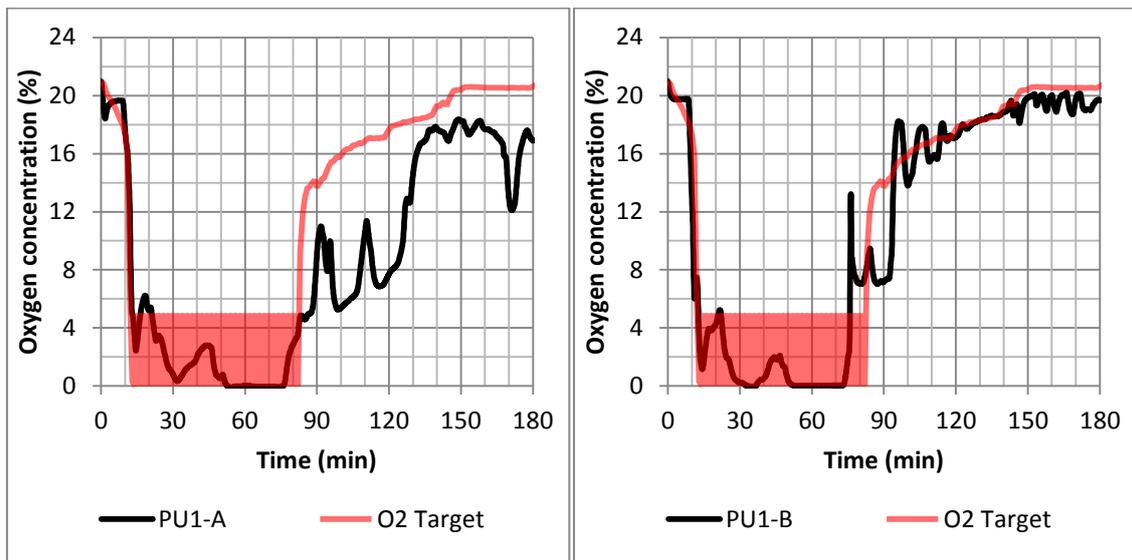
Figure 26: Oxygen concentration of PU1-A (left) and PU A2 (right)

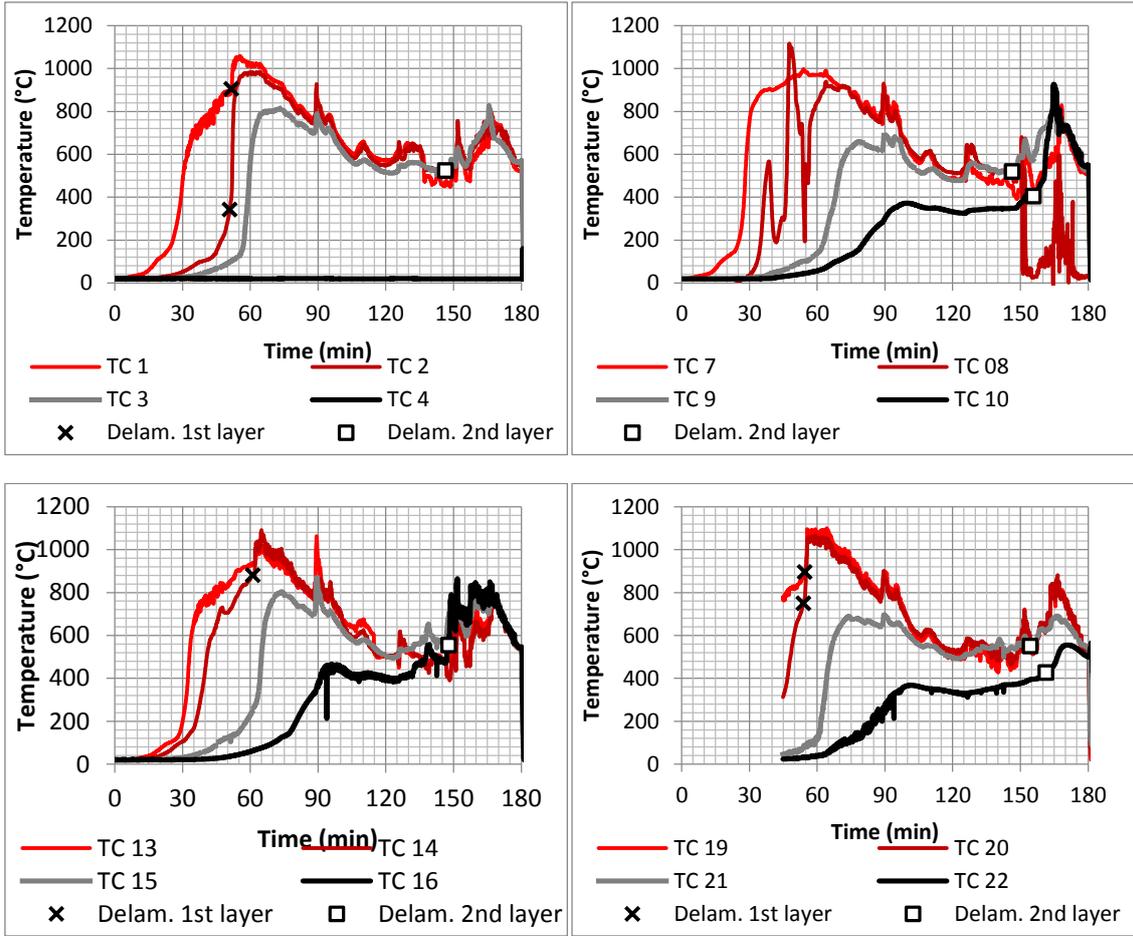
Figure 27: Temperatures measured in the first two plies of specimen PU1-A and in the bond lines of these plies and an indication of delamination according to specified criteria

Temperatures measured with thermocouples positioned parallel to the grain at depths of 20mm, 35mm, 50mm and 70mm are shown in Figure 27 and Figure 28 for specimens PU1-A and PU1-B, respectively. According to the criteria specified in Section 2.3, a sudden temperature rise measured by multiple thermocouples indicated delamination. The time and temperature corresponding to these steep temperature rises are shown in the figures. For test PU1-A thermocouples TC4 and TC8 are not considered for the determination of delamination times, as the measurements indicated a defect of the thermocouples. Additional thermocouples positioned perpendicular to the isotherms also showed sudden increases of temperatures inside the lamellas and bond lines (as will be seen further in this report in Section 2.8.2). The measurements indicated that delamination of the first layer occurred after 45 to 65 minutes and delamination of the second layer started at approximately 140 minutes. In test PU1-B only two thermocouples indicated delamination of the second layer, indicating there was only partial delamination of this layer in this test.
