RESEARCH FOUNDATION

Fire Safety Challenges of Tall Wood Buildings – Phase 2: Task 5 – Experimental Study of Delamination of Cross Laminated Timber (CLT) in Fire

March 2018

Report number: FPRF-2018-05

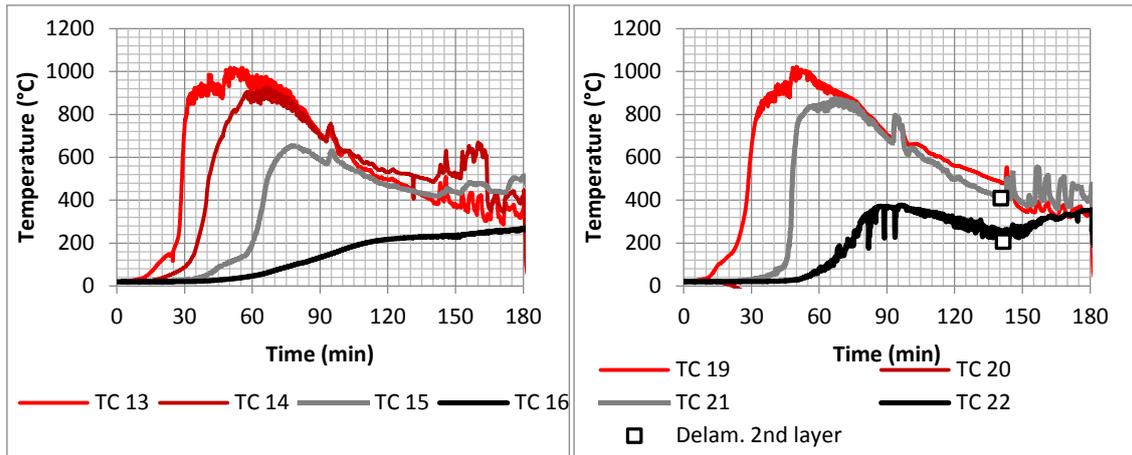
Figure 28: Temperatures measured in the first two plies of specimen PU1-B and in the bond lines of these plies and an indication of delamination according to specified criteria

Temperatures measured with thermocouples positioned parallel to the grain at depths of 20mm, 35mm, 50mm and 70mm are shown in Figure 27 and Figure 28 for specimens PU1-A and PU1-B, respectively. According to the criteria specified in Section 2.3, a sudden temperature rise measured by multiple thermocouples indicated delamination. The time and temperature corresponding to these steep temperature rises are shown in the figures. For test PU1-A thermocouples TC4 and TC8 are not considered for the determination of delamination times, as the measurements indicated a defect of the thermocouples. Additional thermocouples positioned perpendicular to the isotherms also showed sudden increases of temperatures inside the lamellas and bond lines (as will be seen further in this report in Section 2.8.2). The measurements indicated that delamination of the first layer occurred after 45 to 65 minutes and delamination of the second layer started at approximately 140 minutes. In test PU1-B only two thermocouples indicated delamination of the second layer, indicating there was only partial delamination of this layer in this test.

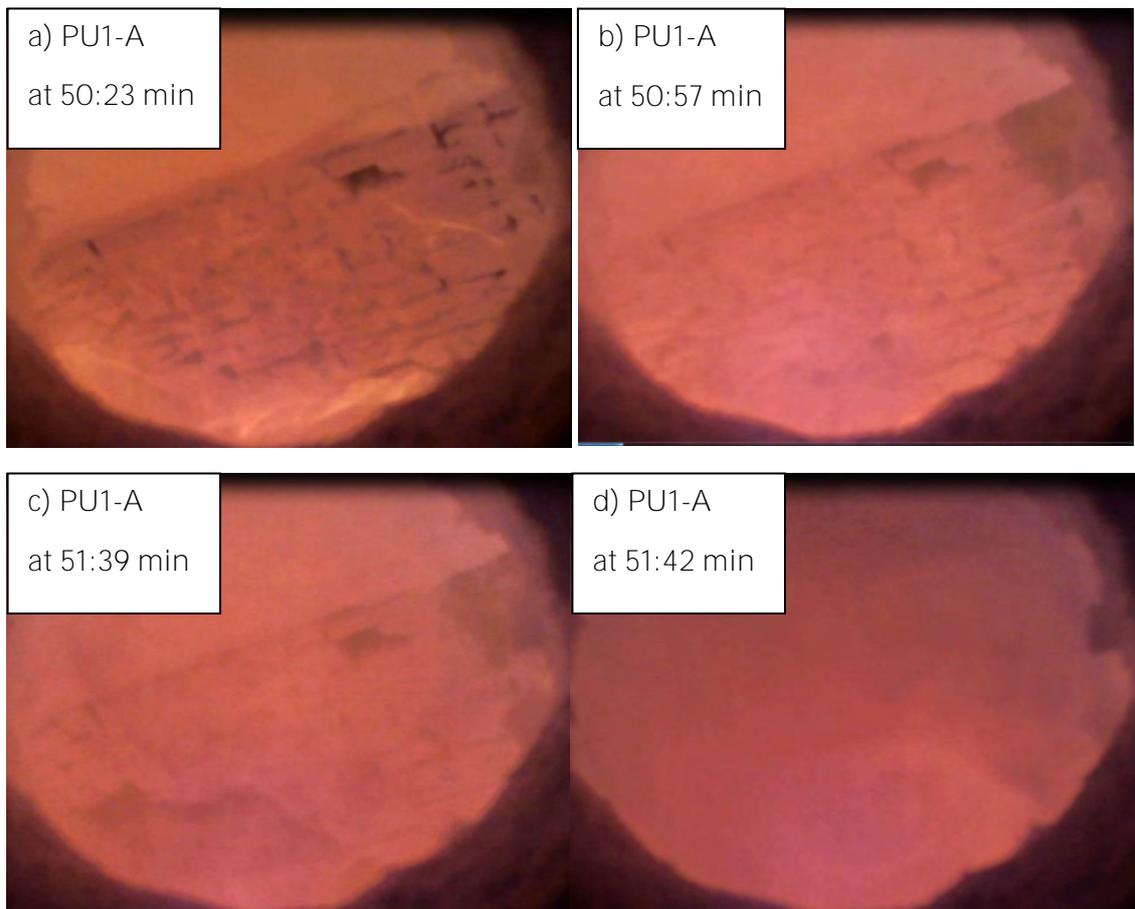
Figure 29: Photos of the exposed surface in test PU1-A during delamination of the exposed ply

Video recordings showed clear delamination during tests PU1-A and PU1-B. At 50:55min of PU1-A the first part of a lamella visibly fell into the furnace (see Figure 29 b). At this period smoke developed rapidly in the furnace, due to lack of oxygen. This smoke development was not seen in tests with CLT of other adhesives. At 51:37 a large part of the exposed layer fell into the furnace (see Figure 29 c) and within a few seconds the furnace was filled with thick smoke, which made it not possible to see the specimen until the decay phase (see Figure 29 d).

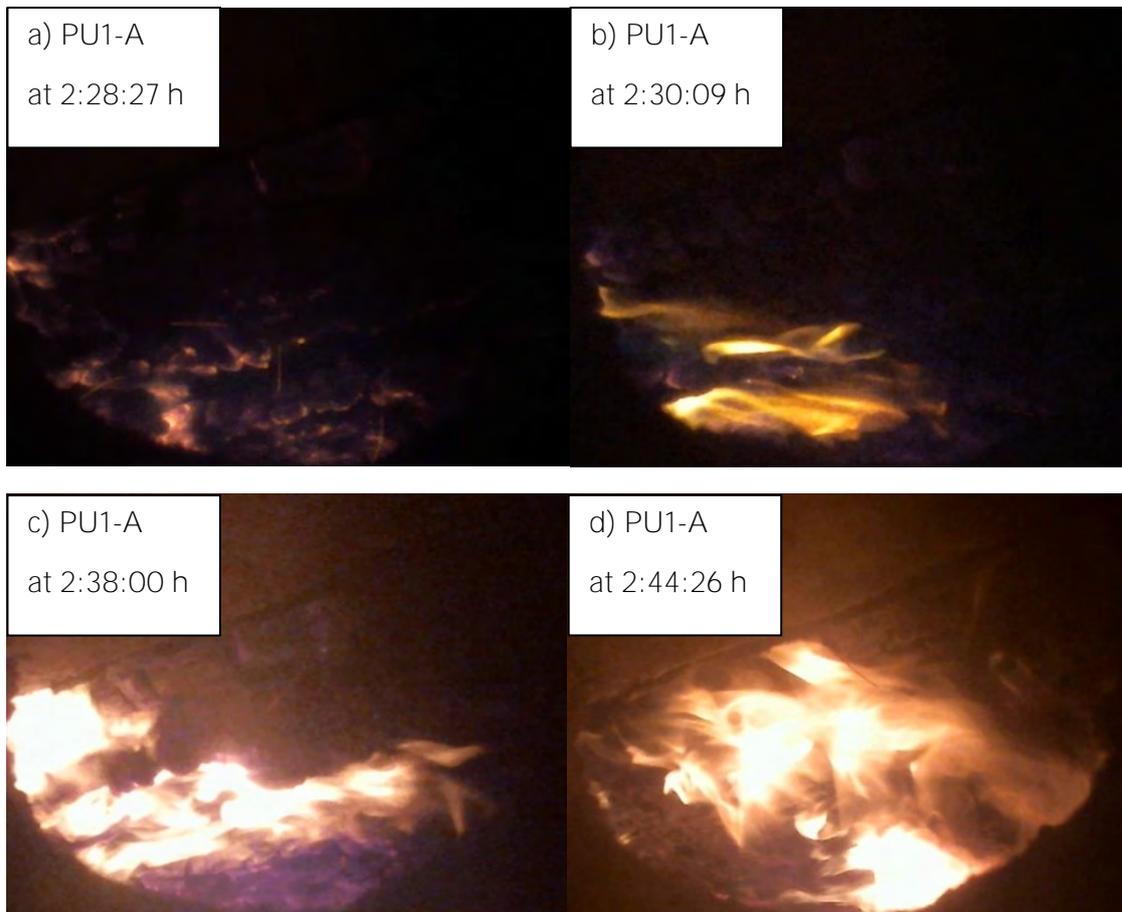
Figure 30: Photos of the exposed surface in test PU1-A during delamination of the second ply

The only light in the furnace was emitted by the burning specimen. During the decay phase of the fire, the video screen became dark and an increase of light indicated an increased amount of combustion (Figure 30a). Flaming on the surface was observed at 2:30h during PU1-A (Figure 30b). Due to the flames, falling of the lamella could not be seen in the video. However, it could be seen that a part of the second layer was still in place at 2:38h (Figure 30c). At 2:44h the intensity of the flames increased, indicating that a significant part of the third layer of lamellas became exposed.

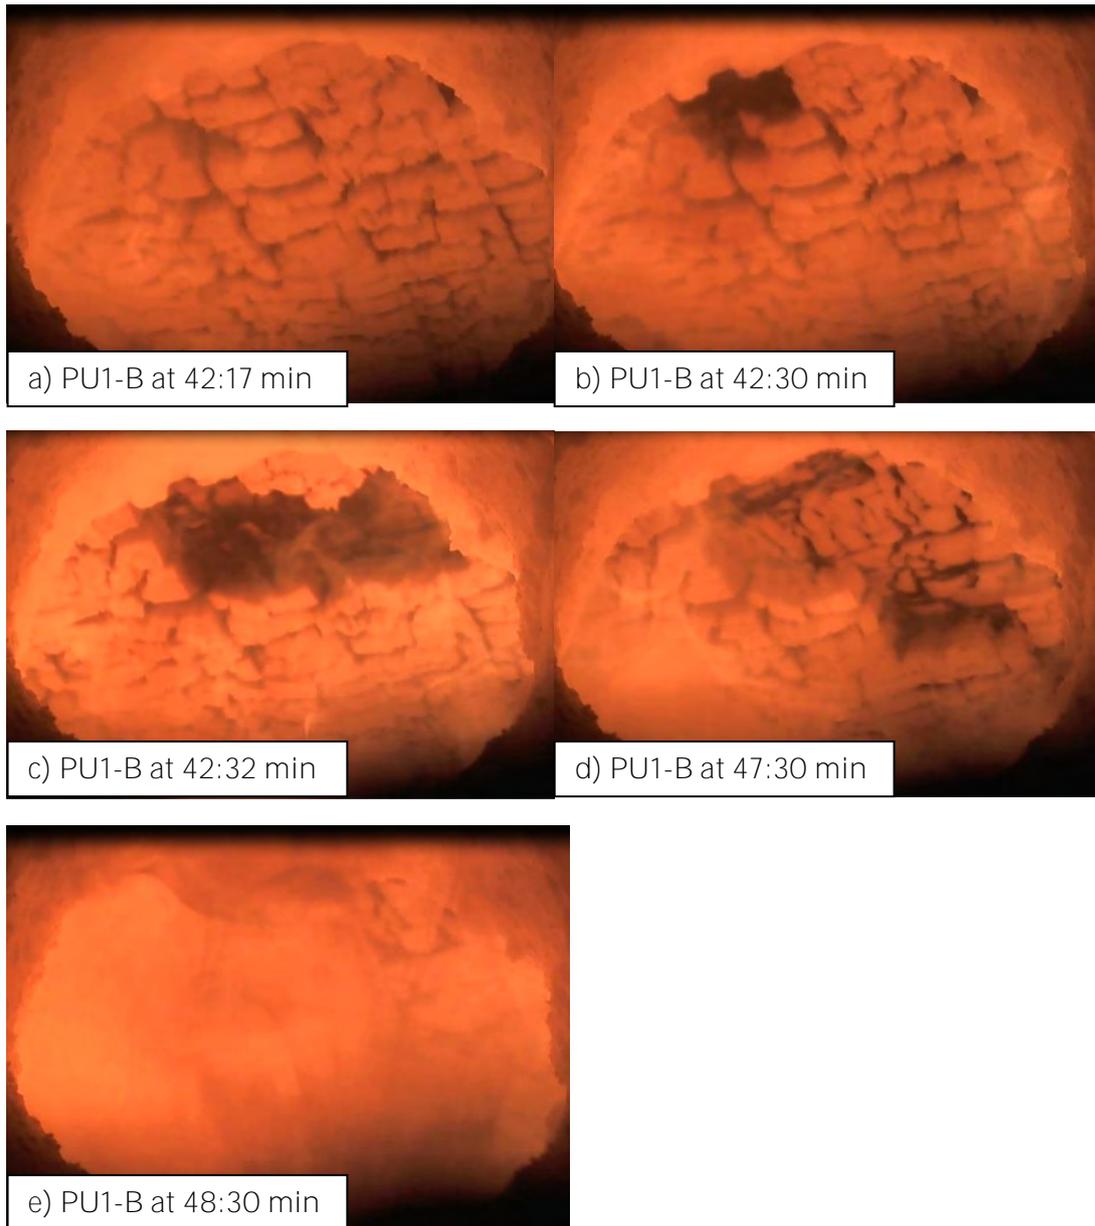
Figure 31: Photos of the exposed surface in test PU1-B during delamination of the exposed ply

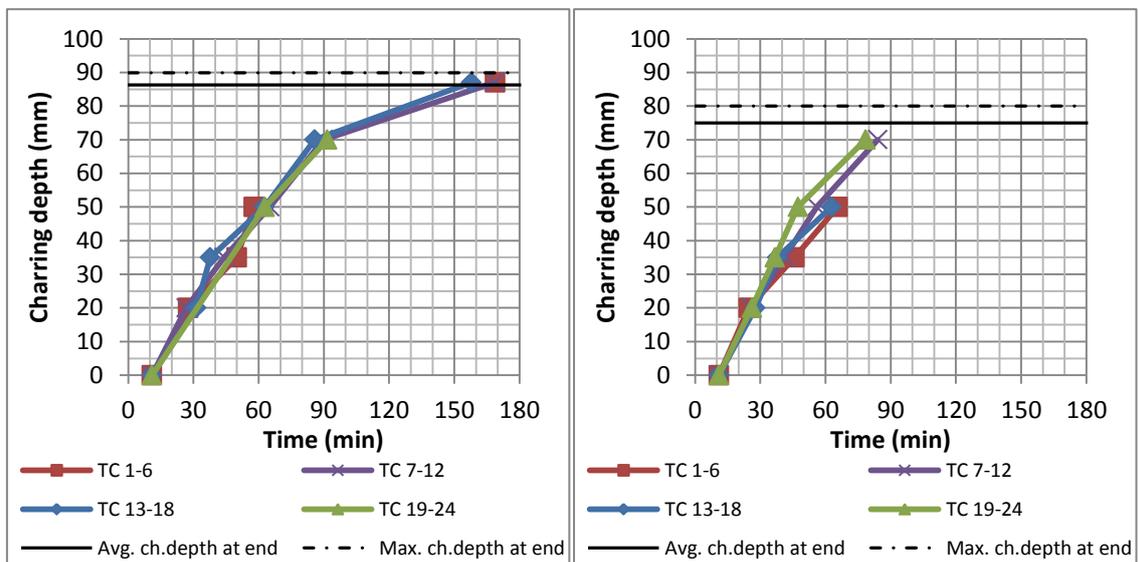
Figure 33: Charring depth during PU1-A (left) and PU1-B (right)

The thickness of the char layer was estimated using the char temperature of wood of approximately 300°C. The char depth during the test was determined using the four sets of thermocouples positioned parallel to the isotherms. Figure 33 shows the determined charring depths corresponding PU1-A and PU1-B. In PU1-A the 300°C isotherm reached three out of four thermocouples at a depth of 87mm at the end of the test. This corresponds well with the charring depths measured at the end of the test (see Table 10), indicating that the thermocouples that were positioned parallel to the isotherm accurately measured the temperatures. In PU1-B the 300°C isotherm only reached two out of four thermocouples in the second bond line.

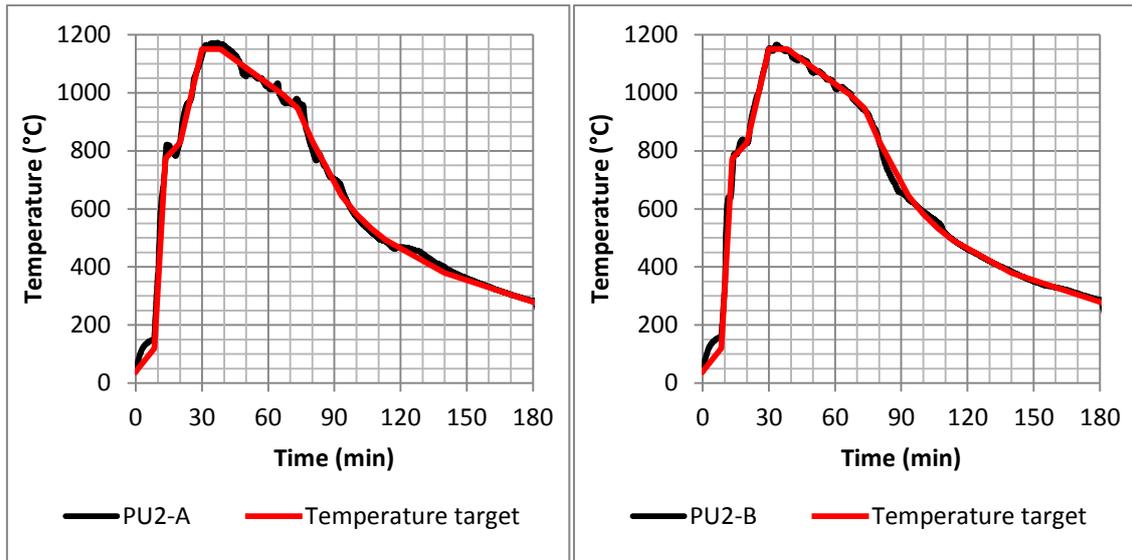
Figure 34: Average temperature measured by the plate thermometers of PU2-A (left) and PU2-B (right)

Figure 34 shows the average plate thermometer temperature together with the target temperature. Figure 35 shows the measured oxygen concentration together with the target oxygen concentration for the duration of the test. No complications arose for the control of the temperature and oxygen content.

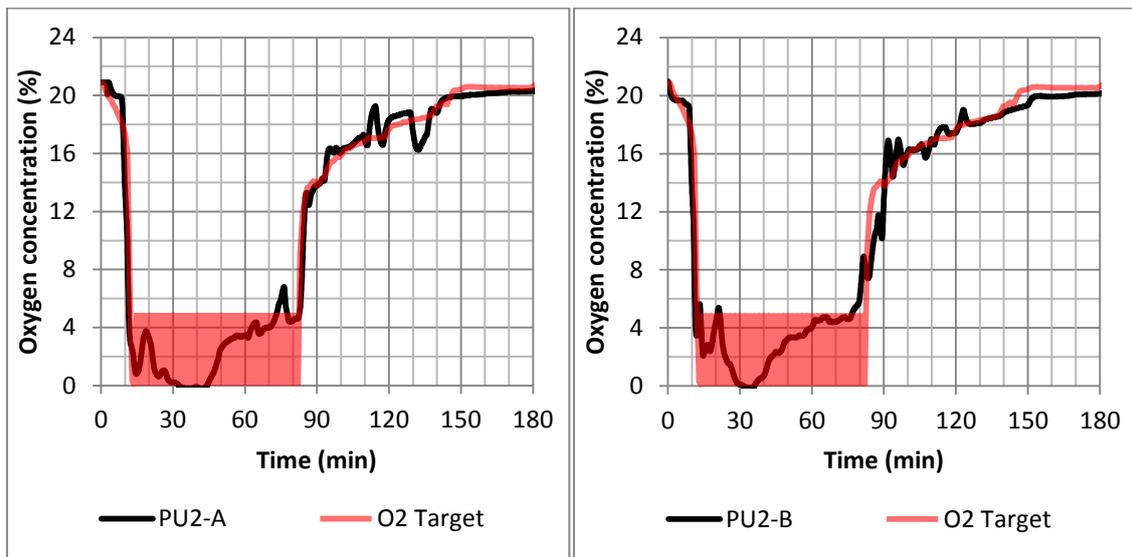
Figure 35: Oxygen concentration of PU2-A (left) and PU2-B (right)

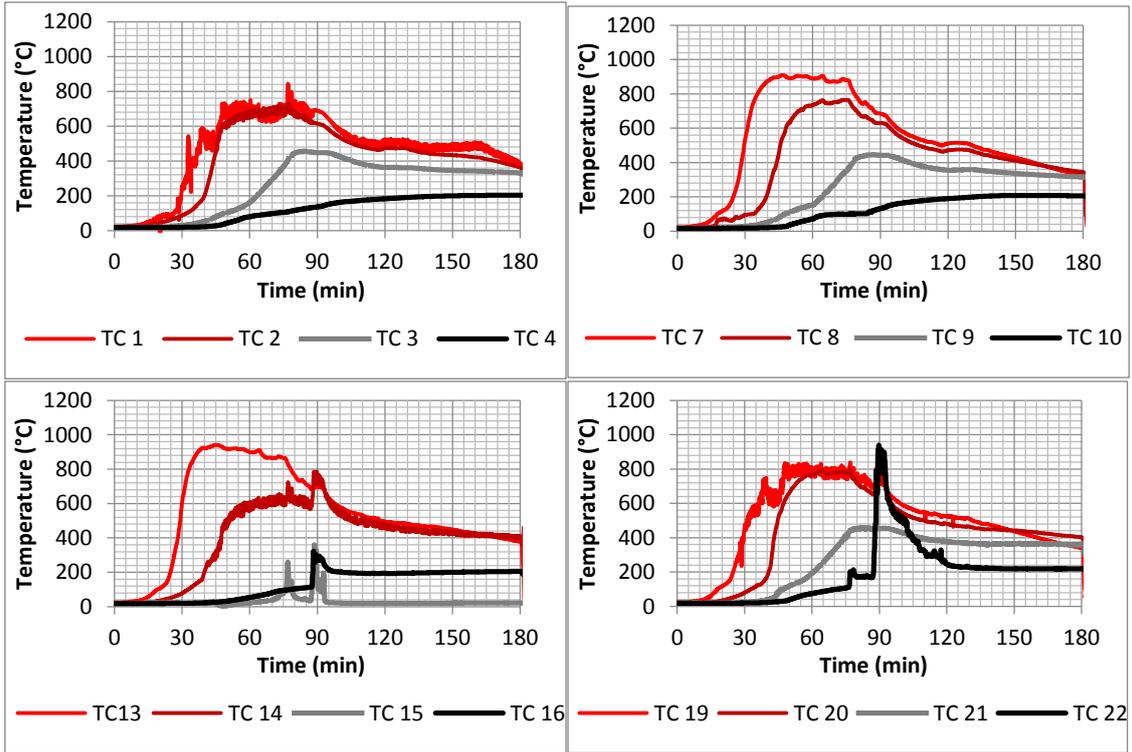
Figure 36: CLT temperatures at 20, 35, 50 and 70mm depth at four locations PU2-A

Figure 36 and Figure 37 show the CLT temperatures at 20, 35, 50 and 70mm from the exposed surface, measured using thermocouples that were positioned parallel to the isotherms. Thermocouples TC15 of PU2-A and TC 3 and 7 of PU2-B were disregarded as they show clear signs of malfunction. The temperature jumps measured by TC 14, 15, 16 and 22 were likely caused by an electrical disturbance in one of the data loggers. The temperature jumps were seen at exactly the same time in measurements made with the same data logger. Therefore, measurements from these thermocouples are not considered for the determination of delamination. According to the criteria specified in 2.3, there is no indication of delamination given by the thermocouples of PU2-A and PU2-B. **The video camera filming approximately half of the specimen's surface did also not record delamination during the test.** The videos of PU2-A and PU2-B showed no signs of delamination. Frames of the videos can be found in Appendix I.

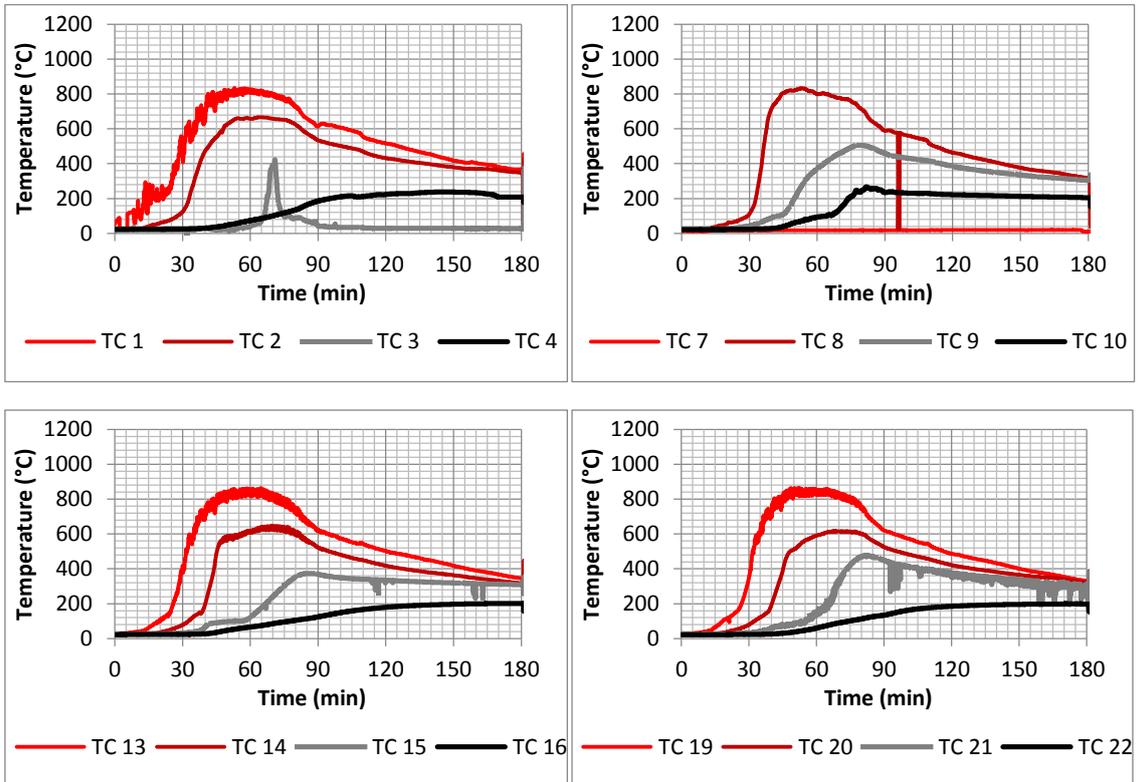
Figure 37: CLT temperatures at 20, 35, 50 and 70mm depth at four locations PU2-B

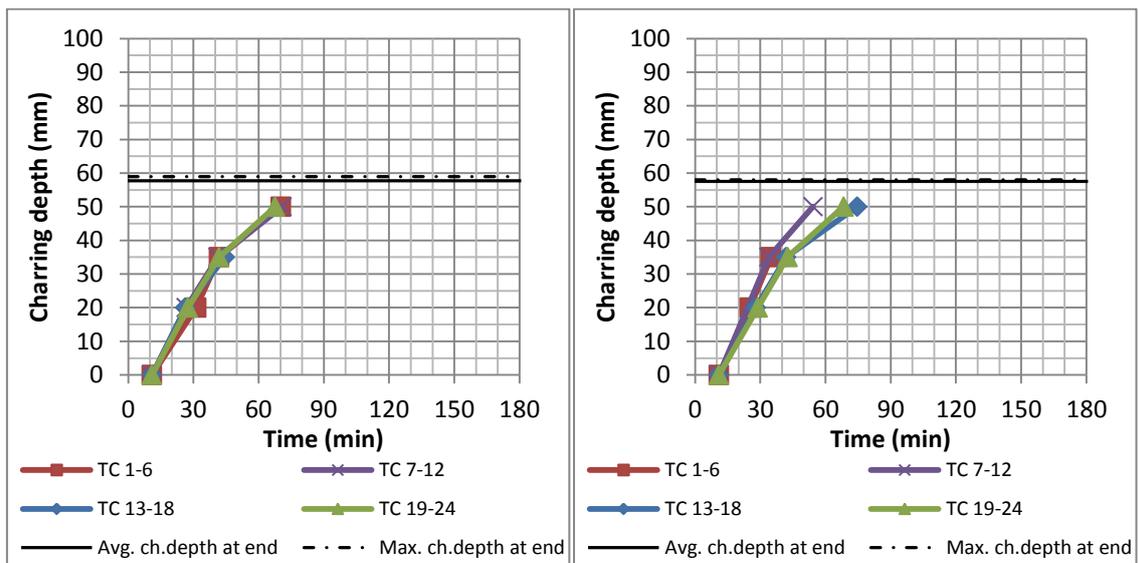
Figure 38: Charring depth during and at the end of PU2-A (left) and PU2-B (right)

Charring rates were determined in a similar way as was done for tests that were already discussed earlier in this report. 300°C was measured in all thermocouples at 50mm depth, but it was not measured at 70mm depth. Figure 38 shows the depth of the char layer during the test based on temperature measurements. Additionally, the average and the maximum char depths measured after the test are indicated. The measured charring depth suggests that the charring rate sharply reduces after approximately 70 minutes, which is approximately when the decay phase starts. The results of the four char depth measurements with a resistograph are shown in Table 6.

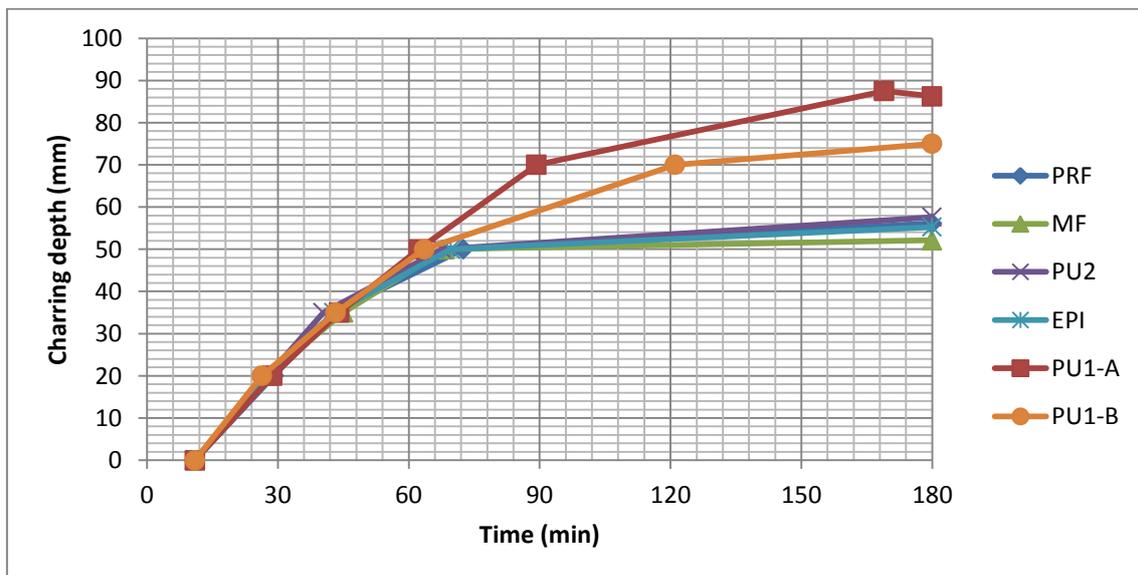
Figure 39: Charring depth throughout tests

The depth of the char layer can be seen as a measure of fire damage of the CLT panel. Figure 39 shows the average charring depth for each type of adhesive. The data point corresponding to 180 minutes is obtained from char depth measurements after the test. The other data is obtained from measurements of thermocouples that were positioned parallel to the isotherms.

It can be seen that the average charring depth of the PU1 specimens was significantly higher than that of all other specimens. A small difference is already seen at 60 minutes, which was during the delamination phase of the first layer of lamellas. Even though the decay phase started around the same time, the char depth of the PU1 specimens increased significantly after 60 minutes.

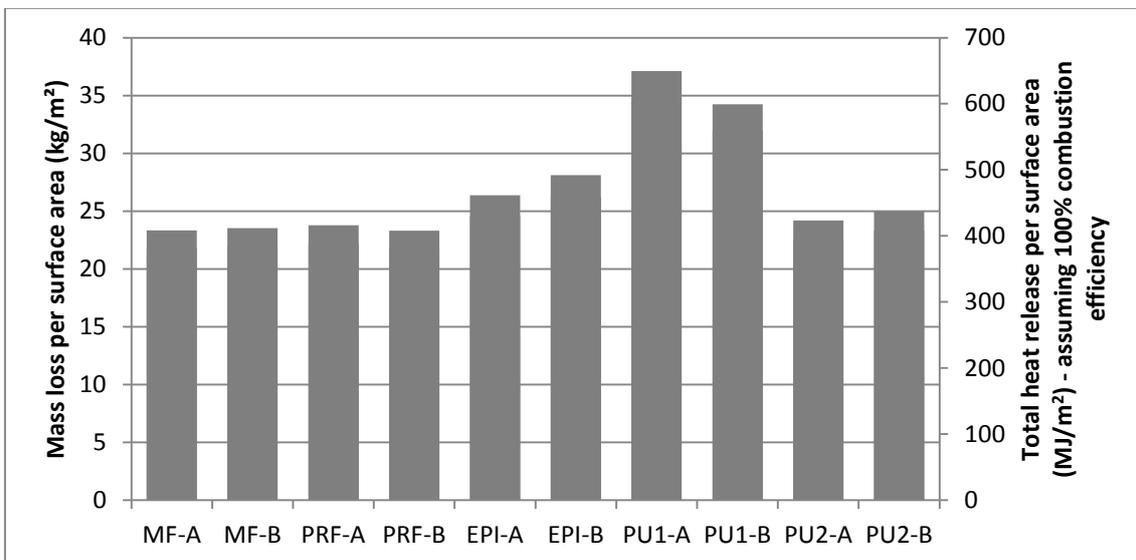
Figure 41: Mass loss of dry timber at end of test.

The total mass loss of dry timber per area of exposed surface corresponding to different tests is shown in Figure 41. It can be seen that the specimens that showed clear delamination on the camera recordings (EPI-B; PU1-A and; PU1-B) lost more mass of dry timber during the fire test. The mass loss of PU1-A and PU1-B is, however, significantly higher than that of EPI-B. The heat release can be estimated from the mass loss of the dry timber, by assuming that all falling char and combustibles produced by the burning wood completely combust.

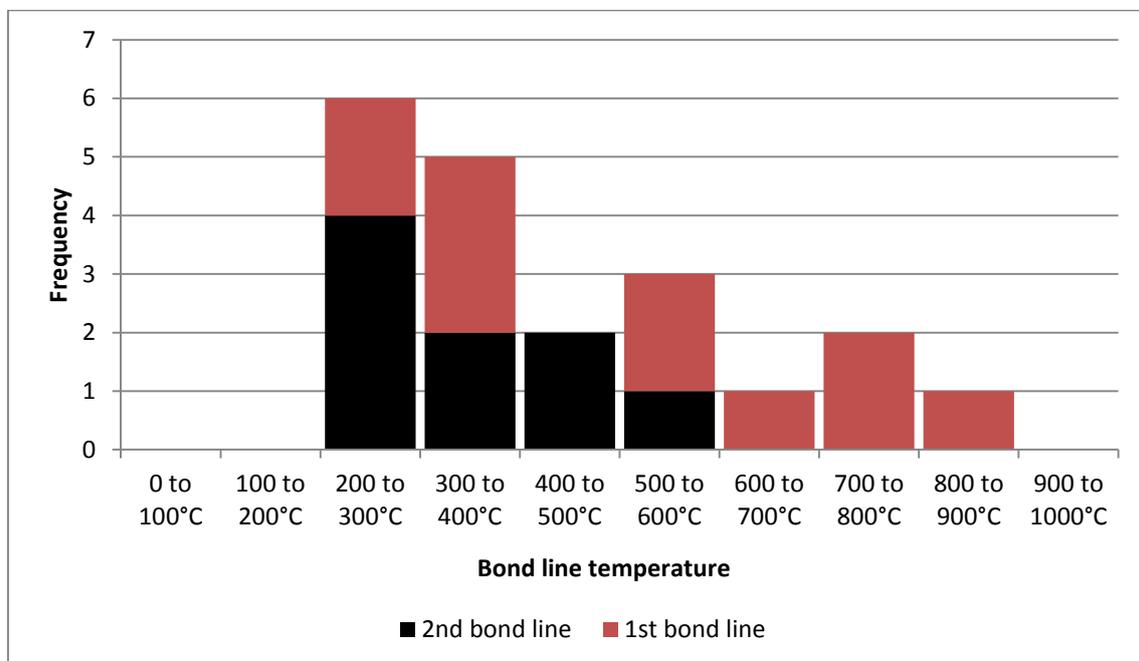
Figure 42: Distribution of bond line temperatures during delamination of the first and second layer in PU specimens and compartment tests.

For the development of engineering methods, it is important to know the critical bond line temperature that leads to delamination. From the compartment tests by Su *et al.* (2017) it could not be concluded whether the bond line fails before the char line surpasses the bond line, as only a part of the temperature measurements suggested that bond line temperatures were lower than 300°C. The same was seen in tests PU1-A and PU1-B. To get knowledge of the critical bond line temperature it was chosen to study the distribution of temperatures at which delamination occurs. In order to get as many data as possible, critical temperatures identified in all compartment tests presented by Su *et al.* and in furnace test PU1-A and PU1-B are all used for this analysis.

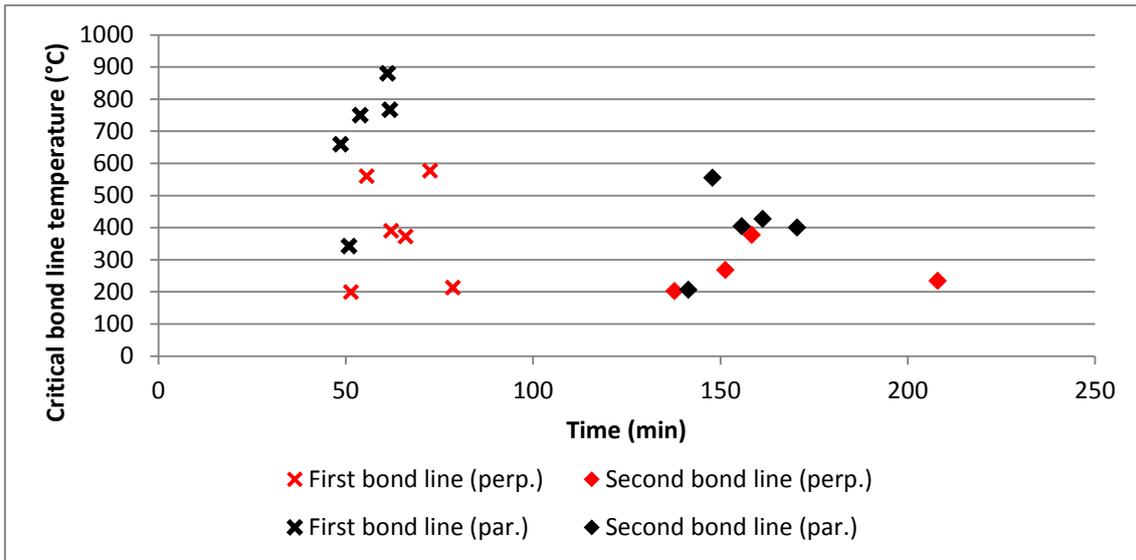
Figure 43: Critical bond line temperature and time of delamination of the first and second layer in PU1 specimens and compartment tests.

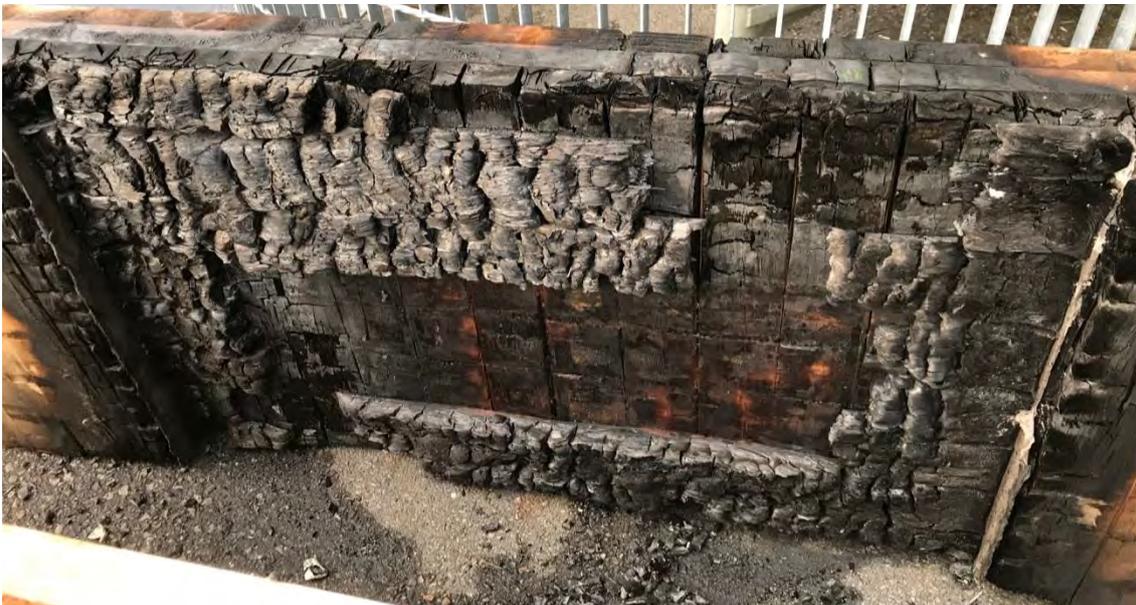
Figure 44: Specimen of test PU1-B after the test.

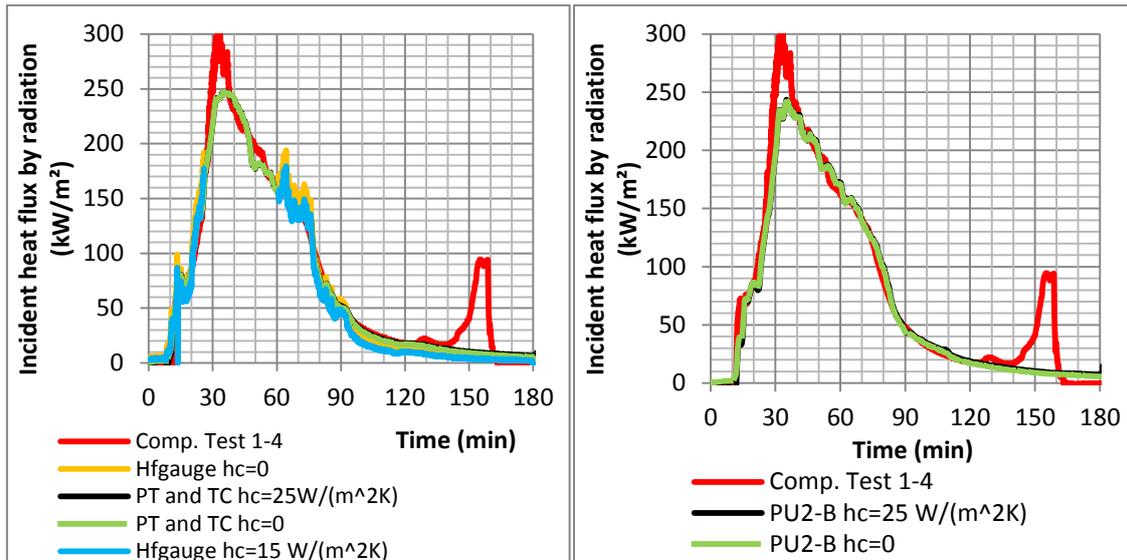
Figure 45: Incident heat flux by radiation of test PU2-A (left) and PU2-A (right)

In two instances the incident radiant heat flux of Compartment Test 1-4 exceeded that of PU2-A and PU2-B. The temperatures of Compartment Test 1-4 exceeded the maximum allowed temperature of the furnace for a few minutes. Therefore, the maximum heat flux of the furnace is lower than the maximum heat flux of the compartment test. The second increase of radiant heat flux seen in the compartment test was caused by delamination of the CLT with PU1 adhesive. The incident heat flux by radiation of other tests is given in Appendix II.

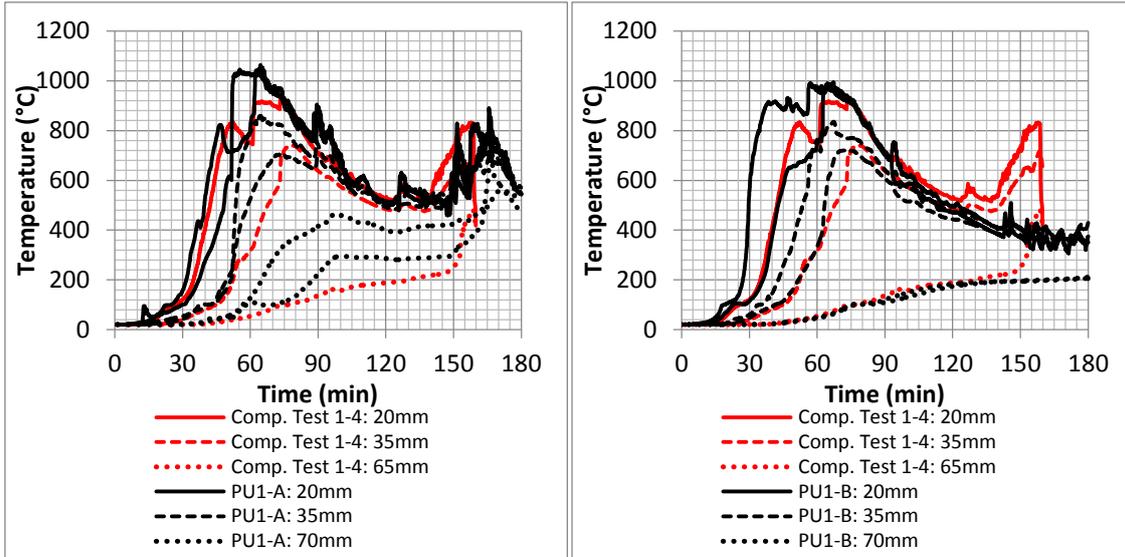
Figure 46: temperatures of PU1-A, PU1-B and Compartment Test 1-4 at different depths. In PU1-B thermocouples were installed at 50mm instead of 70mm depth

Due to the size of the CLT slabs in Compartment Test 1-4, it was not possible to measure temperatures with thermocouples positioned parallel to the isotherms. For comparisons it was chosen to install extra sets of thermocouples in the same way as was done in Compartment Test 1-4. Figure 46 shows the temperatures corresponding to these thermocouples. Especially in the decay phase the temperatures correspond well with each other. In the heating phase the heating rate at each specified depth varied in different positions of the furnace specimens. However, there is a clear resemblance between the curves of the different tests. In results of, both, the compartment test and the furnace test, a sudden increase was measured at approximately 60 minutes. This jump indicates delamination, which occurred approximately at the same time in all tests with PU1 adhesive. A second temperature increase was seen in Compartment Test 1-4 indicating delamination of the second ply. Although the temperatures deeper in the specimen seemed very similar, this increase was not seen in PU1-B. Localized delamination was witnessed with video recordings and measurements of other sets of thermocouples. However, this delamination was not significant enough to increase the fire temperature significantly. A significant part of the exposed surface delaminated approximately 2 minutes after the test was stopped (Figure 44). Temperatures measured within the CLT of test PU1-A were similar to the temperatures measured in the CLT of Compartment Test 1-4 until the end of the test, indicating that the test successfully replicated relevant fire conditions of the compartment test.

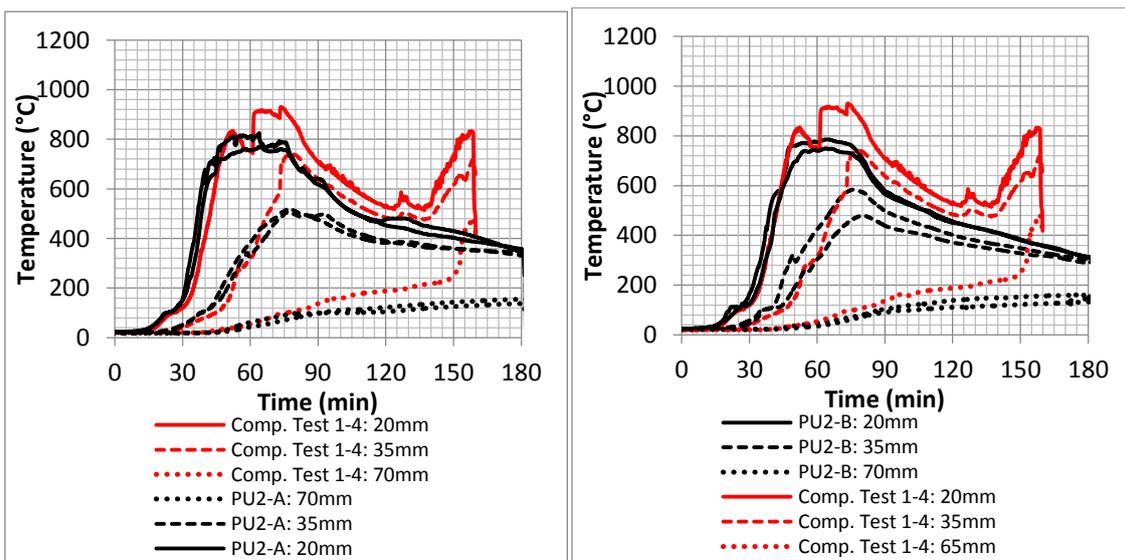
Figure 47: temperatures of PU2-A, PU2-B and Compartment Test 1-4 at different depths

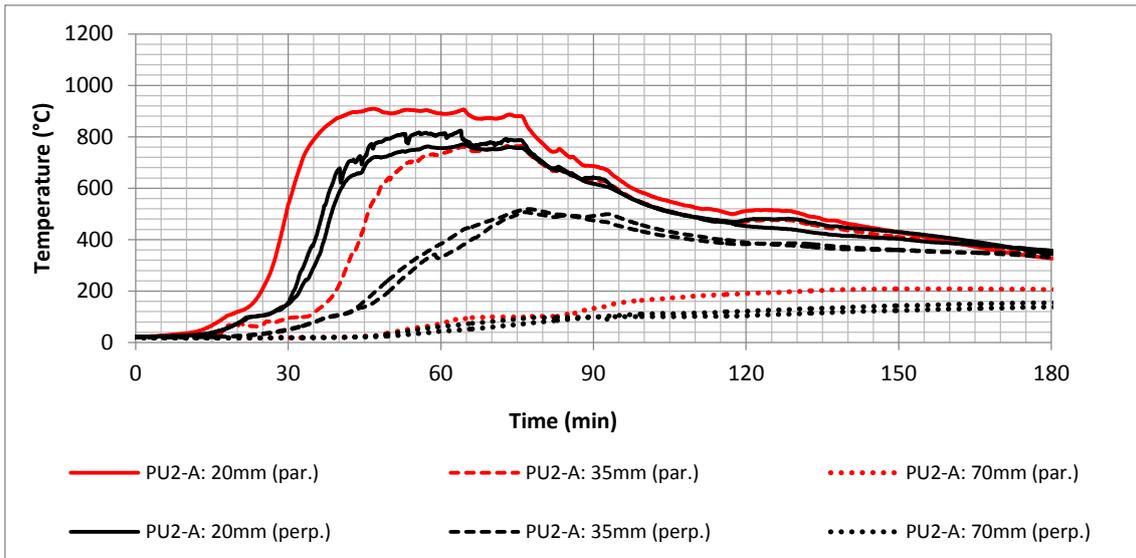
Figure 48: temperatures of PU2-A measured with thermocouples perpendicular and parallel to the isotherms

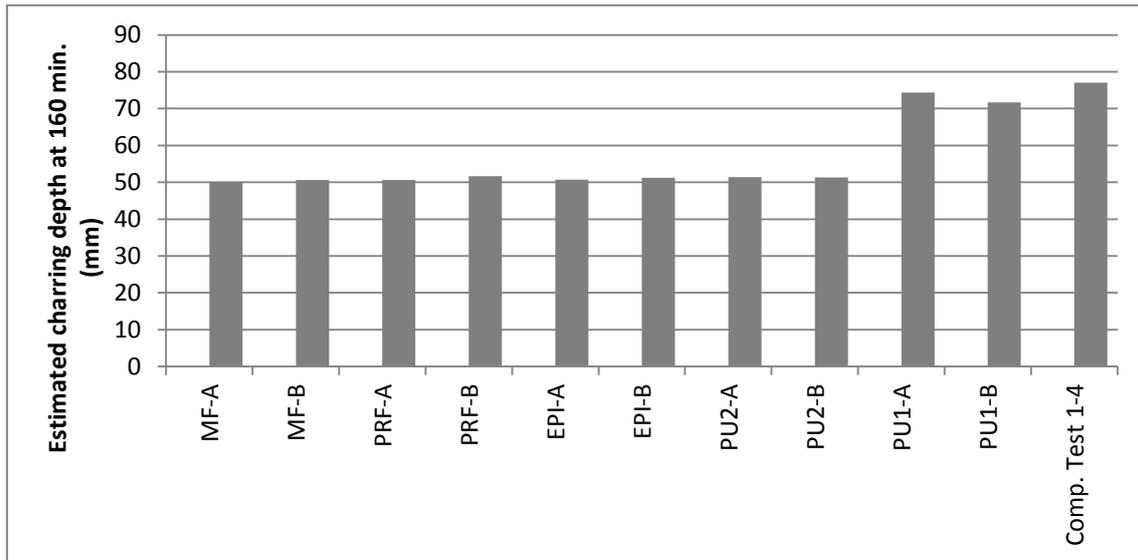
Figure 49: Estimated charring depth at 160 min using linear interpolation.

The char depth was measured after Compartment Test 1-4, which allows comparisons with charring depths resulting from the furnace tests. It should, however, be noted that Compartment Test 1-4 was 20 minutes shorter, as it was extinguished after 160 minutes. For a direct comparison with Compartment Test 1-4, the average char depths at 160 minutes were estimated using linear interpolation (Figure 49). Based on a study of the uncertainty of thermocouple locations and temperature measurements, the expanded total uncertainty for the interpolated char depth is estimated to be ± 0.9 mm (95 % confidence). The estimated charring depth of the specimens of PU-A at 160 minutes corresponds well with the charring depth of Compartment Test 1-4, because the largest difference of average char depth of the two test methods is only 5mm. It should be noted that there was significant spatial (24mm) variation in char depth across the ceiling, as measured after Test 1-4. For both intermediate scale tests of the same CLT product (PU1), the spatial variation of char depth measured was 9 mm. The spatial variation of charring depth measured in tests with other adhesives varied between 2 and 9 mm. However, the resemblance between the average charring rates measured in the PU1 specimens of both tests, indicates that the furnace test successfully replicated relevant fire conditions of the compartment test.

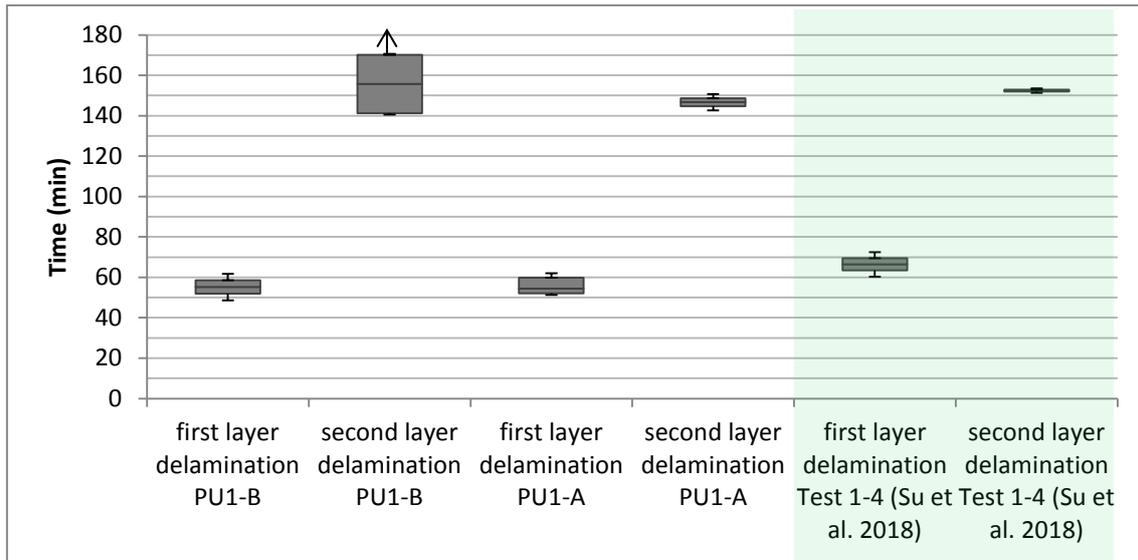
Figure 50: Time of delamination determined from thermocouple measurements

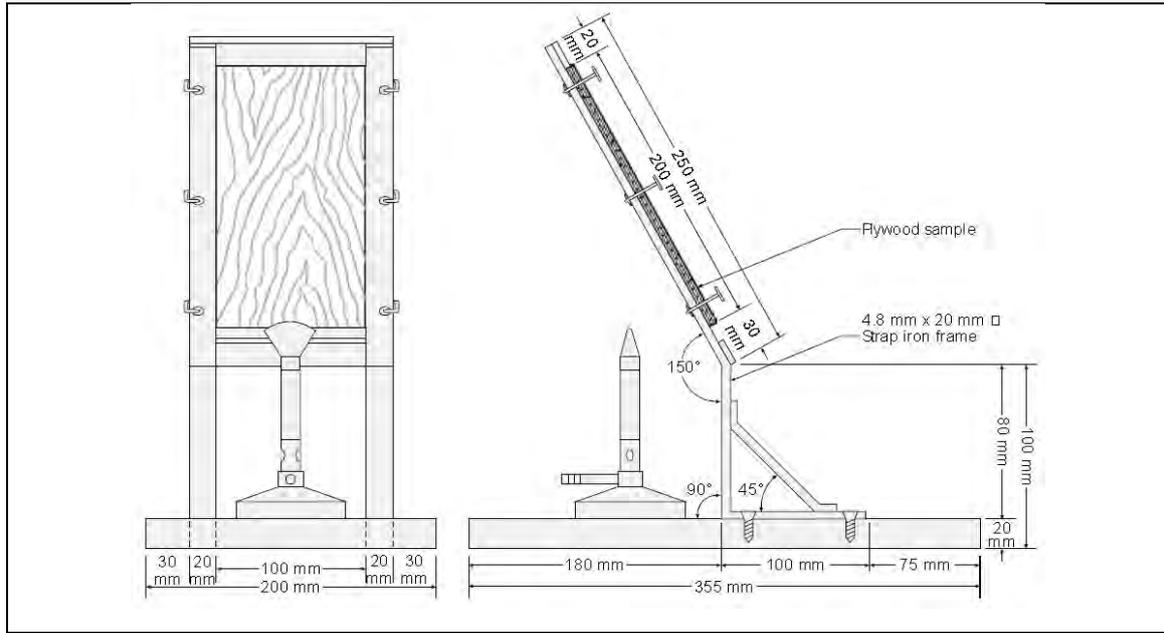
Figure 51: Schematic of apparatus, as presented in NIST (2010)

The PS 1 heat performance test requires a plywood test specimen to be placed on a small scale apparatus as shown in Figure 51, and to be exposed to a 800 to 900°C flame from a Bunsen-type burner for a period of 10 minutes, or until a brown charred area appears on the unexposed side (back side), whichever occurs first. Visual observations of the charred surface are then made based on the extent of veneer delamination, if any.

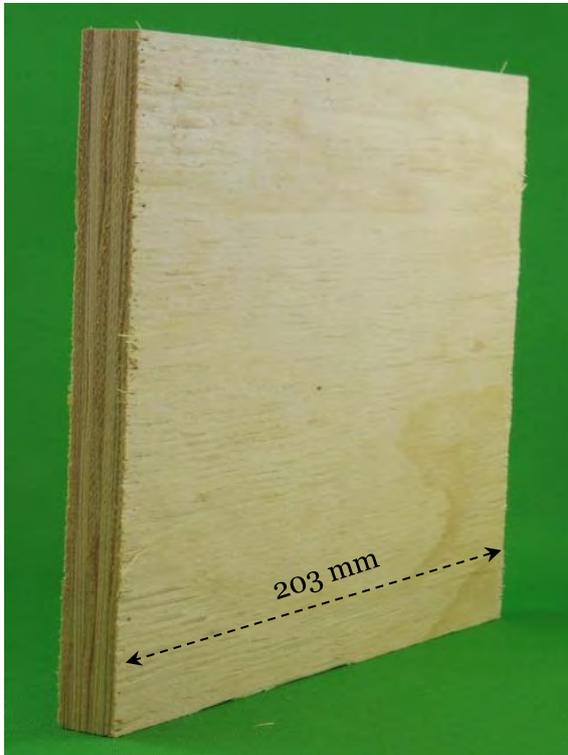
Figure 52: Plywood specimen (PU1-1) prior to flame testing

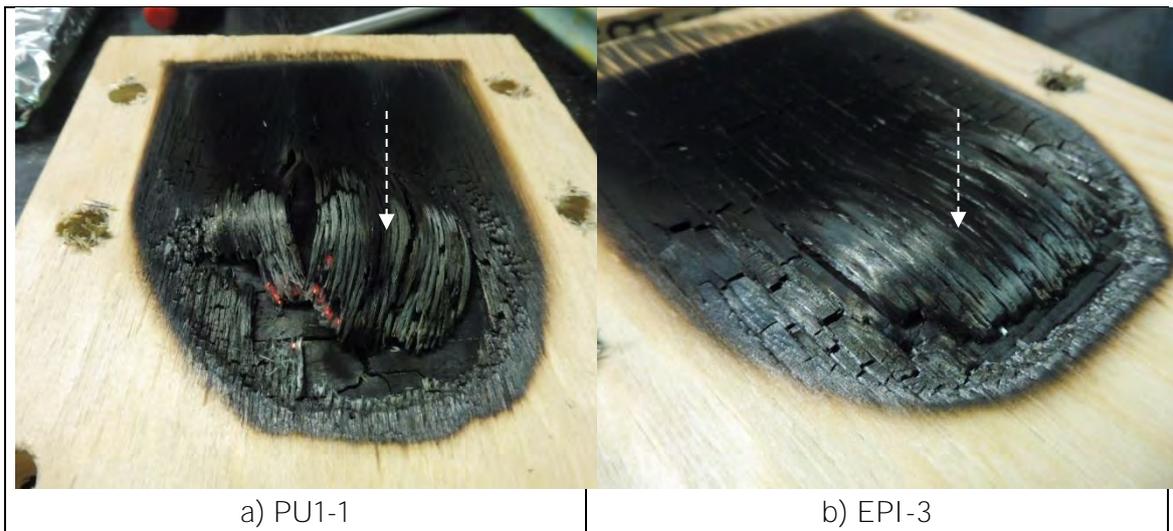
Figure 53: Specimens exhibiting heat delamination (1st ply peeling off)

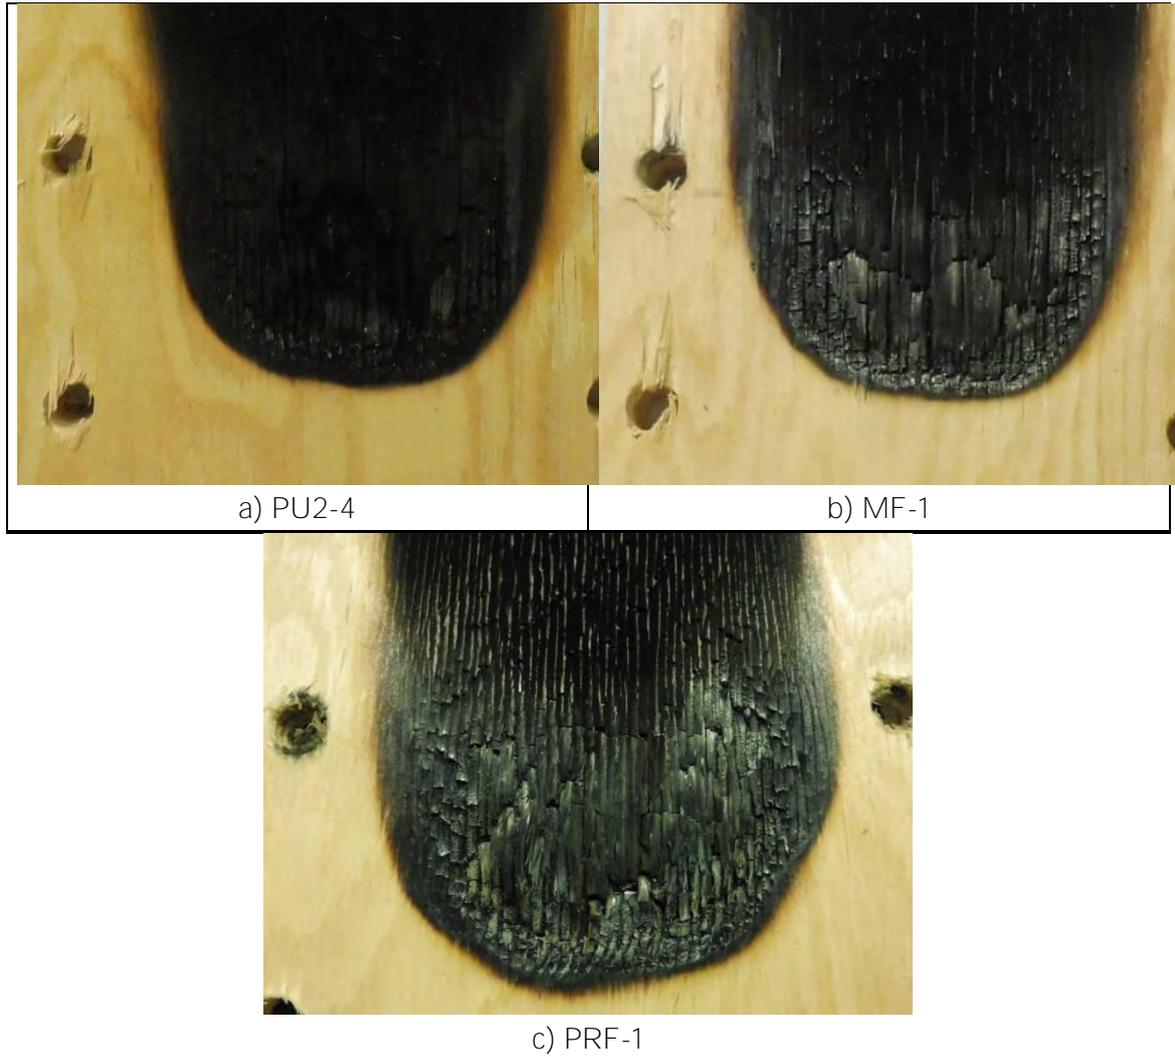
Figure 54: Specimens not exhibiting heat delamination
