RESEARCH FOUNDATION

Fire Safety Challenges of Tall Wood Buildings – Phase 2: Task 5 – Experimental Study of Delamination of Cross Laminated Timber (CLT) in Fire

March 2018

Report number: FPRF-2018-05

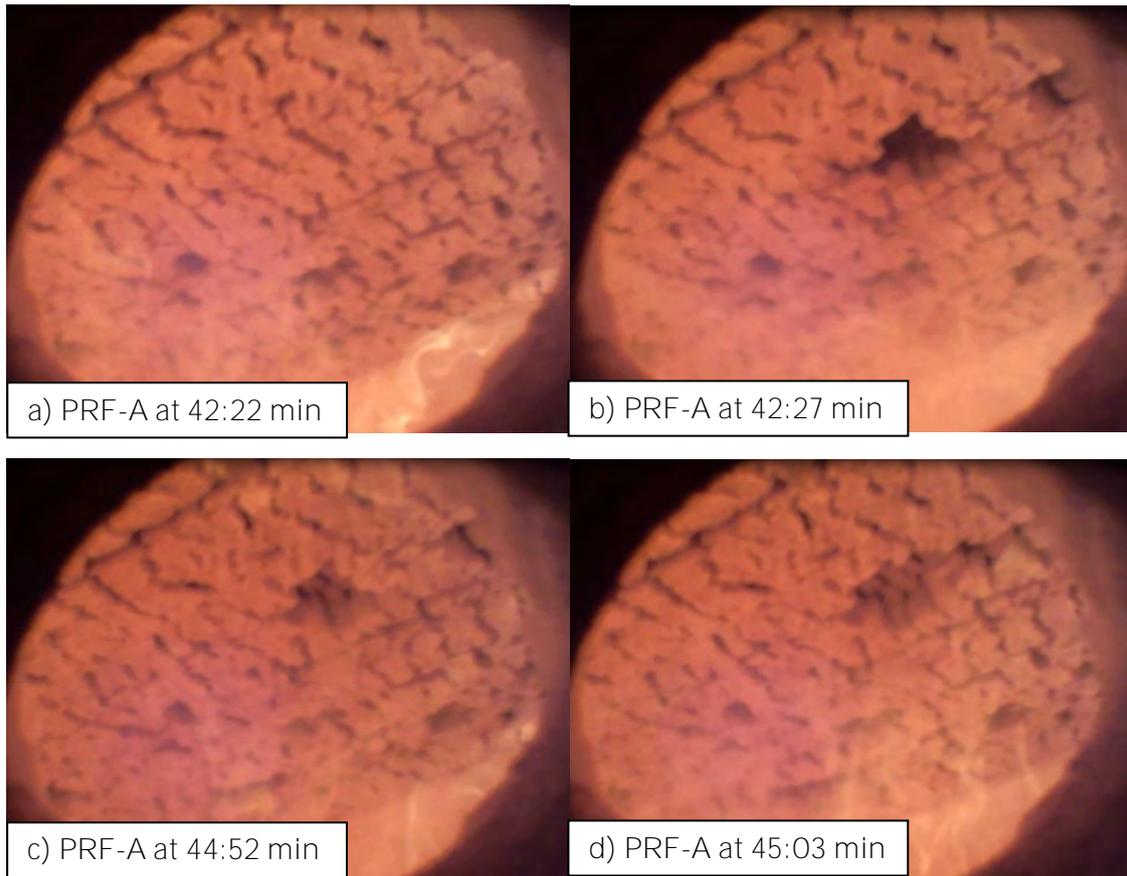
Figure 61: Frames of the video right before and after local falling of char during PRF-A.

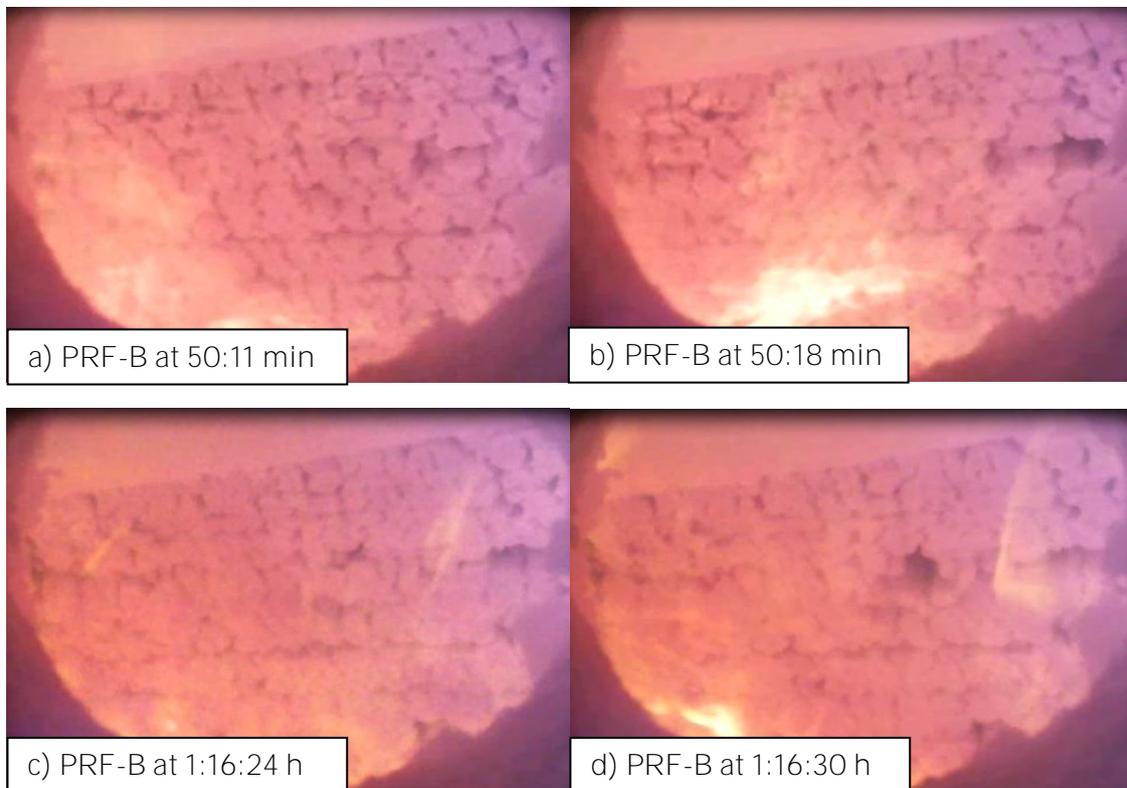
Figure 62: Frames of the video right before and after local falling of char during PRF-B.

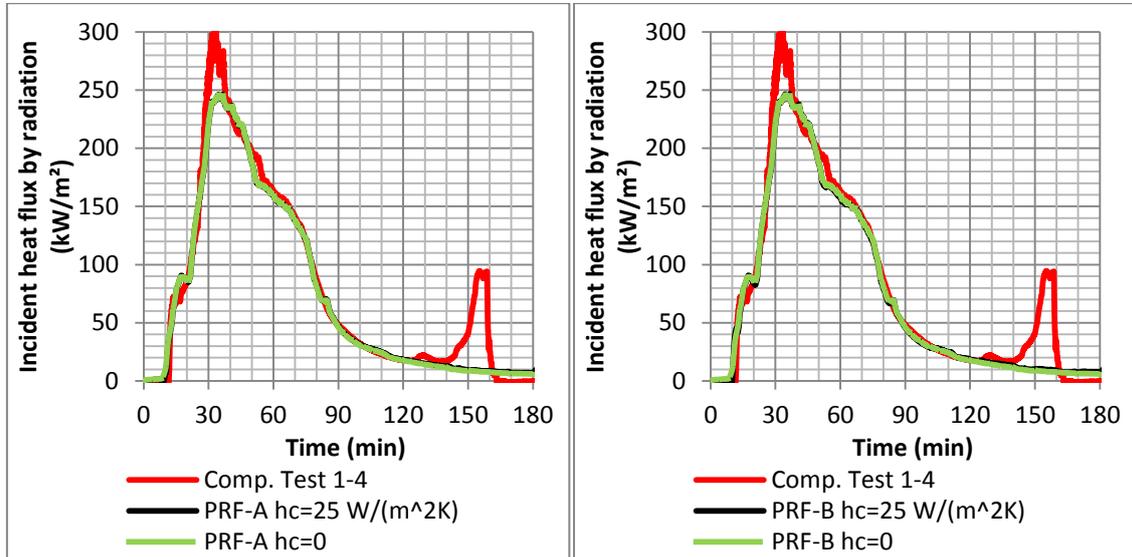
Figure 68: Incident heat flux by radiation of PRF-A (left) and PRF-B (right)

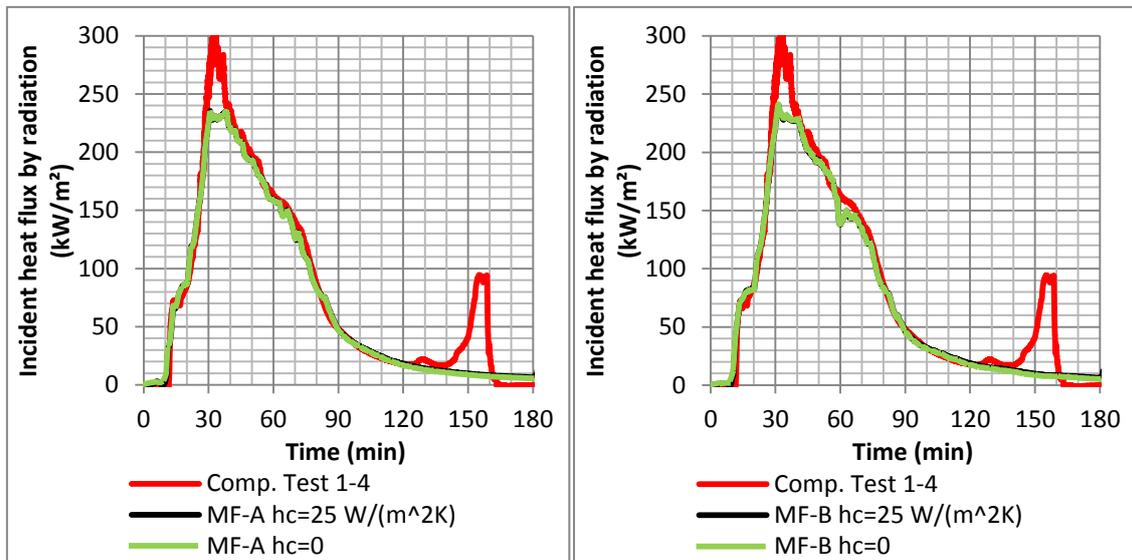
Figure 69: Incident heat flux by radiation of MF-A (left) and MF-B (right)

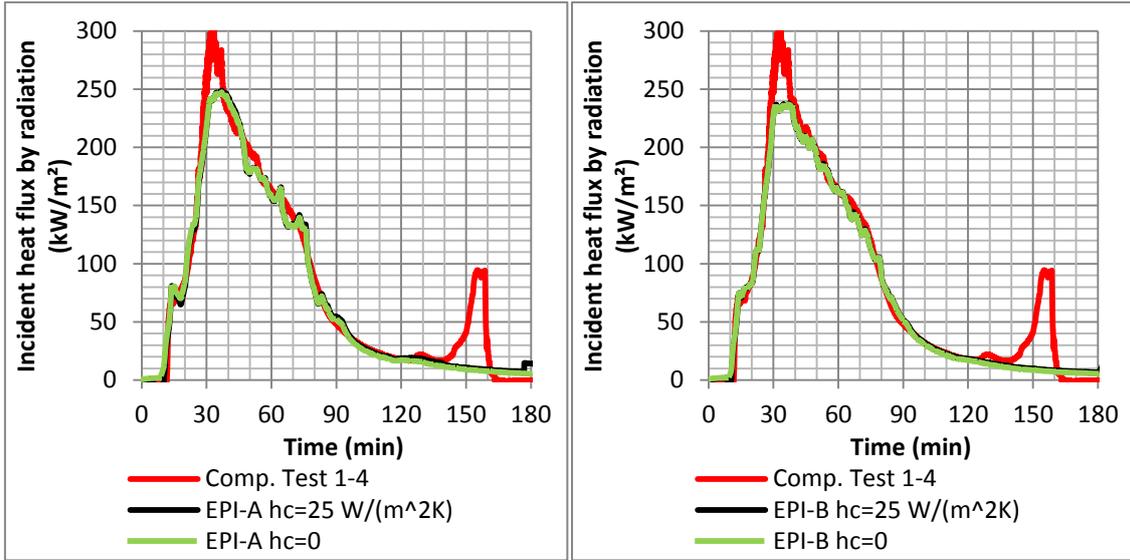
Figure 70: Incident heat flux by radiation of EPI-A (left) and EPI-B (right)

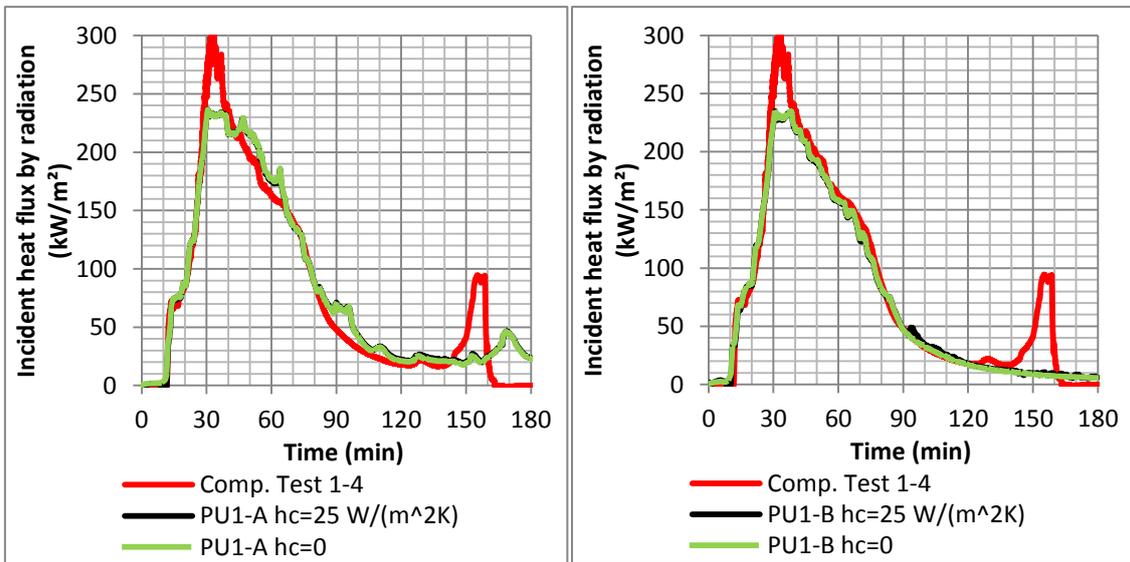
Figure 71: Incident heat flux by radiation of PU1-A (left) and PU1-B (right)

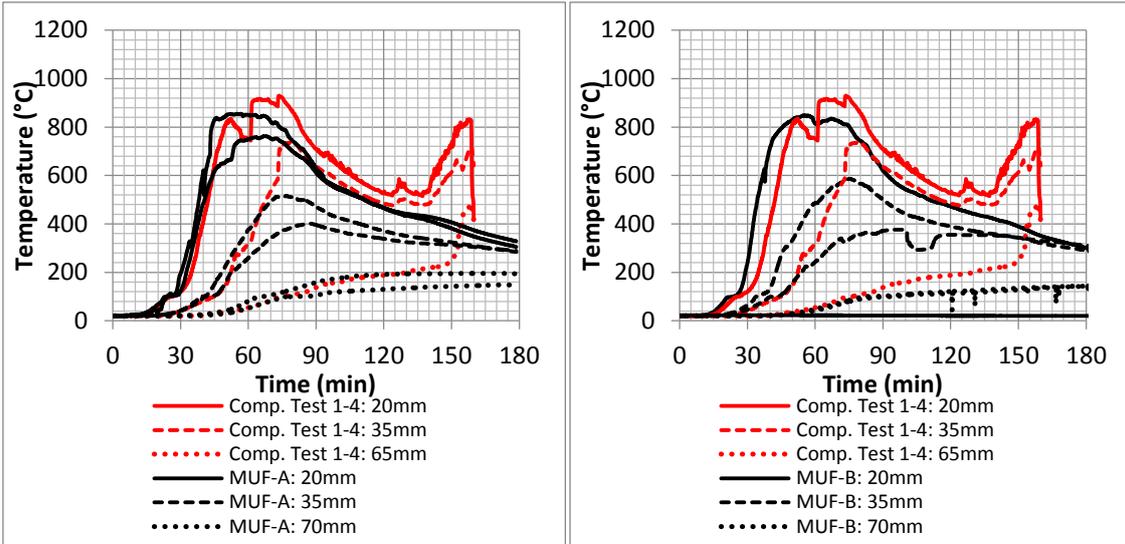
Figure 72: Material temperature comparison with Comp. Test 1-4. MF-A (left) and MF-B (right)

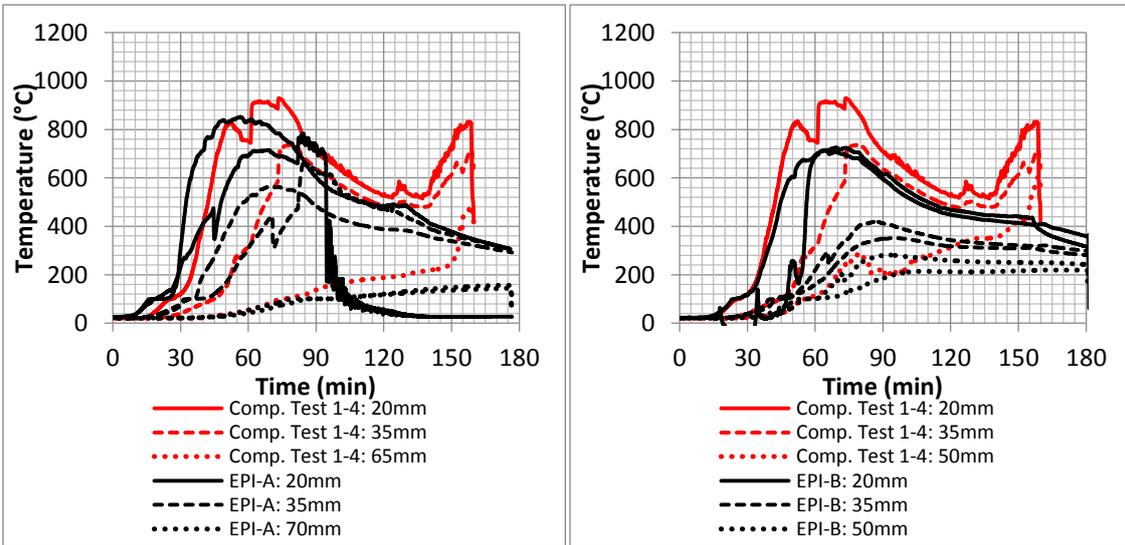
Figure 73: Material temperature comparison with Comp. Test 1-4. EPI-A (left) and EPI-B (right)

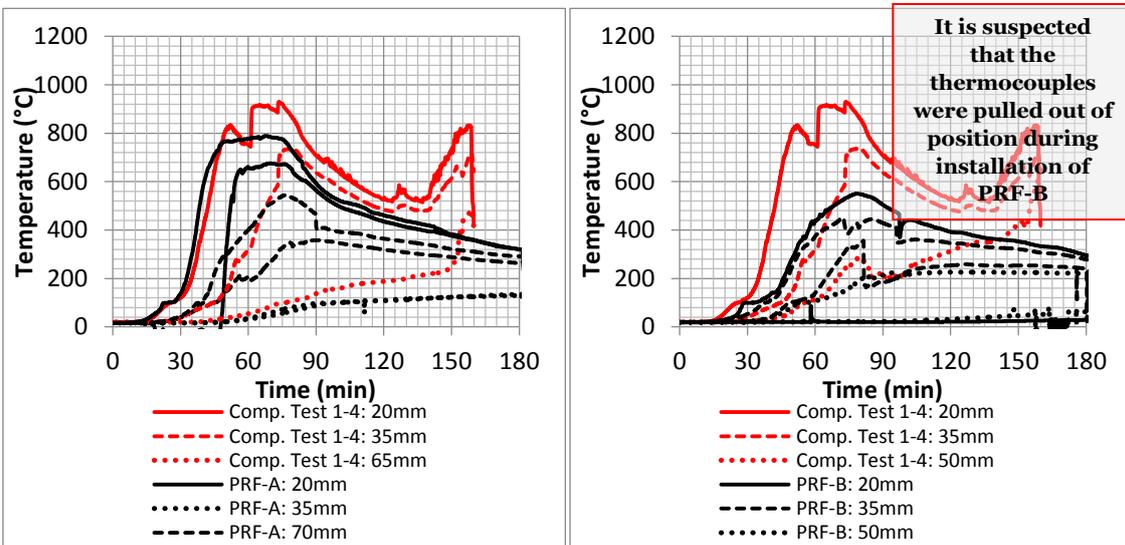
Figure 74: Material temperature comparison with Comp. Test 1-4. PRF-A (left) and PRF-B (right)

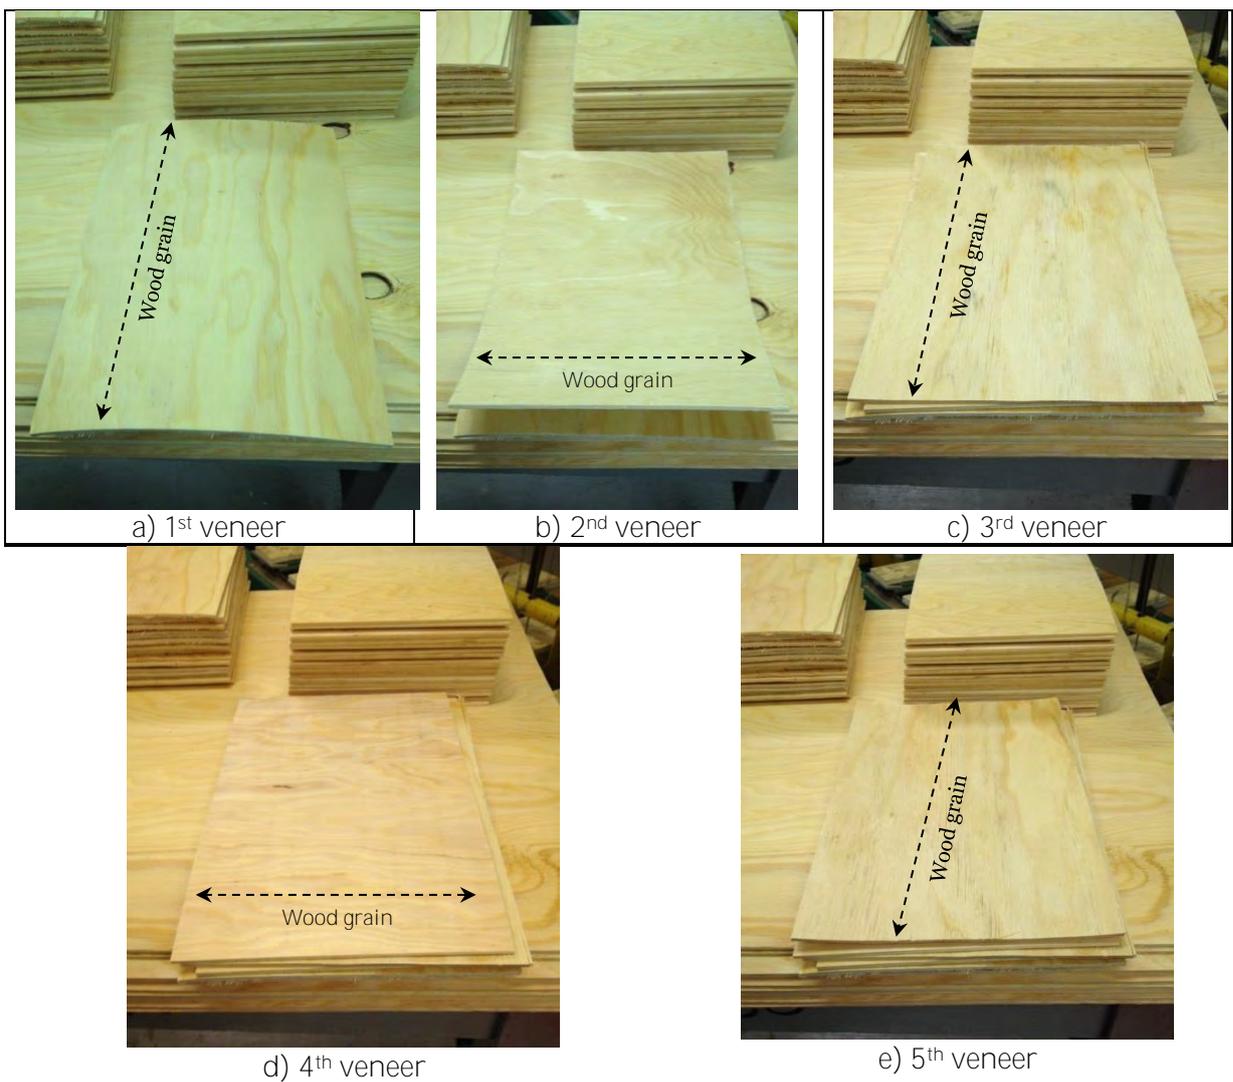
Figure 76: Douglas-Fir veneers used for plywood specimens

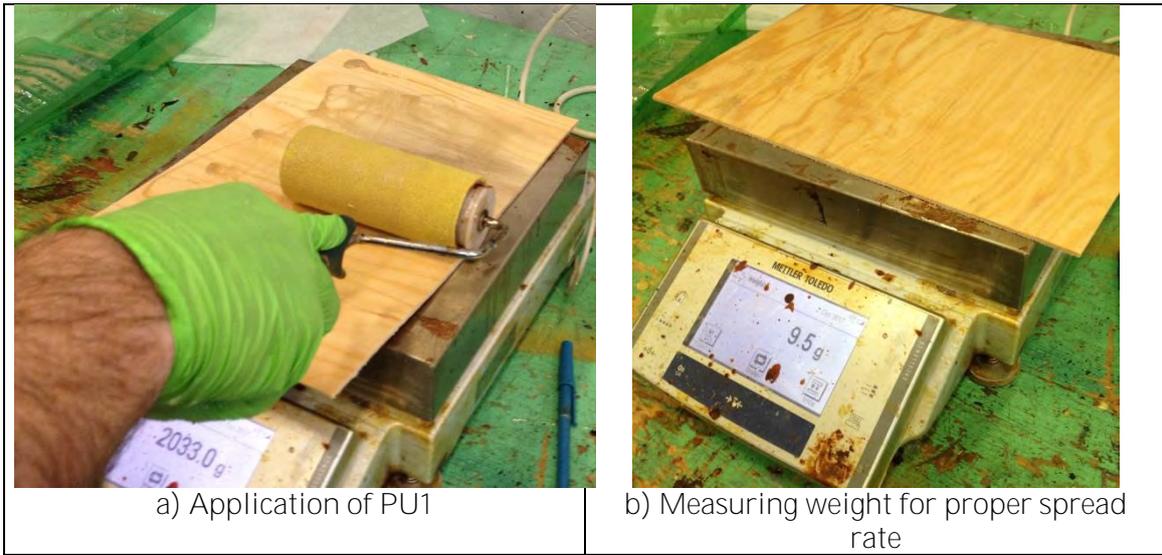
Figure 77: Gluing process of plywood billets

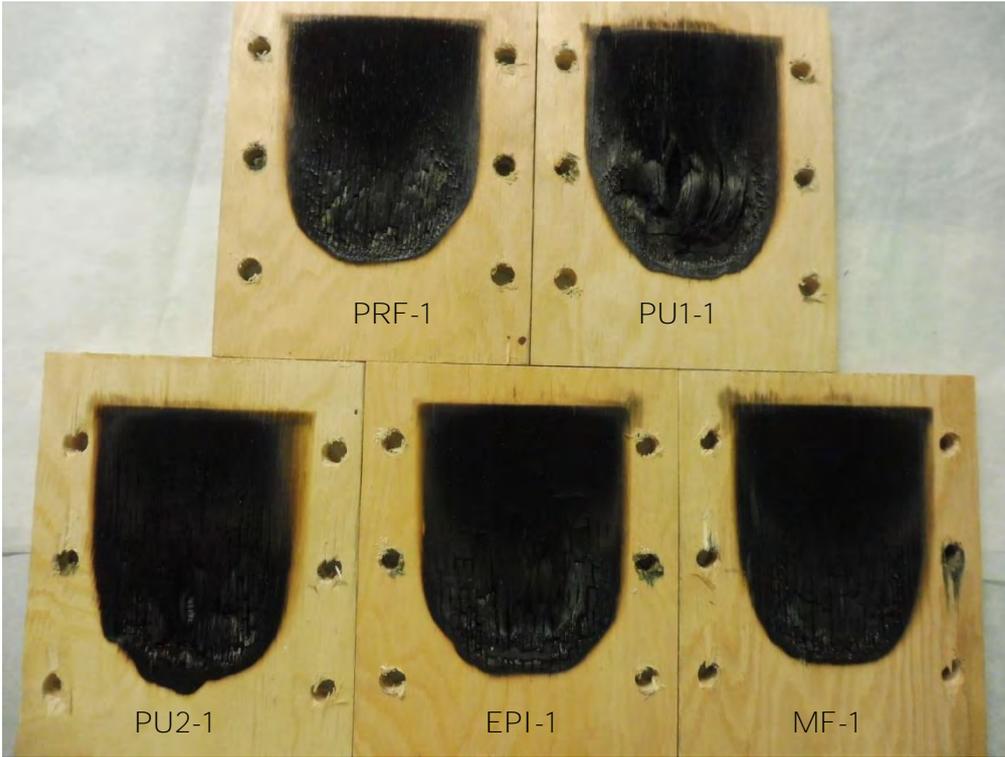
Figure 78: Specimens after PS 1 flame testing (all adhesives)

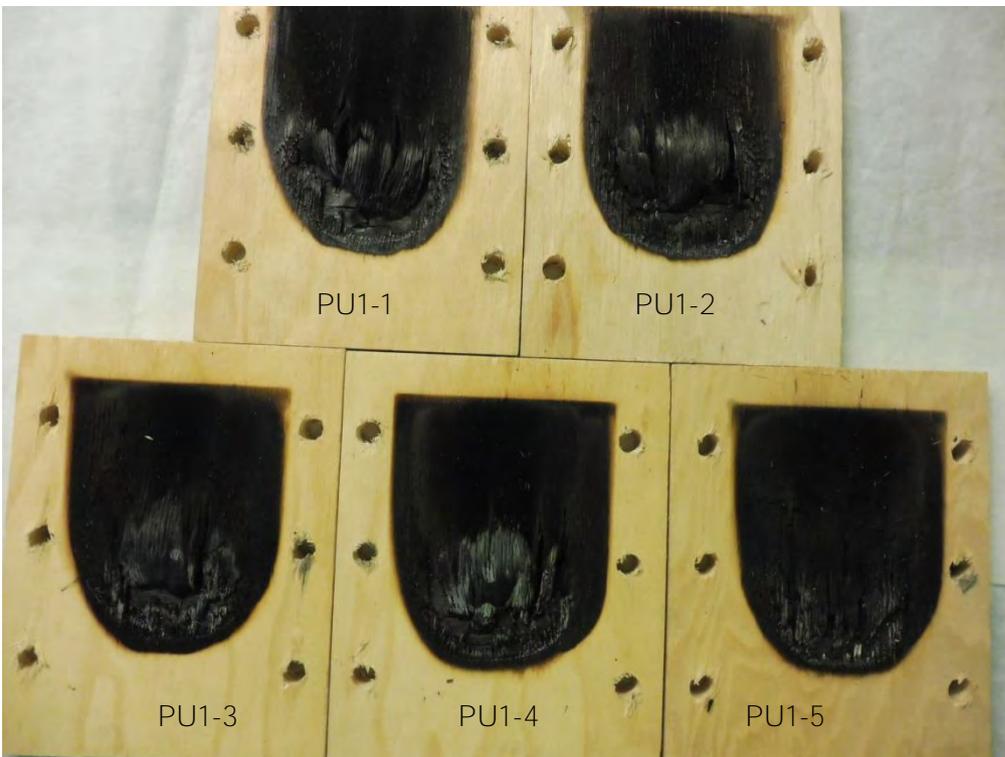
Figure 79: PU1 specimens after PS 1 flame testing

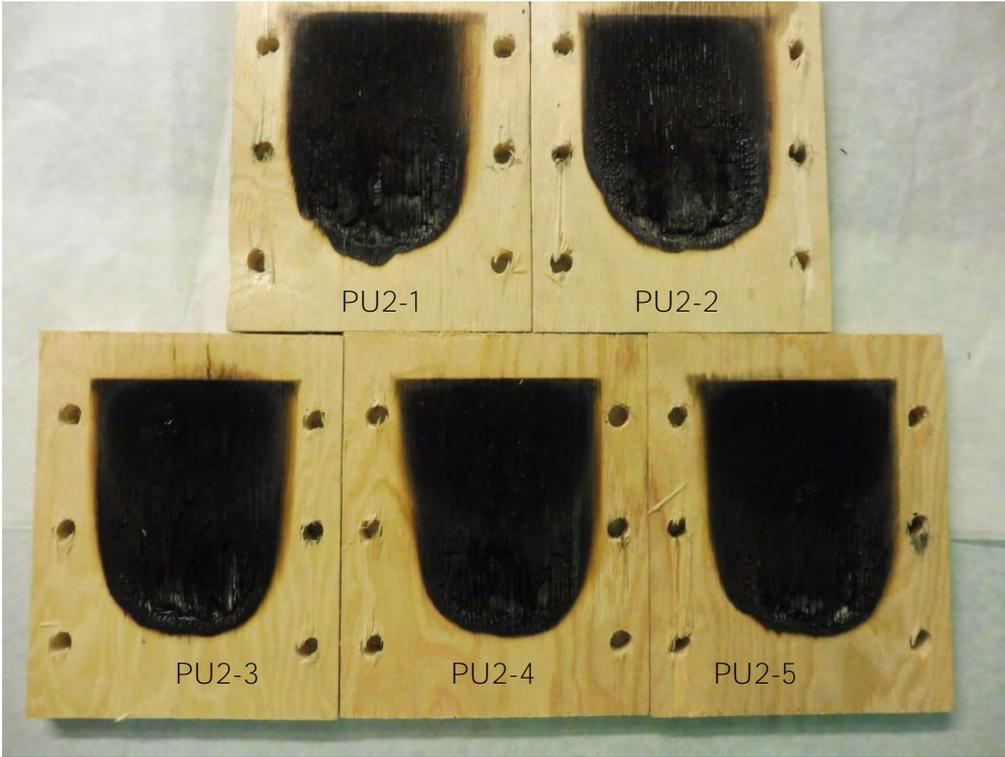
Figure 80: PU2 specimens after PS 1 flame testing

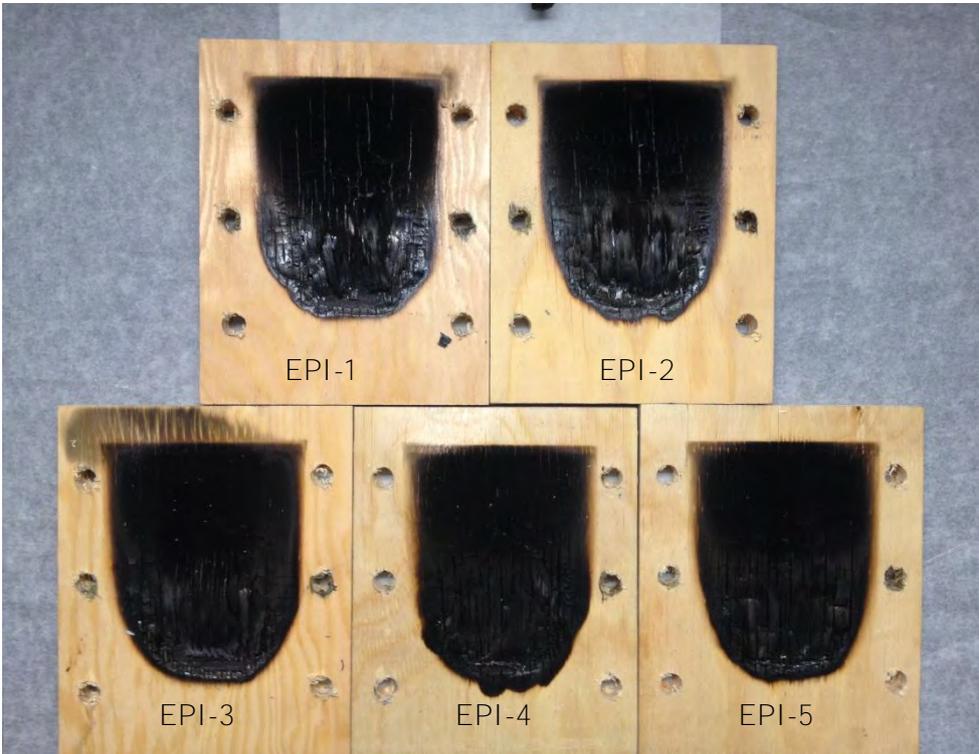
Figure 81: EPI specimens after PS 1 flame testing

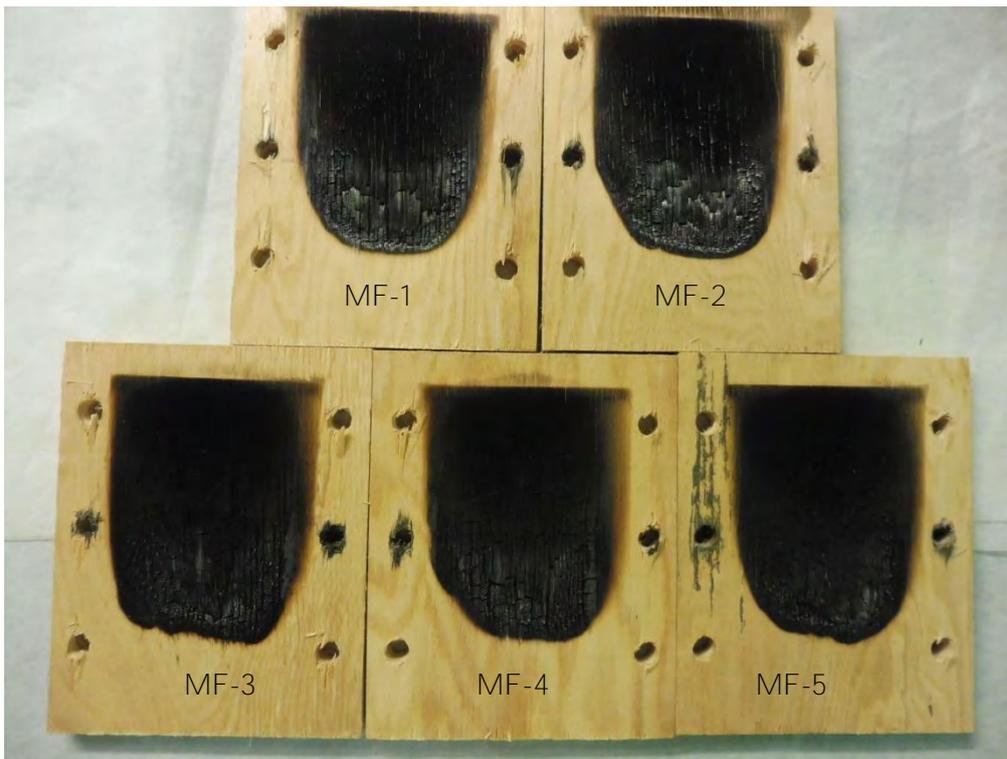
Figure 82: MF specimens after PS 1 flame testing

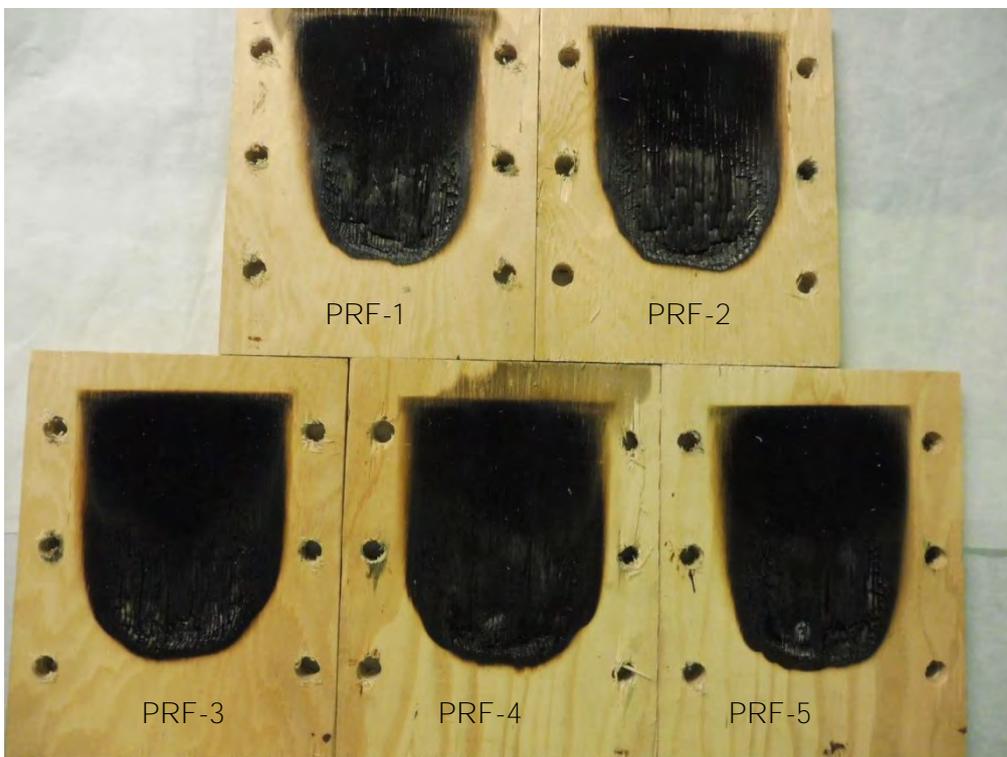
Figure 83: PRF specimens after PS 1 flame testing
