Summary Report

Fire Safe implementation of visible mass timber in tall buildings – compartment fire testing

RISE Report 2020:94

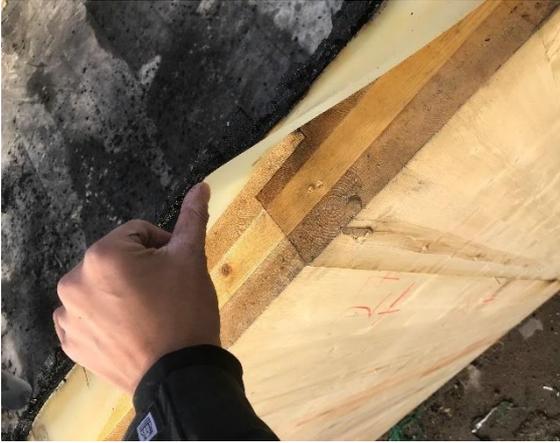
Figure 28 and Figure 29 show the top of the wall in Test 3. The photo of Figure 28 is taken at a lap joint where the top faces of the wall panels were on the same level and showed no damage near the exterior side of the joint. Figure 30 and Figure 31 show typical photos of walls with the alternative wall-ceiling joints that were tested in other tests. No damage was observed near the exterior side of the joint.

Figure 28: Top of the wall lap joint after removal of the ceiling. Typical location without flame spread. Sealing method: resilient profile only (Test 3).

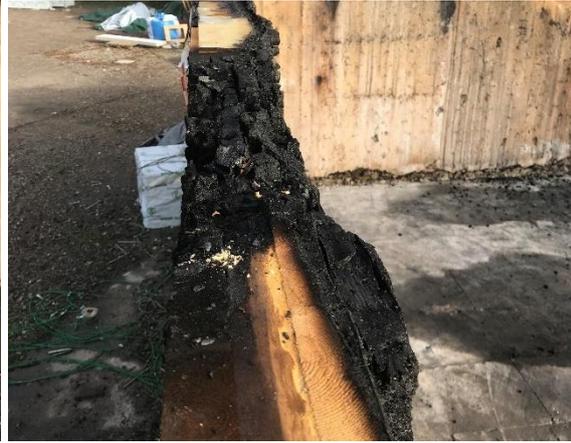
before the start of Test 3 (Figure 27) and fire sealing adhesive was applied to close the void under and above the resilient profile in those locations only. During the test, however, smoke left the intersection at the top of the left wall at an early stage in the fire, indicating lack of air tightness at that location.

Figure 29: Top of the wall after removal of the ceiling and the resilient profile. Location of flame spread through intersection (front side of left wall) - Sealing method: resilient profile only (Test 3).

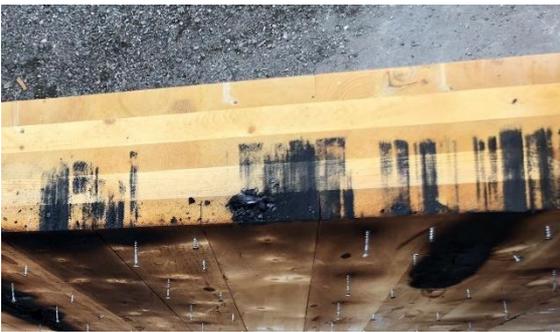
Figure 30: Top of the wall after removal of the ceiling. Typical location. Sealing method: construction tape only (Test 1).

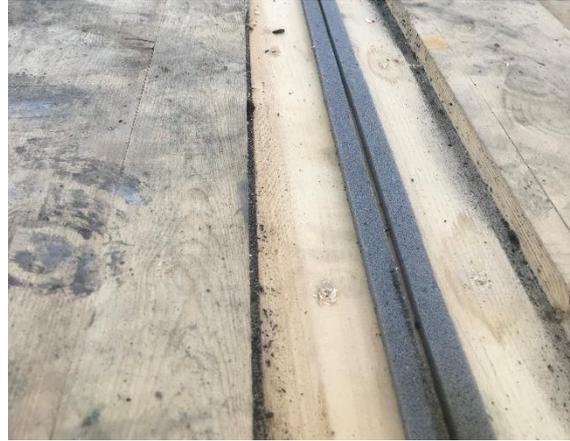
Figure 32 to Figure 35 show the ceiling-ceiling spline board connection alternatives after the test. At most some discoloration of the CLT surface under the spline board was seen at some locations after Test 1 and Test 3. In the other tests, there was no sign of damage on the surface under the spline board.

Figure 33: Photo after removal of spline board. Sealing method: 2x expanding tape under spline board at CLT interface (Test 2)

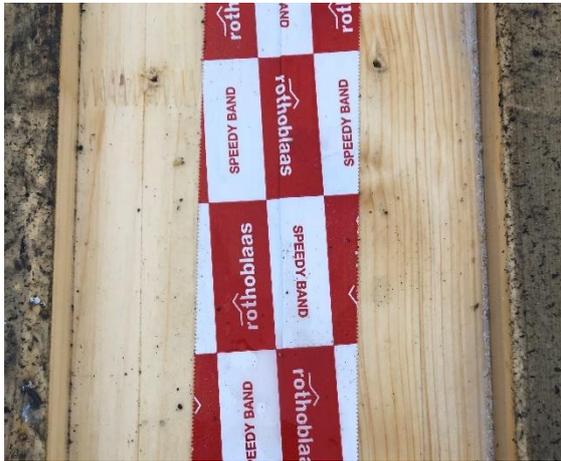
Figure 34: Photo after removal of spline board. Sealing method: construction tape under spline boards at CLT interface (Test 4)

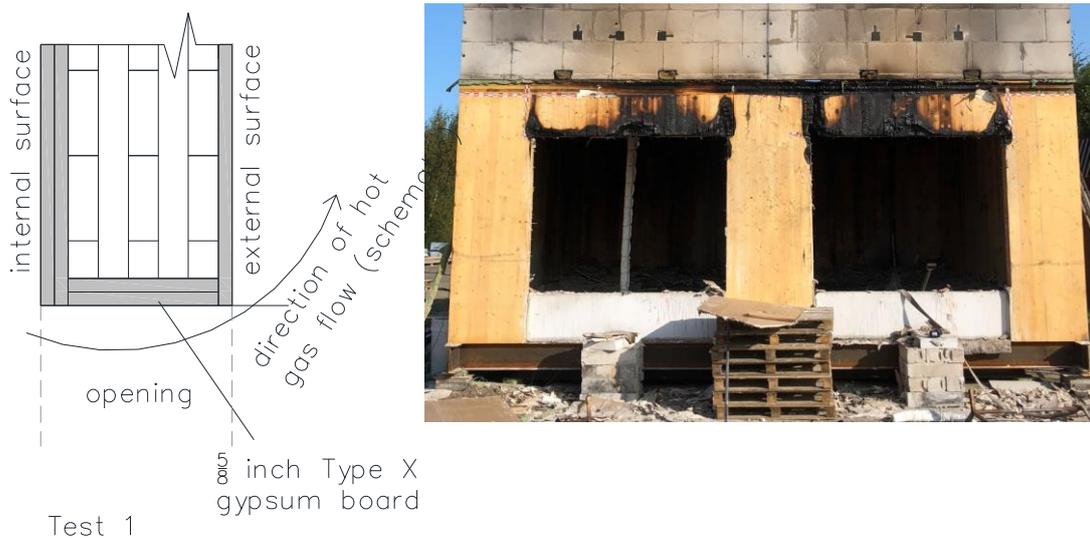
Figure F. 10. Test 1 - Detail above opening (left) and front façade after removal of gypsum boards (right)

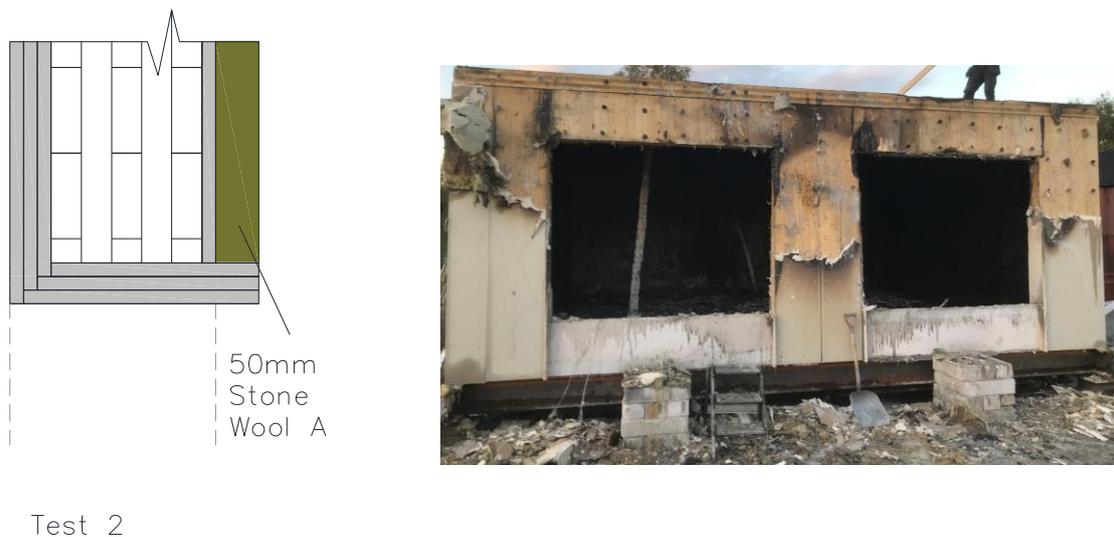
Figure F. 11. Test 2 - Detail above opening (left) and front façade after removal of gypsum boards. NOTE: the sides of the opening had 2 layers of gypsum boards.

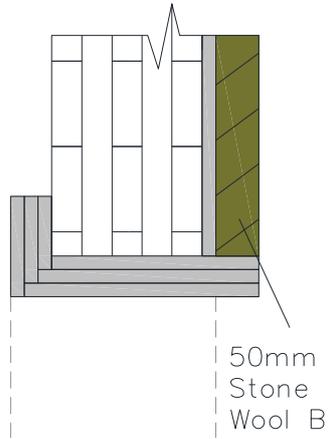
Figure F. 12. Test 3 - Detail above opening (left) and front façade after removal of gypsum boards. NOTE: Stone wool B (1200 x 555 x 45) was thinner and had smaller batt dimensions than stone wool A, which was used in other tests (1200 x 2700 x 50mm). The stone wool batt above the right opening fell at an early stage.

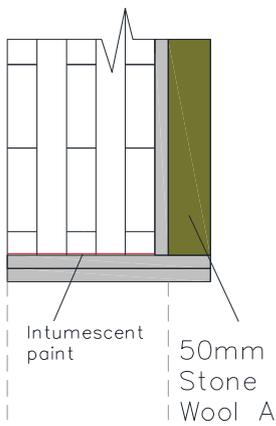
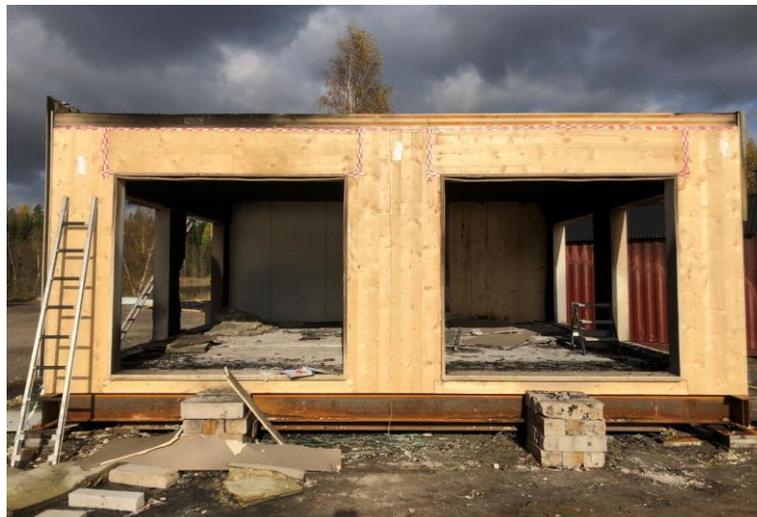
Figure F. 13. Test 4 - Detail above opening (left) and front façade after removal of gypsum boards.

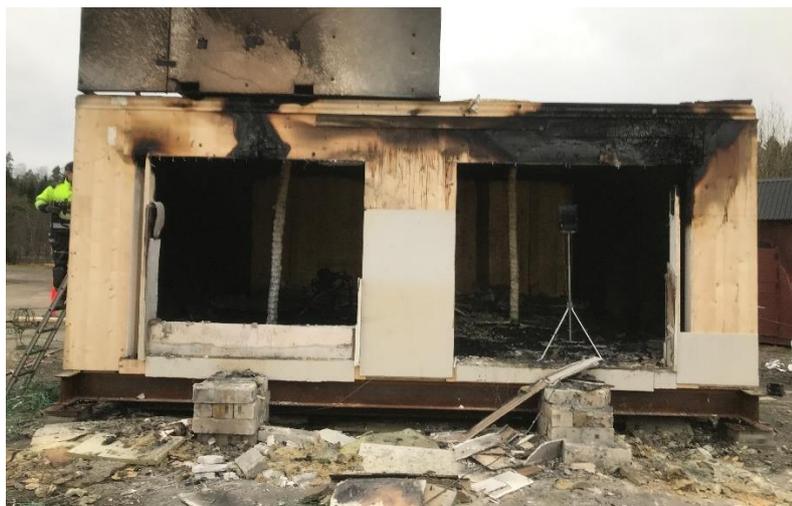
The detail above openings at the façade is a sensitive detail, which is subject to high gas velocities and thermal exposures. This study included different details for each test. Iteratively looking for an effective solution that leads to minor damage. It should be noted that Test 5 included cavities in the front façade as it was originally planned to have larger openings. The damage in the façade of Test 5 is therefore, considered not representative for real buildings.

Figure F. 16. Test 5 - Detail above opening (left) and front façade after removal of gypsum boards. NOTE: Test 5 was originally planned to have larger openings. During the test series it was decided to perform a test with the same openings as Test 1, 2 and 3 and modify the opening width in the front façade. As a result a cavity existed between the

external and internal gypsum boards at the outer side of both openings. It is expected that a smouldering fire entered the cavity on the right side of the right opening, which stayed behind the outer gypsum boards.
