## Post-Fire Rehabilitation of CLT

Daniel Brandon  
Johan Sjöström  
Fredrik Kahl

RISE Report 2021:67

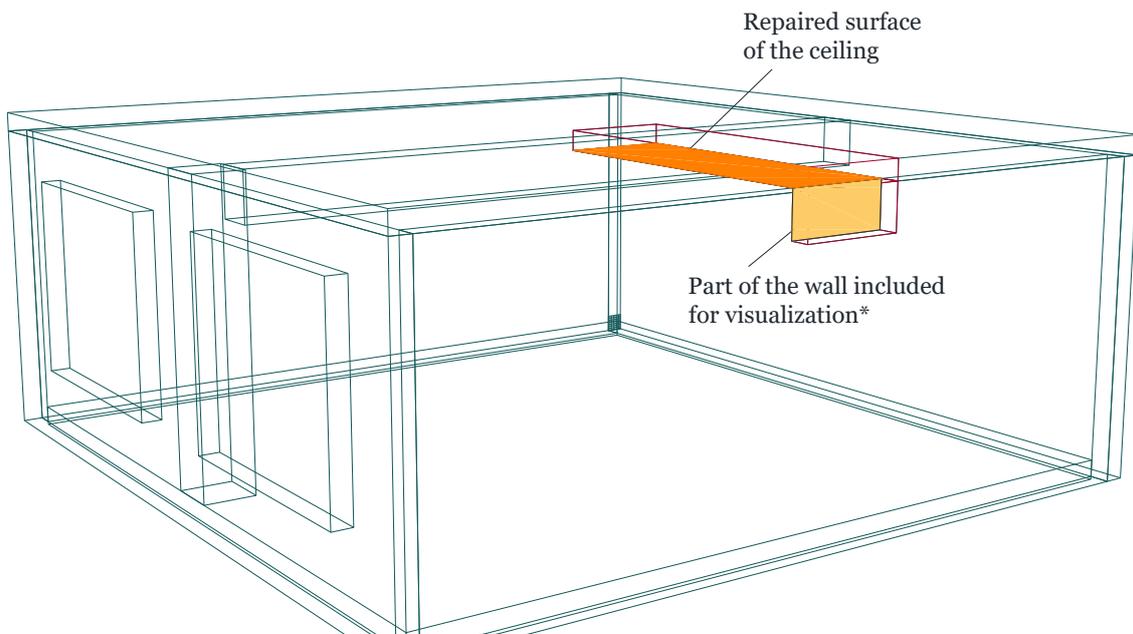
Figure 1: The original location of the specimen situated in the room of origin

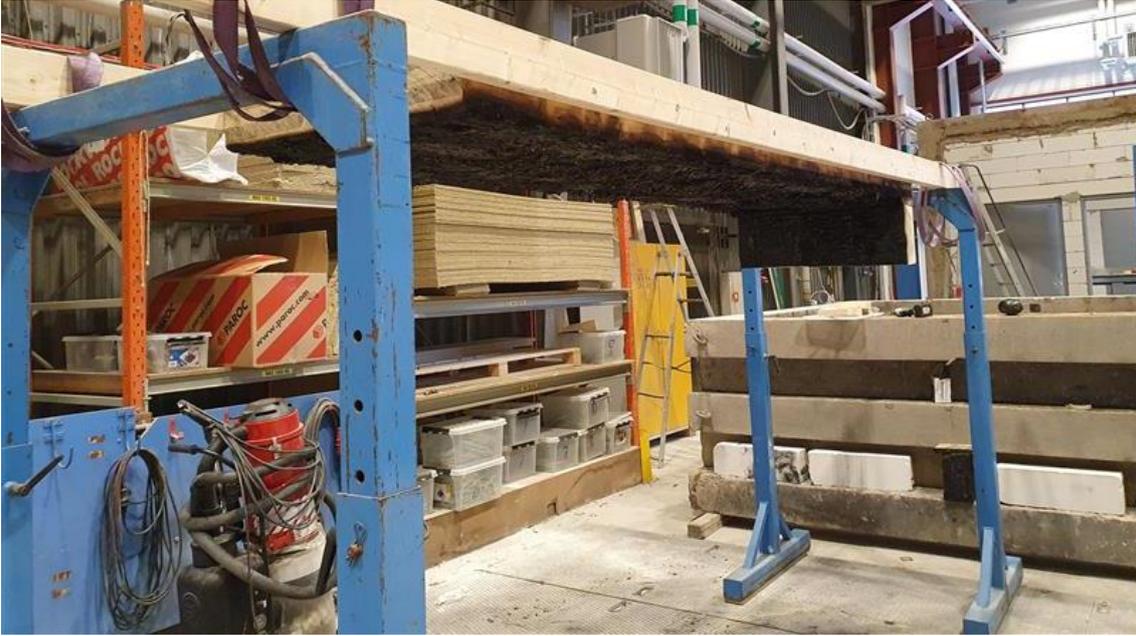
Figure 2: The specimen situated above the floor in the new working space. Note: the specimen was moved during the process, because of logistical reasons.

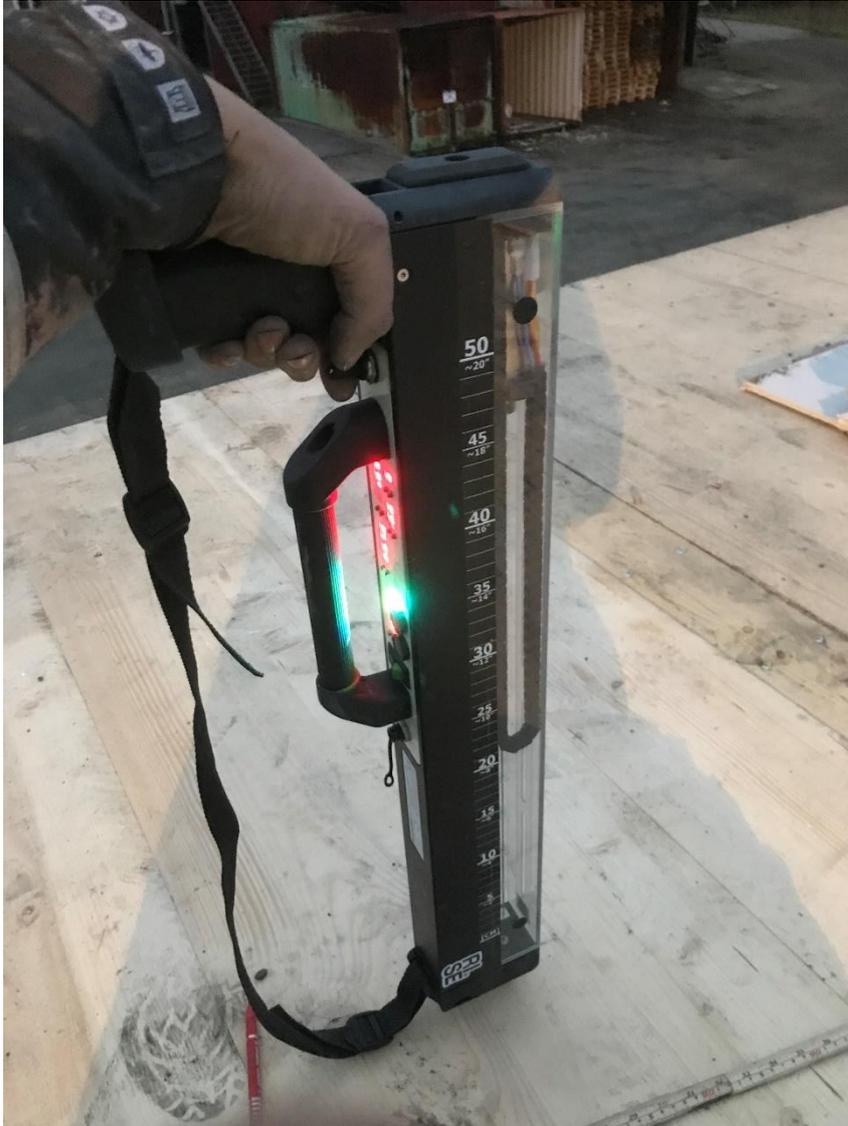
In this study it was chosen to use a resistograph<sup>2</sup>, to determine the layer that needs to be removed (Figure 3). In most resistograph measurements there will be a relatively sharp drop of resistance, which has been used in multiple studies to identify the char depth (Brandon and Dagenais, 2018; Su *et al.*, 2018; Brandon *et al.*, 2021). Before the sharp drop of resistance there is often already a reduced resistance for some millimetres of drilling, providing a rough indication of the thickness of the heat affected layer.

Figure 3: Resistograph, drilling with a thin long drill through the ceiling to identify the thickness of the residual cross section.

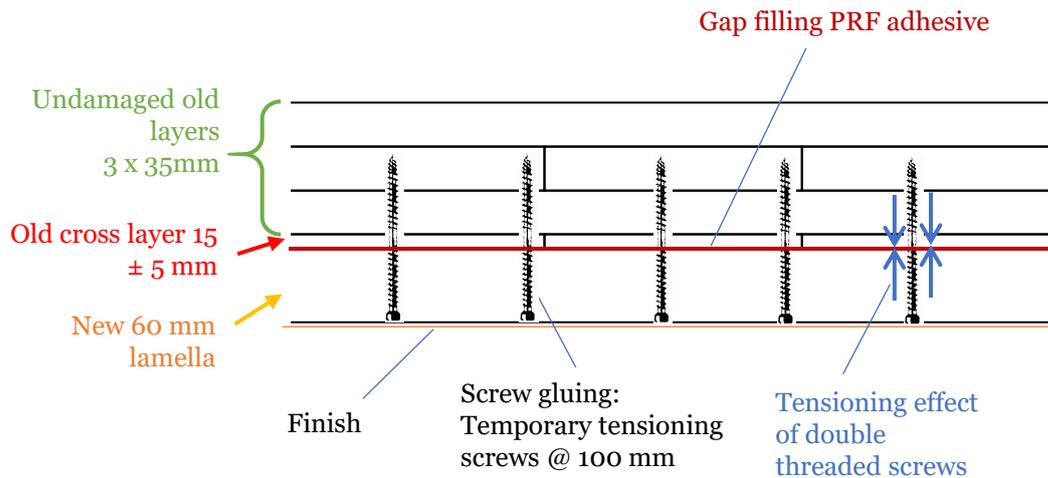
To maintain the overall thickness of the floor slab, the cross layer needed to be planed down to approximately  $15 \pm 5$  mm ( $0.6 \pm 0.2$  in) as shown in Figure 5. Thus, removing the exposed lamella entirely and  $20 \pm 5$  mm ( $0.8 \pm 0.2$  in) of the cross layer. The indicated geometrical tolerance of 5 mm (0.2 in) is included to allow a planed surface that is not perfectly parallel to the CLT and to account for CLT that is not perfectly plane before the repair, while ensuring that the repaired specimen has at least the same dimension as the initial CLT. The tolerance for the flatness of the planed surface is significantly smaller as further discussed in the next sub-section. Based on the measurements of Section 4.1, removing the indicated layer was expected to be sufficient to remove the vast majority of charred material and leave some local heat affected wood in the slab. Since this remaining heat affected wood is in the cross layer and the cross layer does not contribute to the flexural stiffness and bending capacity, the heat affected wood is not expected to impact the bending capacity and the flexural stiffness. It can, however, impact the shear capacity. As indicated in Chapter 2, maintaining the full shear capacity is not important in general and it was decided to repair the specimen according to the lay-up of Figure 5

Figure 5: Lay-up of rehabilitated CLT

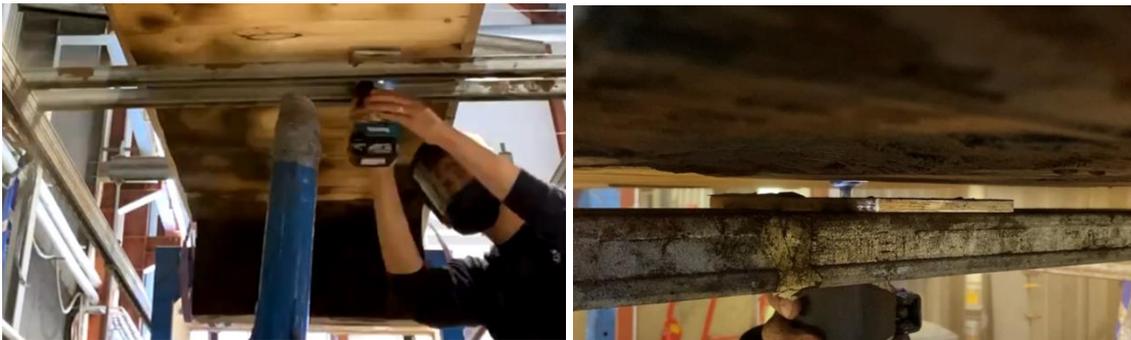
Figure 7: Planing of the charred surface with a router sliding on a frame (left and right)

A battery charged router with a planing bit was used to plane the surface. This relatively light equipment will only subject relatively small forces to the frame and, therefore, avoids vibration issues. The surface was planed in four runs. For every run, the height of the planing bit was adjusted reducing the depth of the CLT panel by approximately 5 to 7 mm (0.2 to 0.3 in). For the final run only about 3 mm (0.1 in) was milled away to limit the vibrations in the frame and subsequently to reduce imperfections in the planed surface.

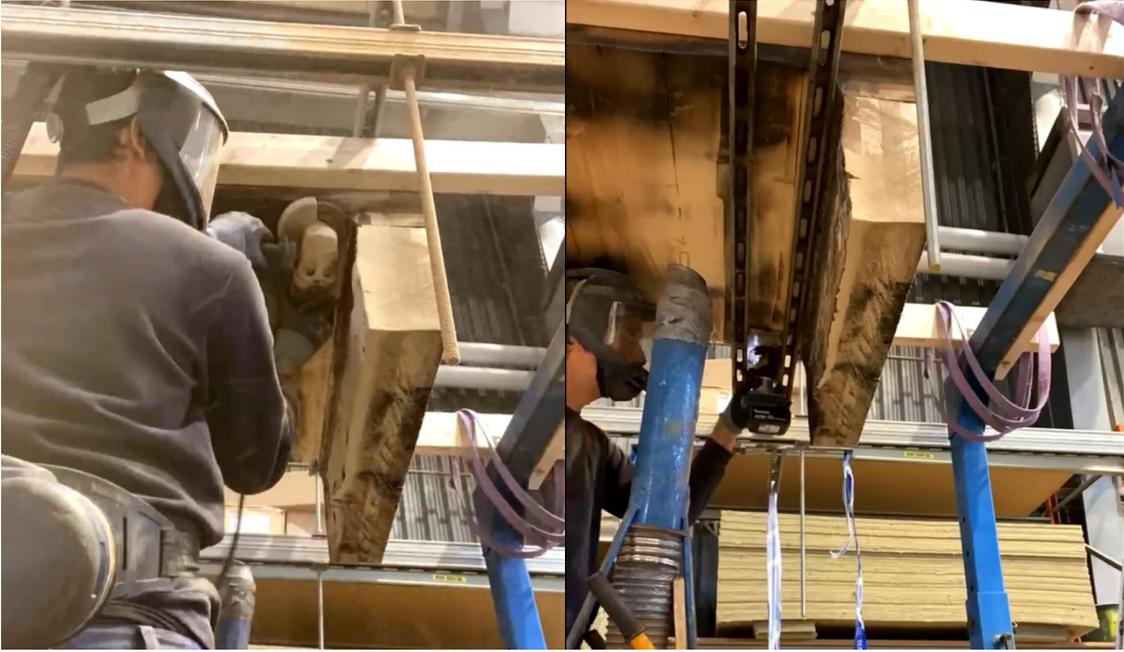
Figure 8: Using an angle grinder with a flap sanding disc to reduce the corner rounding (left) to allow the router on the planing frame to come as close to the corner as possible (right).

Due to the geometry of the router used, it was not possible to plane the surface all the way to the intersection of the ceiling and the wall. To get as close as possible to the intersection, an angle grinder with a flap sanding disc was used to reduce the rounding in the corner (Figure 8). Approximately the last 12 cm (4 in) at the edge of the ceiling at the ceiling-wall intersection have been planed with a handheld planer that was especially made to plane wood until about 10 mm (0.4 in) to an inner corner (Figure 9). The last 10 mm (0.4 in) at the ceiling edge has been grinded down with an angle grinder.

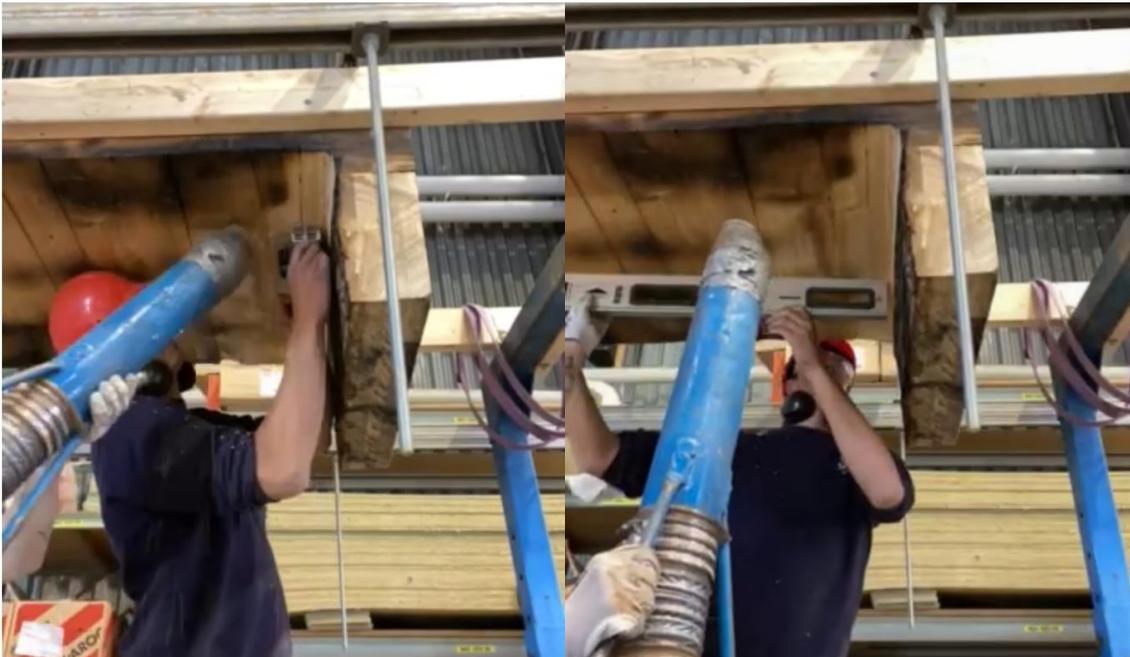
Figure 9: Using a planer specialised in planing near inner corners (left) and assessing the planeness of the surface (right).

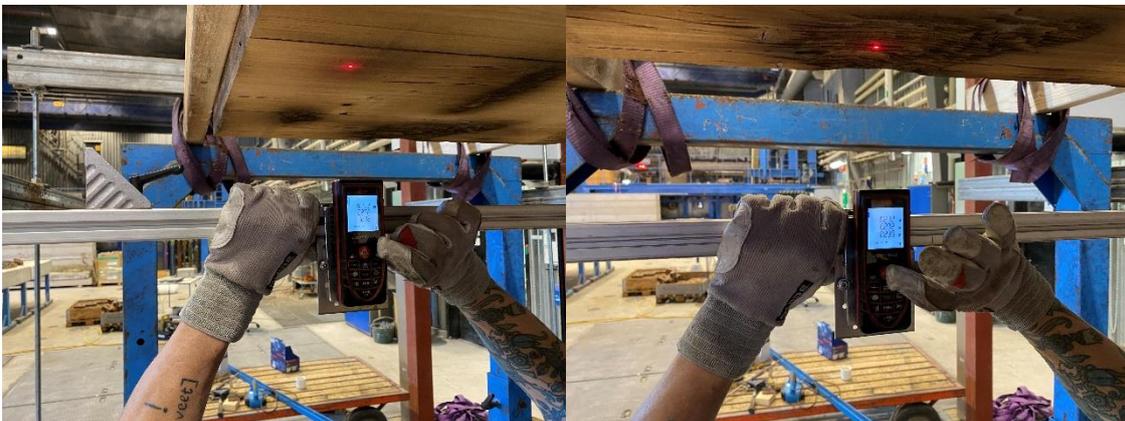
After planing, the planeness of the surface was assessed by holding a long straight level against it (Figure 10, Figure 11, Figure 12, Figure 13) and measuring the variability of the surface with a laser distance meter attached to the milling frame (Figure 14). The variability of the distance between the planed surface and the plane of the sliding frame was within 1 mm ( $\sim 0.04$  in), with exception of some locations with deeper charring and near the ceiling-wall corner. Near the ceiling wall corner, distance variations up to 2 mm ( $\sim 0.08$  in) were seen. The deepest identified gap was 8 mm ( $\sim 0.31$  in) which was at a location where the char depth exceeded the milled depth (Figure 14, right). Additional adhesive were applied at such locations as further discussed in Section 4.5.

Figure 14: Checking the planeness of the surface with laser distance meter

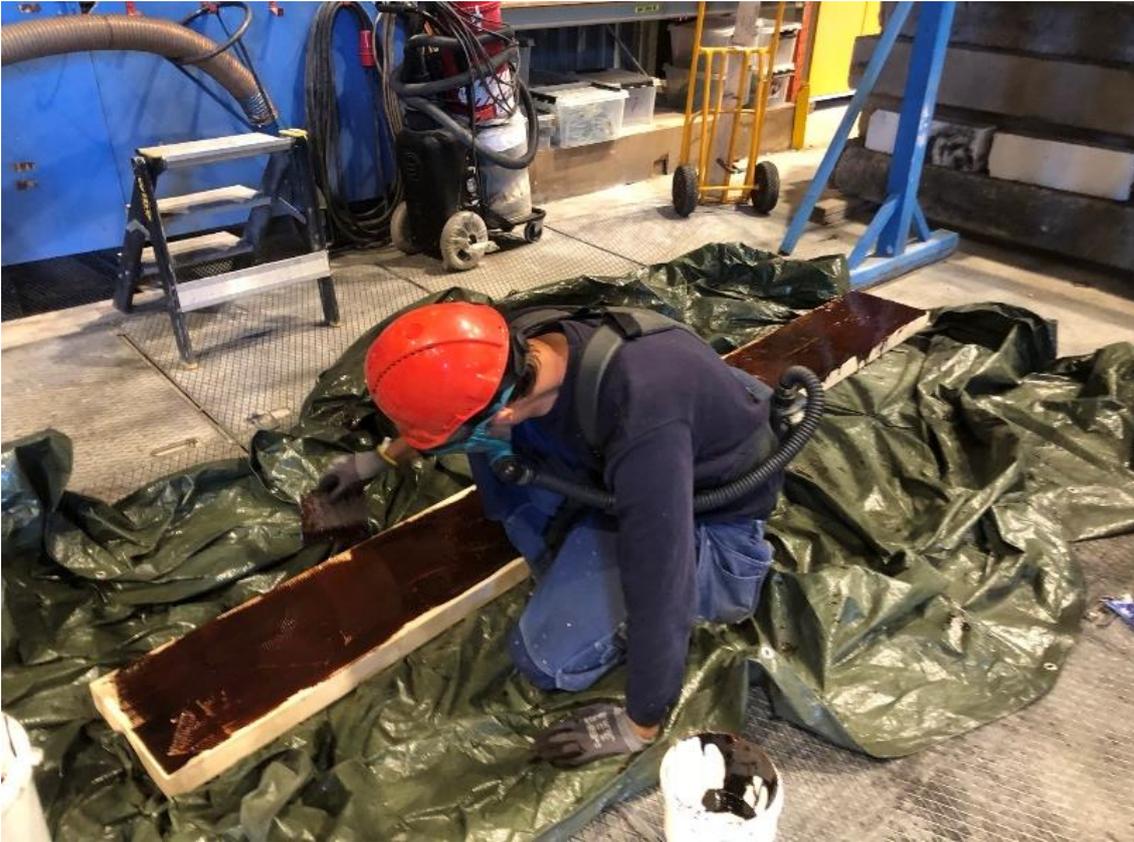
Figure 16: Applying adhesive on the lamella with a glue comb

Before gluing, the location of the screws for screw gluing were marked on the new lamellas. Around 3 hours before the gluing process, the new lamellas were planed on the side where the glue was to be applied. The gap filling PRF adhesive used was Prefere 4094/5827 and the implemented ratio between the resin and the hardener was 100 to 20 parts by weight and is mixed in accordance with the manufacturers technical data sheet. The time elapsing between mixing of the application of the glue was at most 30 minutes and for the first lamella a separate batch was mixed. Using a glue comb, the glue was applied on the new lamella (Figure 16), which was located directly under the ceiling where it needed to be glued. In occasional remaining gaps of the planed surface of the CLT specimen the adhesive was also applied (Figure 17). A short open assembly time was achieved by gluing the lamellas in succession, only starting application of glue on the next lamella when the previous lamella was glued and the glue line was fully compressed with screws. Within 4 minutes after the onset of glue application the new lamella was assembled into position with three screws. The screwing of all remaining screws was done within 10 minutes. During the screwing with the double threaded screws, significant amounts of glue were pressed out. To avoid difficulties for gluing subsequent lamellas, the pressed-out glue was scraped off regularly. The duration of these processes was well within the ranges specified in the technical data sheet of the adhesive system.

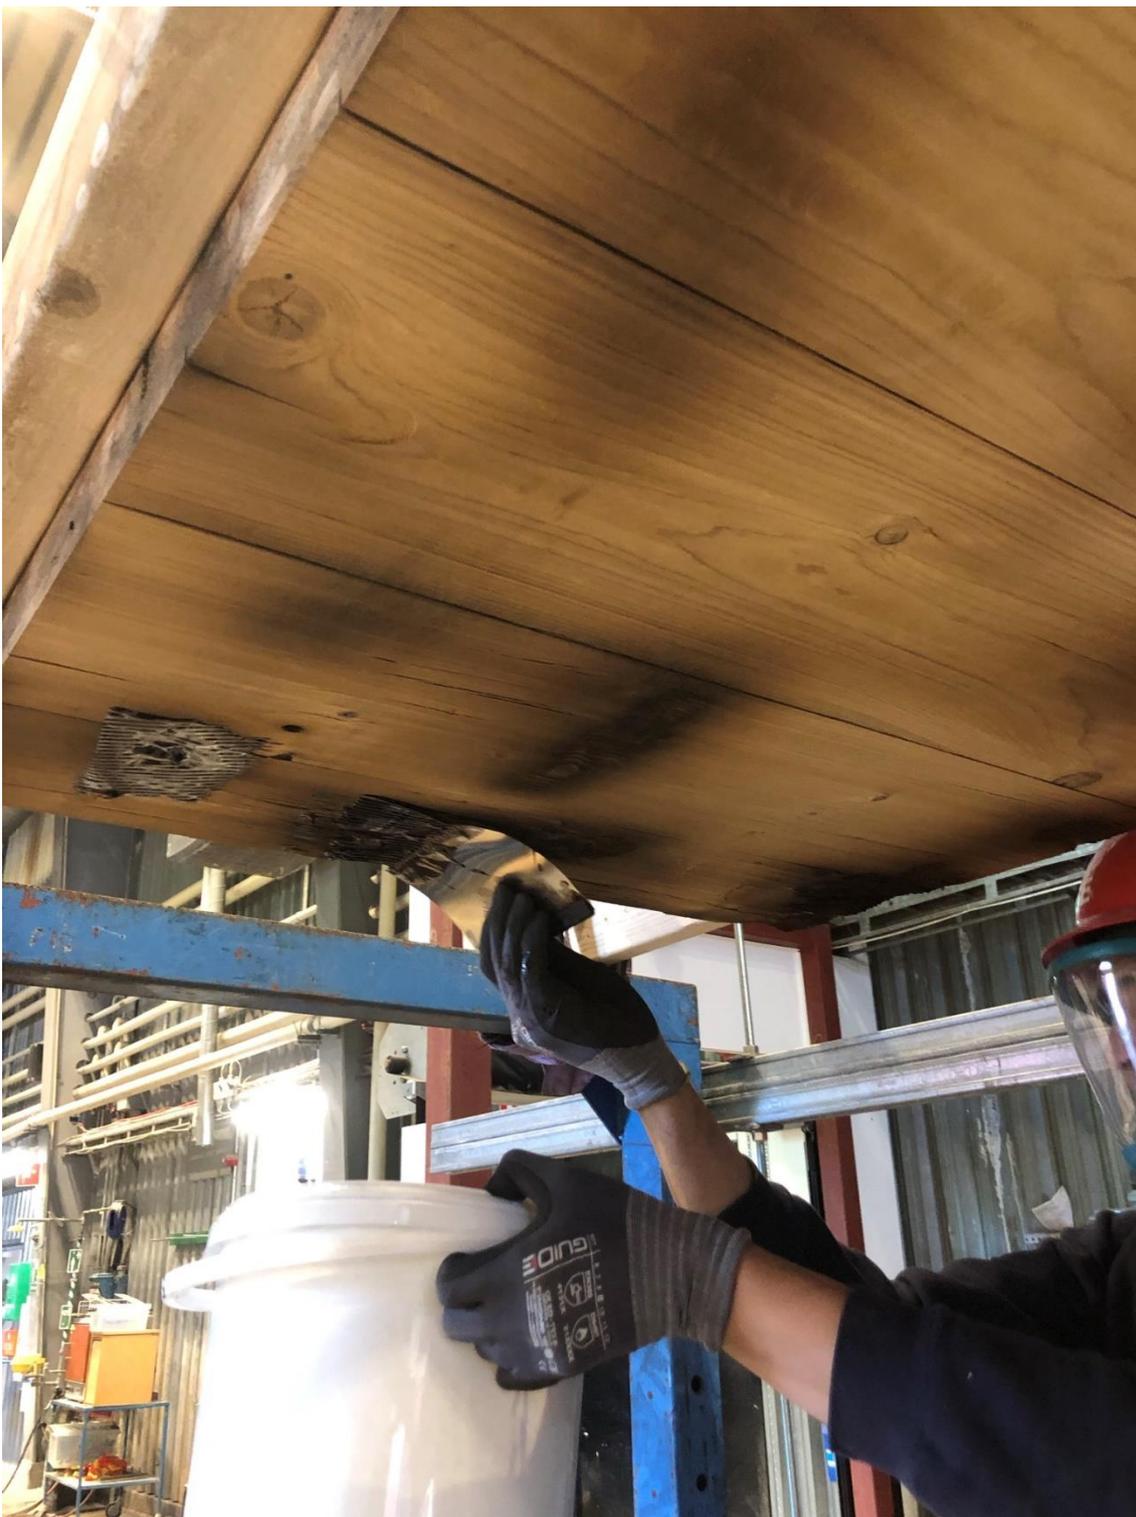
Figure 17: Applying adhesive on the ceiling with a glue comb at the locations in the ceiling with deeper char depths than the milled depth

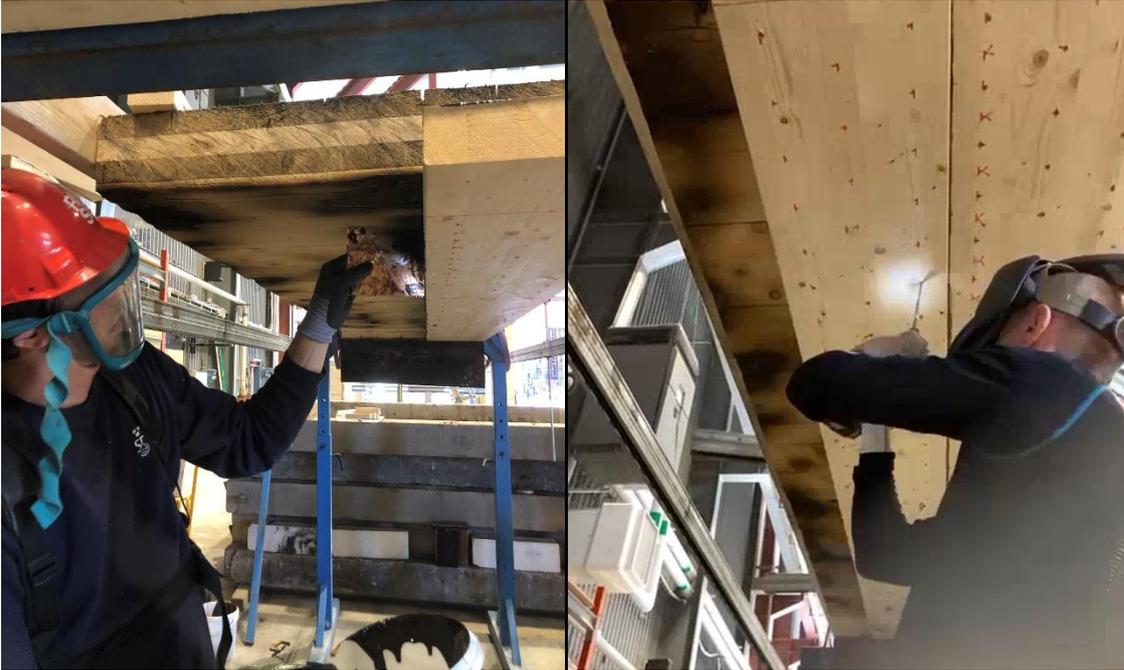
Figure 18: Scraping off pressed out glue (left) screw pressing (right)

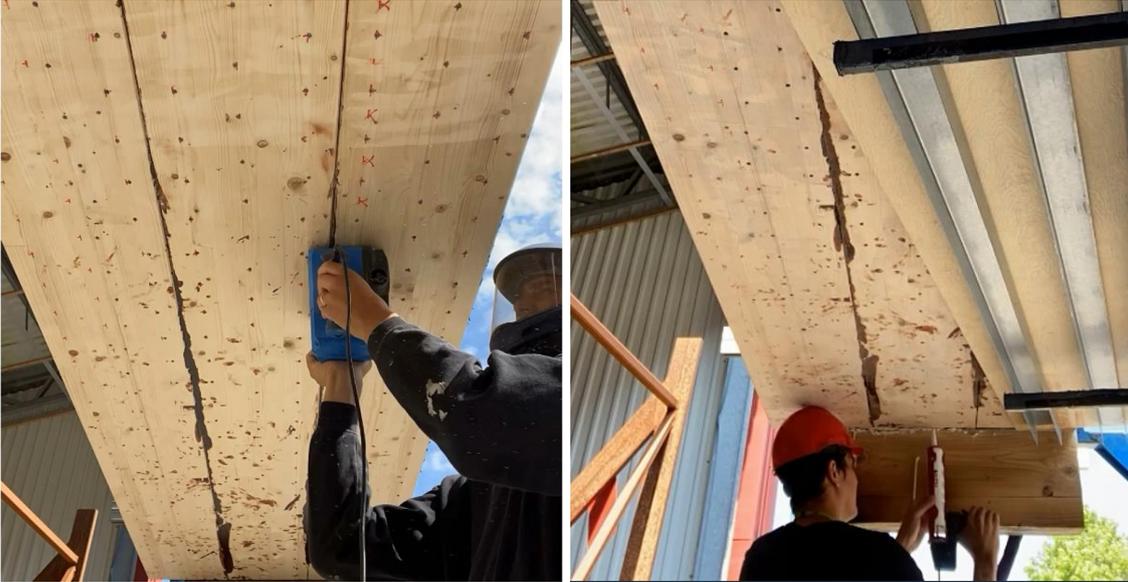
Figure 19: Sanding (left) and fire sealing the ceiling-wall joint (right)

The surface of the repaired specimen was sanded, fire sealing was applied in the ceiling-wall joint, the screws for screw gluing were removed and a 3.6 mm (0.14 in) 3-layer plywood was glued to the surface using a panel lift to apply a small amount of pressure. The glue used was a regular PVAC wood glue. For this case study a large sheet of 2.4 x 0.9 m (7.9 x 3.0 ft) was glued and a smaller sheet of 0.4 x 0.9 m (1.3 x 3.0 ft) were glued.

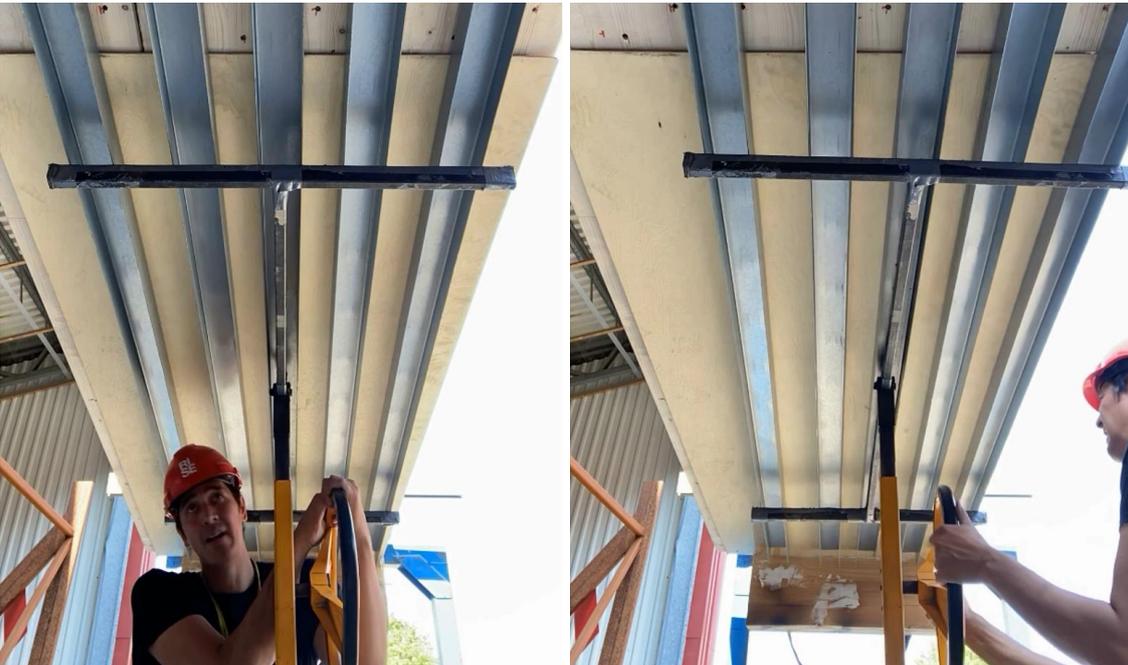
Figure 20: Putting a small amount of pressure with a panel lift and moving the lift's position a few times with 5 minute time intervals to compress at different locations.

The large sheet was larger than the surface with which pressure was applied. To prevent the edges from peeling some gypsum screws were used at the locations where peeling occurred. These screws were removed afterwards and the holes were filled and finished. It is expected that pins inserted with a pin nailer would be a better alternative as they are inserted more quickly and are practically invisible. The small sheet was glued on more easily as, with a similar compression force and a smaller surface area, the pressure was higher.

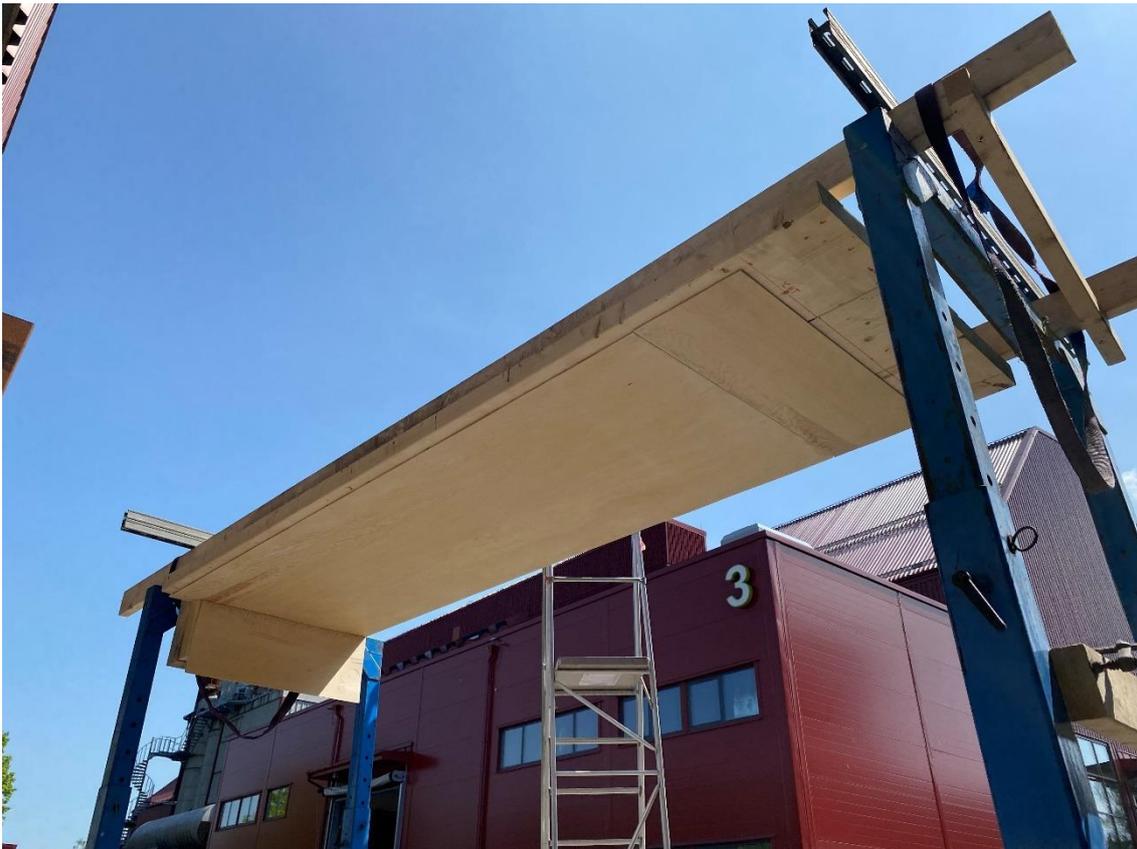
Figures of the specimen after rehabilitation are shown in Figure 21 and Figure 22. Figure 23 shows a closeup of the ceiling joint, where the new ceiling lamella is structurally supported by the new wall lamella<sup>7</sup>. To achieve this the ceiling should be repaired prior to the wall.

Figure 21: Specimen after rehabilitation work

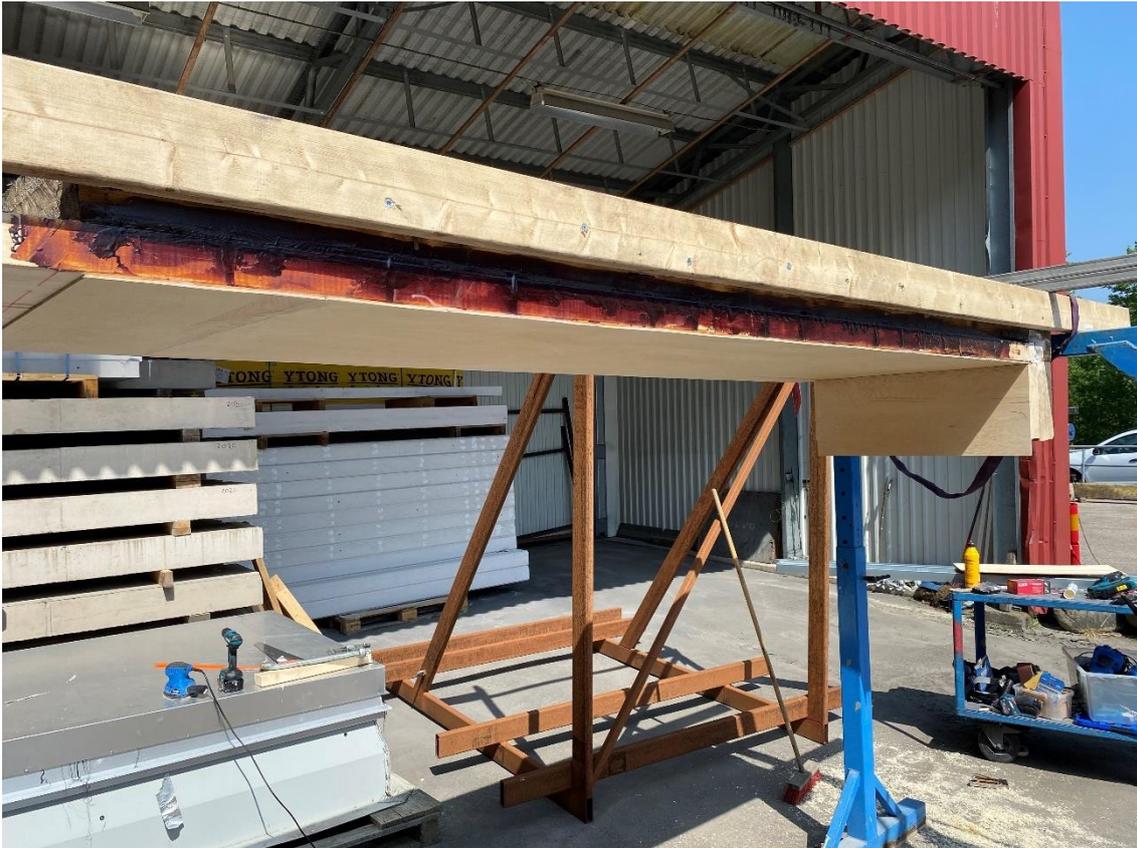
Figure 22: Specimen after rehabilitation work

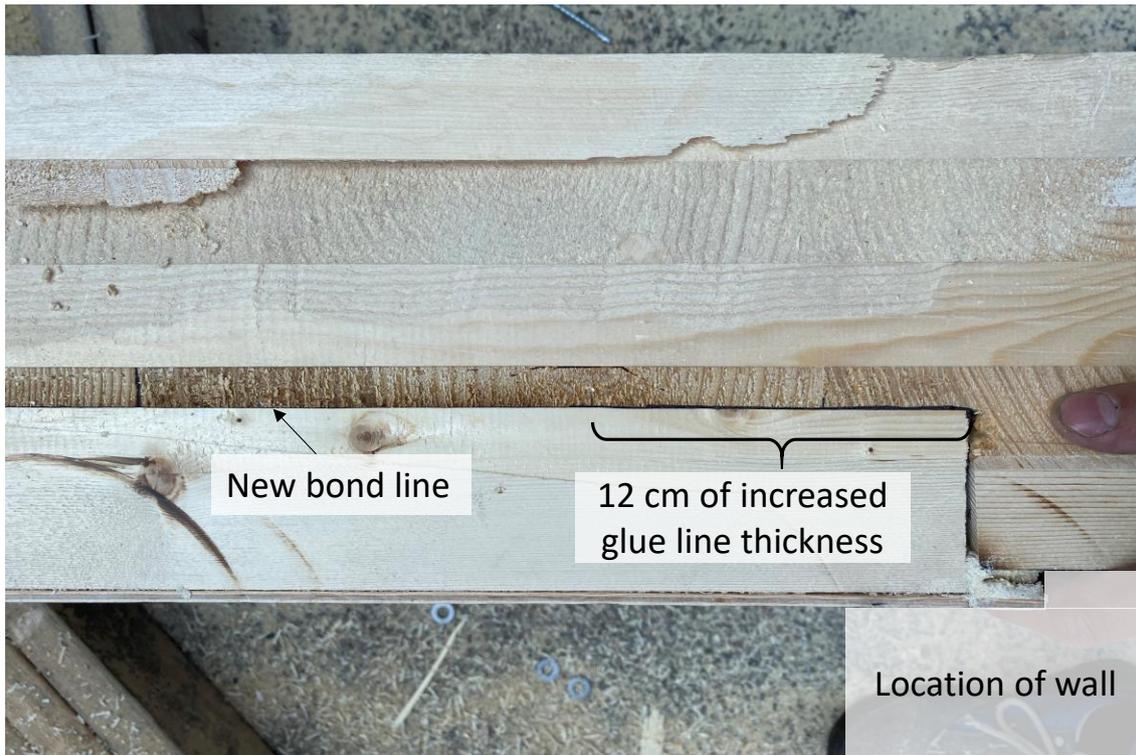
After the rehabilitation process, a longitudinal cut was made splitting the ceiling in two long elements. In this cut the glue line thickness was between 0.1 and 0.2 mm (0.004-0.008 in) with exceptions of (1) a location where the char depth was higher than the depth that was milled away, and (2) approximately the last 120 mm (5 in) to the ceiling-wall corner. Figure 24, shows the bond line at a typical part of the longitudinal cross section. Figure 25 and Figure 26 show the longitudinal cross section at the corner joint and the location of deeper char, respectively. Near this corner, the glue line thickness varied between 0.4 and 1.4 mm (0.015-0.055 in). At the location of deeper charring, a length of approximately 90 mm (3.5 in) of the longitudinal section had an increased glue line thickness, exceeding 1.5 mm (0.06 in) for a total length of approximately 20 mm (0.8 in). The measurements in the longitudinal cross section, therefore, indicated that a gap filling adhesive graded for glue line thicknesses up to 1.5 mm ( $\sim 0.06$  in) was appropriate for this case study.

Figure 25: Photo of the longitudinal-section of the rehabilitated CLT member at the location of the ceiling wall joint, an indication of the location of the PRF bond line and an indication of the location of the wall

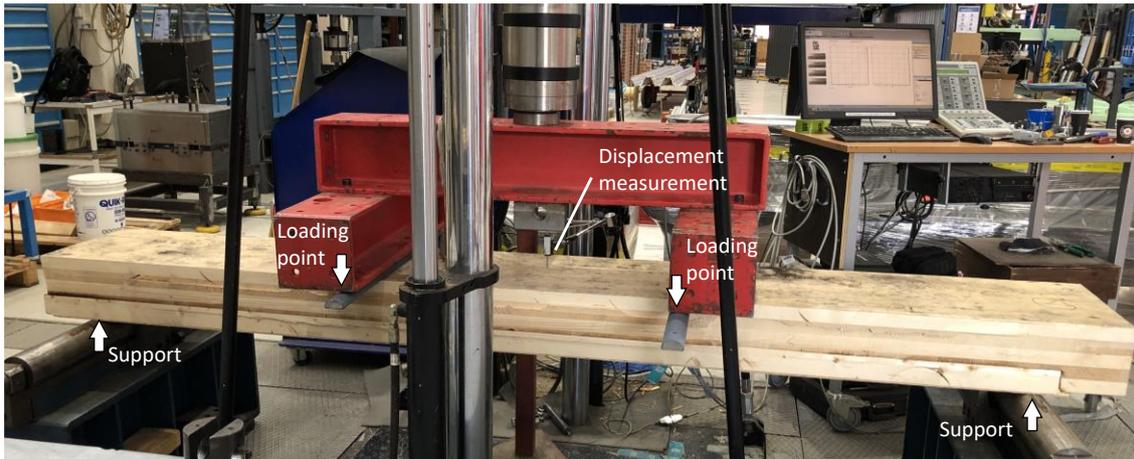
The specimen was cut longitudinally to create 2 specimens for structural testing. Two 4-point bending tests were performed according to EN 408:2010. It should be noted that the length of the available specimens was shorter than described by the standard, increasing the risk of shear failure during the tests. The total span was 2580 mm (~8.5 ft) with 860 mm (~2.8 ft) between the support and loading points and between the two loading points.

Figure 27: Bending test setup

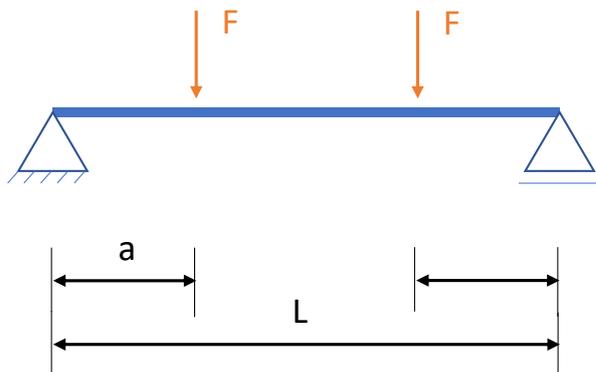
Figure 29: Load diagram for 4-point bending.
