# Comparative Fire Test of Timber and Steel Beams

This report deals with the results of such a comparative test conducted by the Southwest Research Institute, San Antonio, Texas.

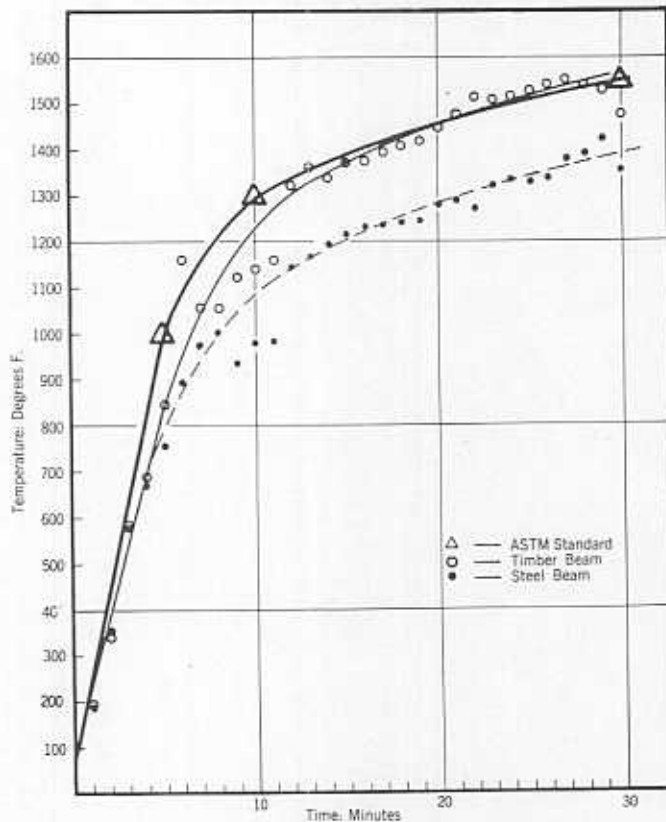
Figure 5. Conformance of test-chamber temperatures to ASTM Standard Time-Temperature Curve.

This is illustrated in Figure 5, which is a graphic comparison of the average temperatures near the wood and the steel beams, with those required by the Standard Curve. An analysis of this information indicates that the area under the average test chamber temperature curve was within 10 per cent of the area under the Standard Curve.

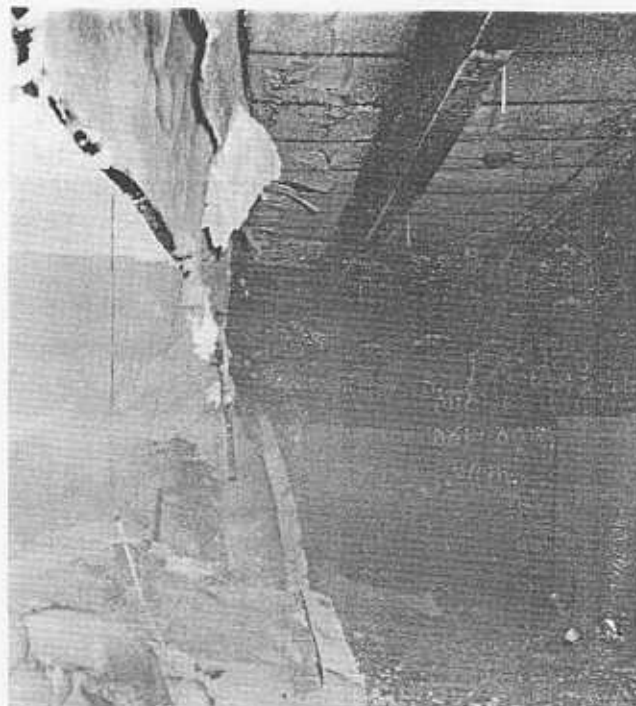
Figure 7. Interior of the test structure immediately after the steel had collapsed indicating that flaming on the wood member had ceased as soon as the source of heat was removed.

statement, Figure 7 is a view of the under side of the roof before a fire hose was applied to cool the structure, prior to disassembly of the roof panels. The water was also used to extinguish the afterglow, on the laminated wood beam, to obtain an accurate measurement of the amount of char on the wood beam at the time of failure of the steel beam.
