# Fire Safety Challenges of Tall Wood Buildings – Phase 2: Task 1 - Literature Review

# Daniel Brandon and Birgit Östman

SP Technical Research Institute of Sweden Stockholm, Sweden

September 2016

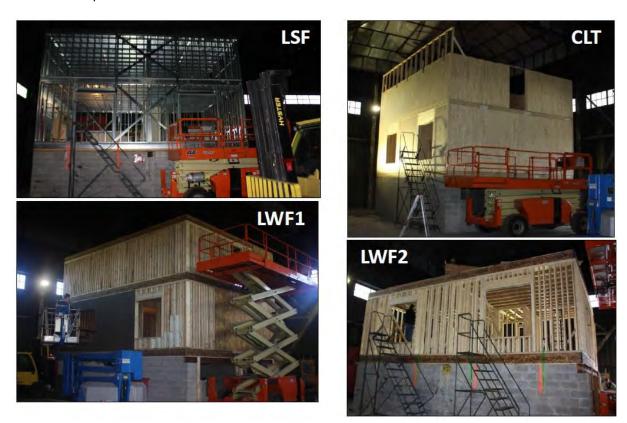
Figure 14: Compartments of test L1 (LWF1), L2 (CLT), L3 (LSF) and L4 (LWF2) under construction, from Su and Lougheed (2014)
