Final Project Report

Fire Safe implementation of visible mass timber in tall buildings – compartment fire testing

RISE Report 2021:40

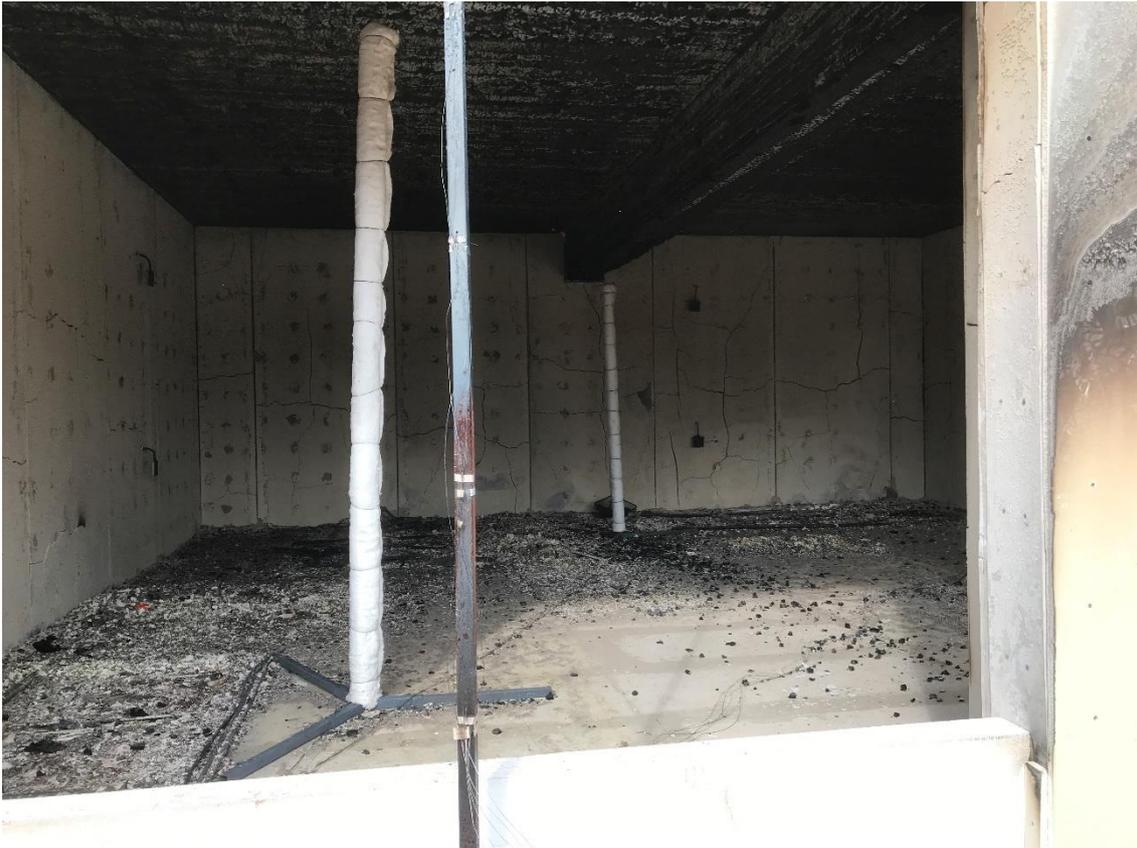
Temperatures were measured behind every layer of gypsum board at various locations. These temperatures are shown in Annex J. In this section an assessment of the involvement of protected CLT in the compartment fires is made. That assessment is made by temperatures measured at the interface between the CLT surface and the base layer of gypsum board protection. In Tests 2, 3, 4 and 5, all measured temperatures at the protected CLT or glulam surfaces were lower than 200 °C for the whole test duration, indicating no material decomposition and, therefore, no contribution to the heat release in the locations where temperatures were measured. In Test 1 the protected CLT or glulam surface temperatures were measured in seven locations of which one location, at the back wall 700 mm from the floor, had temperatures above 300 °C (but below 350 °C), indicating local charring at this location (Buchanan and Abu, 2017). In three other locations the temperatures exceeded 200 °C (but not 250 °C), indicating some local and minor material decomposition and contribution to the fuel load at the CLT surface. There was no gypsum board fall-off observed in Test 1 and the exposed layer of gypsum was still fully visible (see Figure 61).

Figure 61: Interior at the end of Test 1

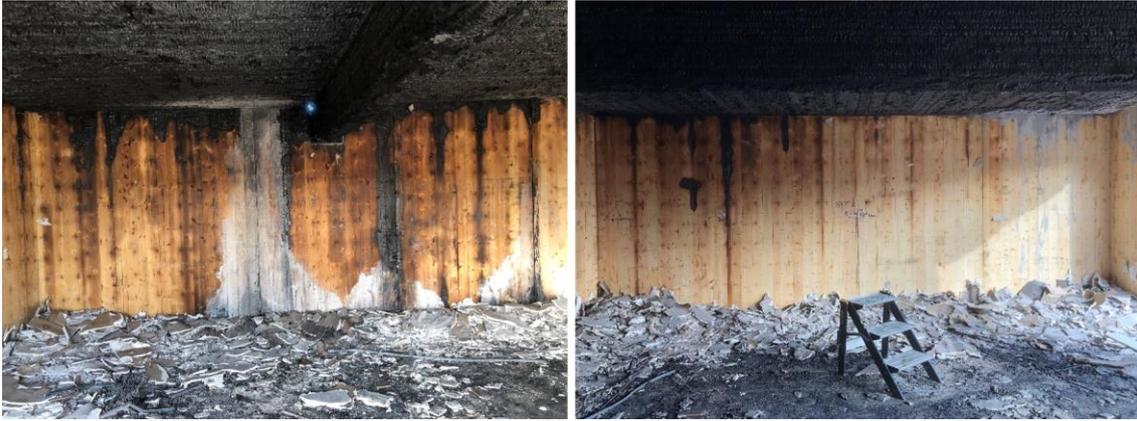
Figure 62 and Figure 63 show photos of CLT surfaces after removal of the gypsum after Test 1 (2 gypsum board layers). Local charring was seen, especially in locations near the intersection of walls and the exposed ceiling and in some lap joints between two wall panels. Figure 64 shows the top of the back wall after removal of the ceiling. The right picture shows the location of the most significant charring that took place in a lap joint where the ceiling meets the wall. As indicated before in Figure 7, there was no fire sealant applied at the interface between the gypsum boards and the ceiling of Test 1. In all other tests a fire sealant adhesive was used in this location only at locations where a gap was visible between the outer boards and the ceiling. The location of the local maximum char depths on gypsum protected surface after Test 1 was determined and indicated in the char diagram of Section 6.12. Figure 65 and Figure 66 show the CLT surface after removal of the gypsum boards for Tests 2 to 5. It should be noted that the gypsum boards in Test 2 and 3 were removed by the local fire brigade with water mist, which left stains and some damage of wood grains. Water mist was used to assess its potential as an alternative technique for extinguishing smoldering behind the gypsum boards using less water than conventional methods, as discussed in Annex L.

Figure 62: **Test 1**, Back wall (left) and right wall (right) after removal of the 2 gypsum board layers.

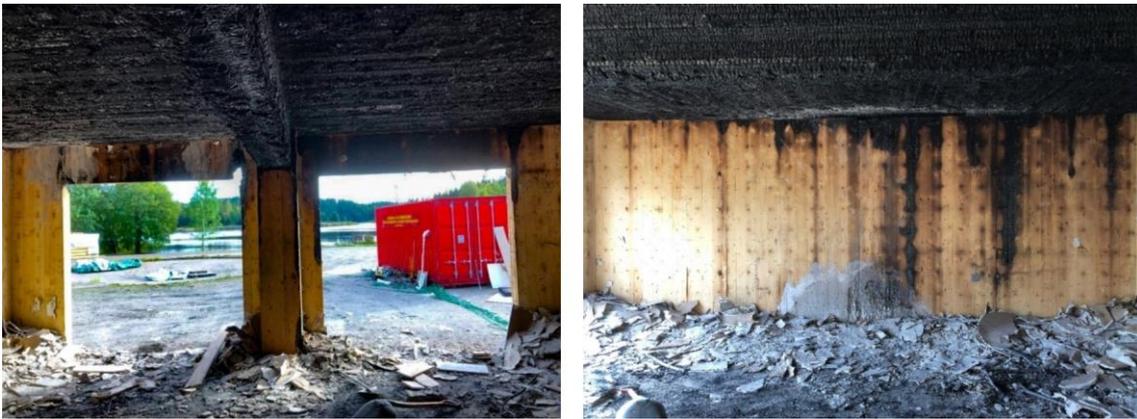
Figure 63: **Test 1**, Front wall (left) and left wall (right) after removal of the 2 gypsum board layers.

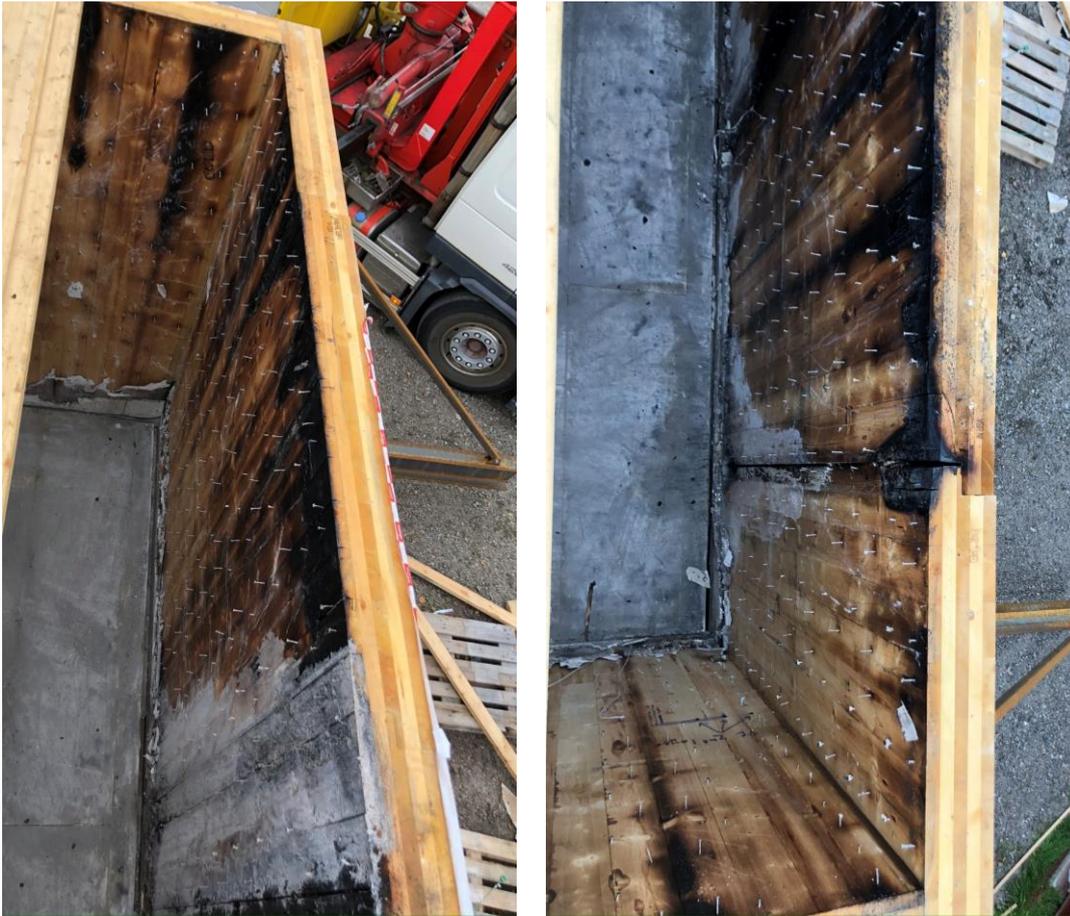
Figure 64: **Test 1**, Top of back wall after removal of ceiling.

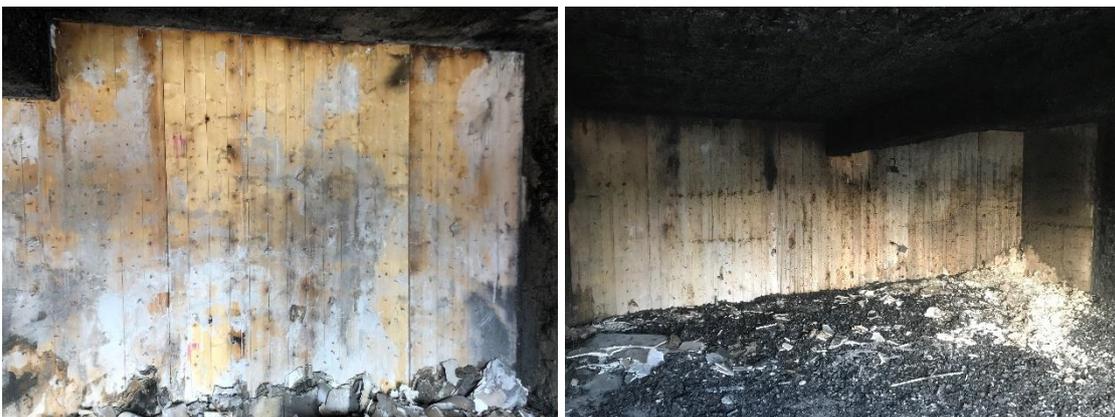
Figure 65: Protected walls of **Test 2** (left) and **Test 3** (right) of left wall after removal of the 3 gypsum board layers.

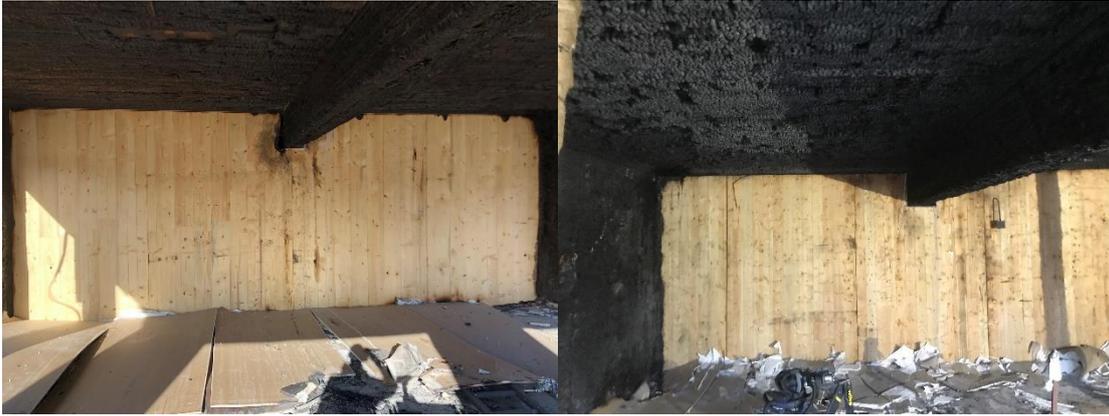
Figure 66: Protected walls of Test 4 (left, 2 GB layers) and Test 5 (right, 3 GB layers) after removal of gypsum boards.

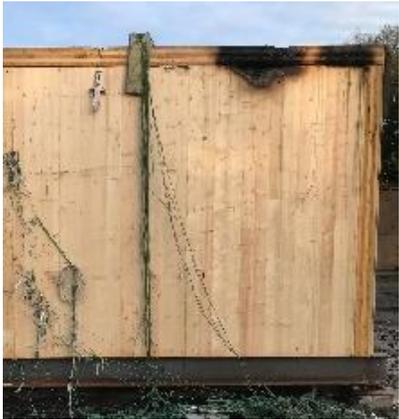
Test 2	None	-	-
Test 3	Wall-ceiling joint at the front side of the left wall	<p>Smoke exited the intersection at the top of the left wall on the front side directly after flashover, indicating the intersection was not sealed at this location. The smoke development took place at the location where several thermocouple wires were running (Note: these were moved before the photo was taken). To avoid loss of data, the stone wool was placed over the intersection (under the wires) to protect the wires. In extreme cases, small amounts of water on the external surface were used to minimize the exposure to the thermocouple wires.</p>

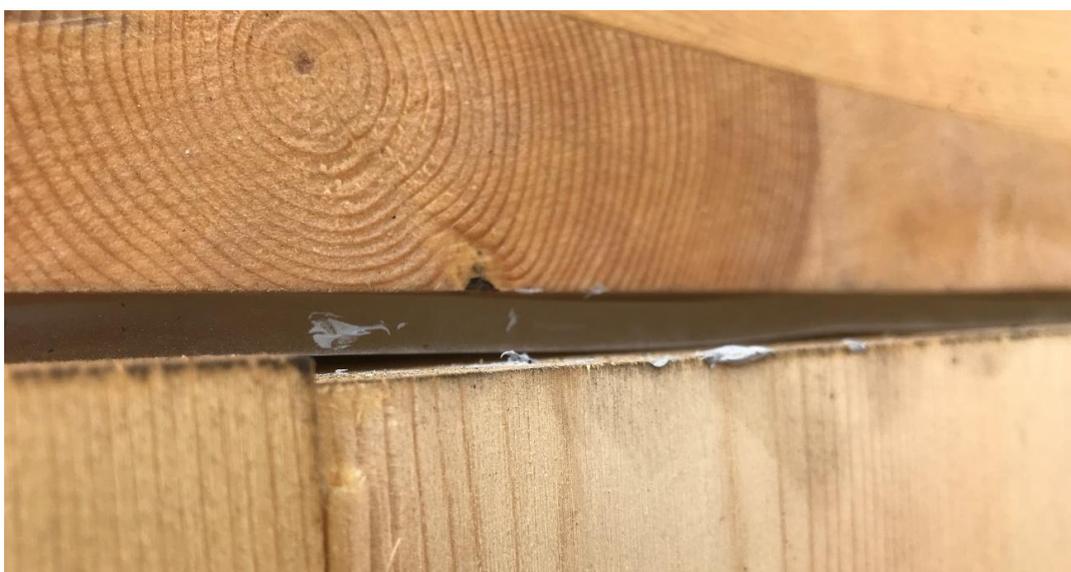
were identified before the start of Test 3 (Figure 85) and fire sealing adhesive was applied to close the void under and above the resilient profile in those locations only. During the test, however, smoke left the intersection at the top of the left wall at an early stage in the fire, indicating lack of effective gas seal at that location.

Figure 85: Location of imperfect detail at wall-ceiling joint with a resilient profile identified before the test

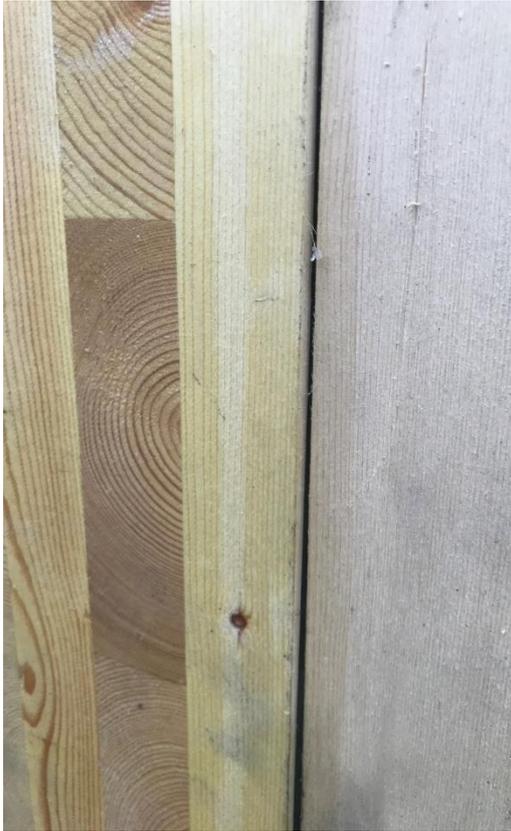
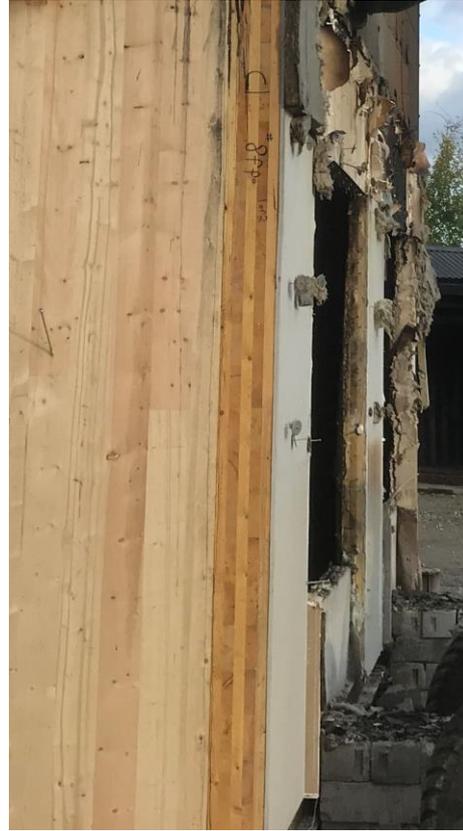
None of the corner joints between walls showed any sign of fire spread through the connection. Figure 94 shows the external side of typical wall-wall corner joints with construction sealant and Figure 95 shows the external side of typical wall-wall corner joints with construction tape (left) and expanding tape (right) after the test. Detail drawings of these connections are given in Figure 6 D.

Figure 94: Typical wall-wall butt joint with construction sealing after the test.

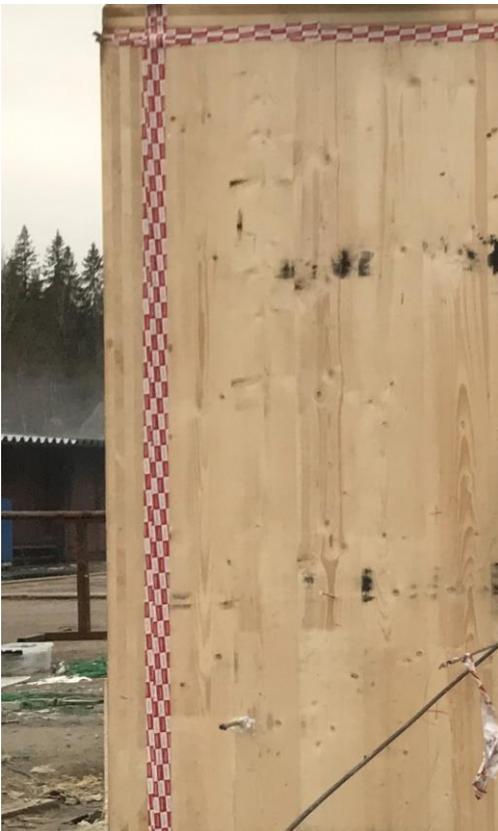
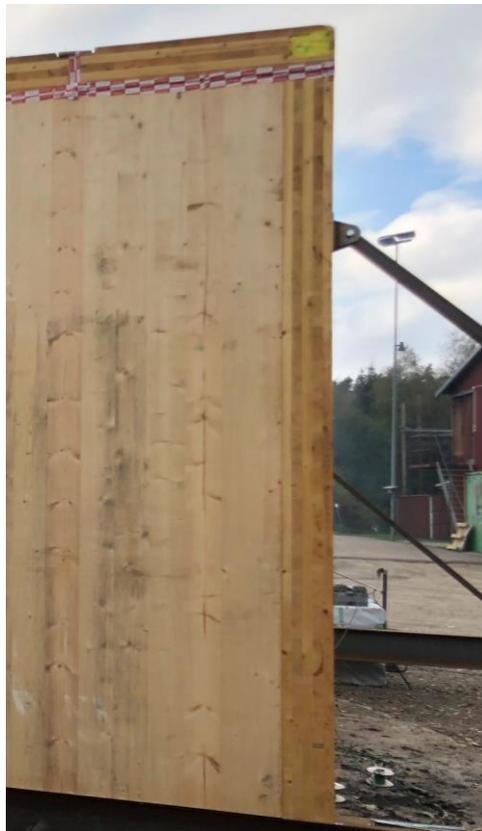
Figure 95: Typical wall-wall butt joint with construction tape (left) and expanding tape (right) after the test.

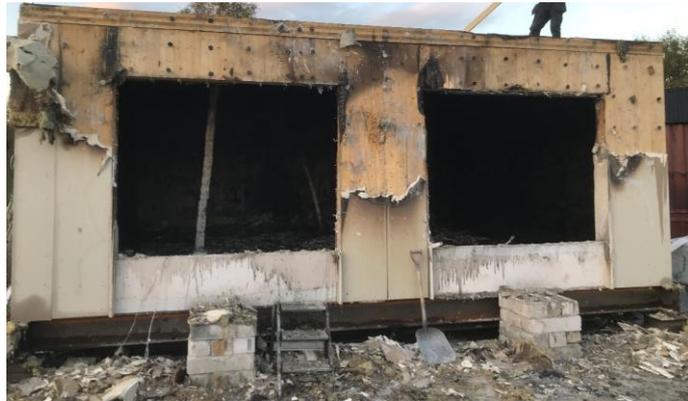
In Test 2, the top of the opening had 3 layers of gypsum boards, while the side of the opening had 2-layers of gypsum boards. The opening dimensions were the same as those of Test 1. After the test there was some minor charring on the sides under the inner corners. Note: the black fire sealing adhesive smeared out above the left corner of the left opening should not be confused with char.

Figure 97: Test 2 - Detail above opening (left) and front façade after removal of gypsum boards. NOTE: the sides of the opening had 2 layers of gypsum boards.

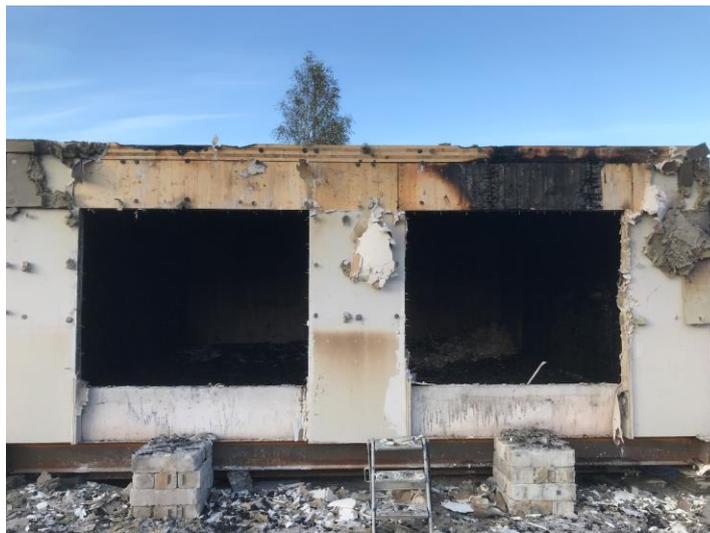
Test 3 had thinner and smaller stone wool battens. A full batten above the right opening fell approximately 11 minutes after flashover. This resulted in some superficial charring of the CLT in that location. The other battens remained in place, for the whole period of external fire extension. Each batten was fastened with six screws and 2 inch diameter washers with an edge distance of about 2 inch. It is expected that improving the fastening method or the use of larger battens would have delayed this fall-off.

Figure 98: Test 3 - Detail above opening (left) and front façade after removal of gypsum boards. NOTE: Stone wool B (1200 x 555 x 45) was thinner and had smaller batt dimensions than stone wool A, which was used in other tests (1200 x 2700 x 50mm). The stone wool batt above the right opening fell at an early stage.

In order to limit smoldering above the opening in the façade, it is recommended to design the detail above the opening robustly. Improved performance was found by placing the gypsum board in a manner that the joints between gypsum boards are not directly exposed to the expected flow of hot gasses. It is also recommended to extend the gypsum boards that are protecting the opening edges to partly lead the fire plume away from the façade, as shown in Figure 112. Although the detail has not been tested as such, implementing a line of fire sealing adhesive between the CLT at the top of the opening and the base layer of gypsum board instead of intumescent paint (used in Test 4 and 5) is expected to improve the performance of this detail.

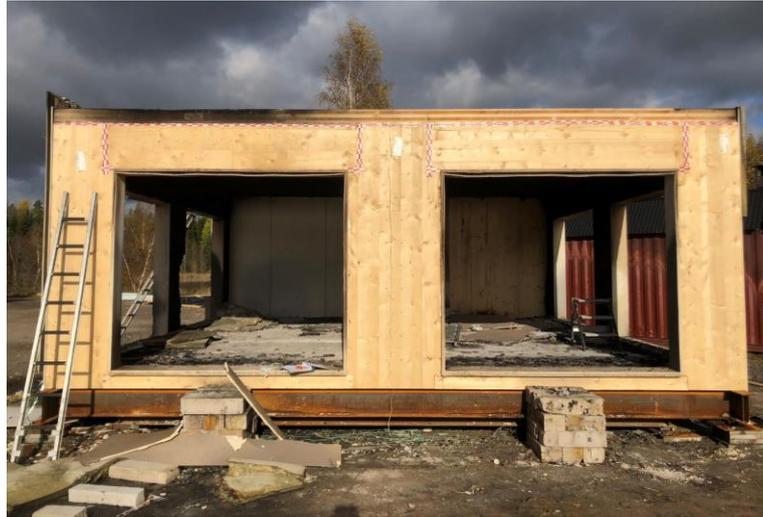
The façade of Test 4 was undamaged with the exception of a location where 5 thermocouples were positioned at the back opening of the left façade.

Figure 99: Test 4 - Detail above opening (left) and front façade after removal of gypsum boards.

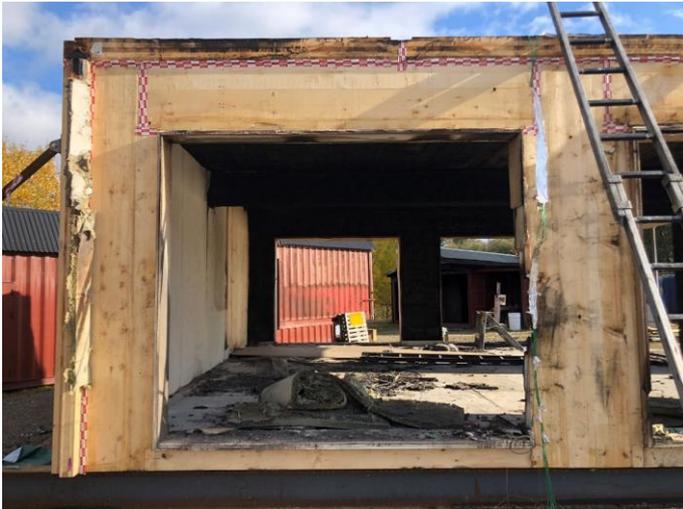
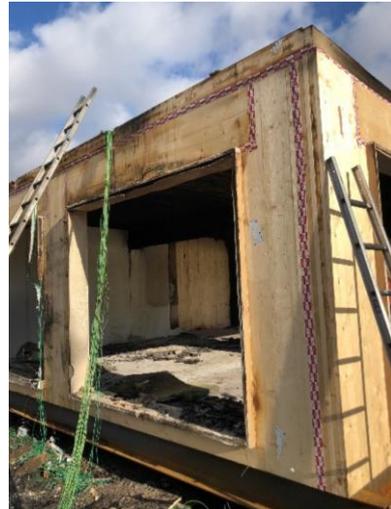
Figure 100: Test 4 - Left façade after removal of gypsum boards.

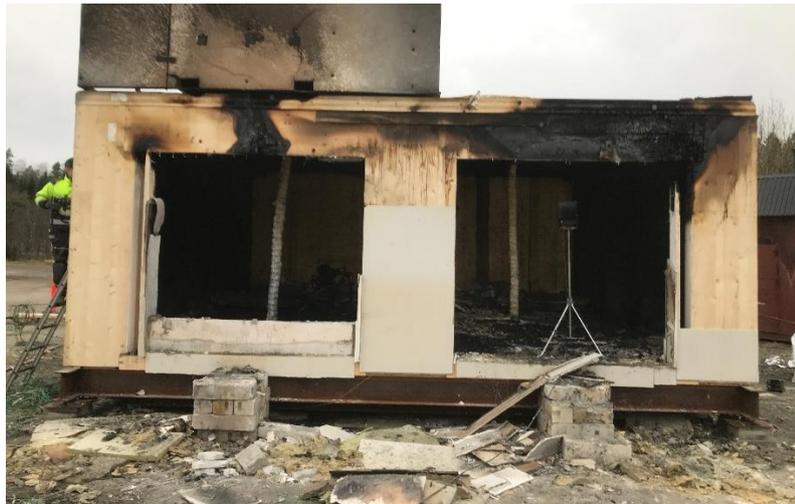
Test 5 included cavities in the front façade as it was originally planned to have larger openings. The damage in the façade of Test 5 is therefore, considered not representative for real buildings with a mass timber structure. Based on the damage it is expected that some combustion started in the right cavity. This led to charring above the right corner of the right opening.

Figure 102: Test 5 - Detail above opening (left) and front façade after removal of gypsum boards. NOTE: Test 5 was originally planned to have larger openings. During the test series it was decided to perform a test with the same openings as Test 1, 2 and 3 and modify the opening width in the front façade. As a result a cavity existed between the external and internal gypsum boards at the outer side of both openings. It is expected that a smoldering fire entered the cavity on the right side of the right opening, which stayed behind the outer gypsum boards.

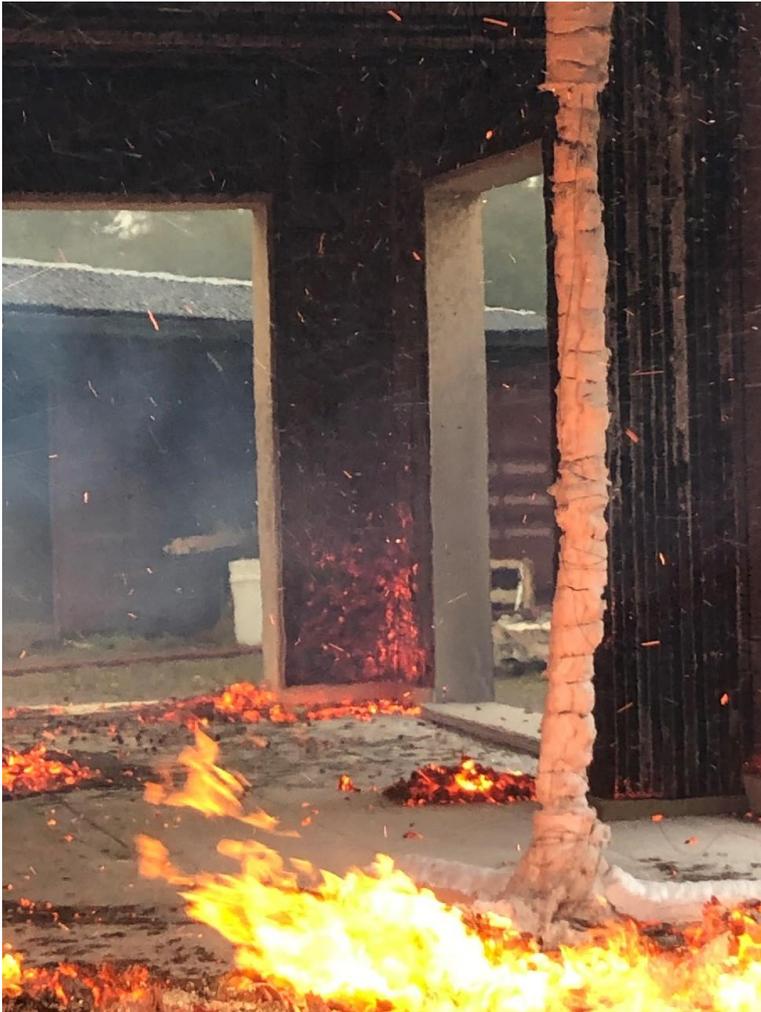
As the surface temperatures are higher in the bottom part of the walls due to oxidation, this interaction is more significant in the bottom of a corner between two exposed walls. The increased charring is a consequence of both an additional heat flux and a reduced protective char layer. The photo of Figure 114 shows a corner where two exposed walls intersect at a late stage of decay of Test 4. At the time of this photo, smoldering combustion in most other surfaces started to extinguish as concluded using an infrared camera. However, the bottom corners where two exposed walls intersected were visibly smoldering more severely and significantly longer than other surfaces.

Figure 114: Photo at the final stage of Test 4

Based on the fact that Test 3 did not pass the ICC criterion, it is not recommended to implement two exposed CLT wall surfaces that intersect in one corner. However, the data from Tests 2 and 5 do not indicate a similar phenomenon at the intersection between an exposed wall and an exposed ceiling. Further research is recommended to study the radiative interaction between the lower part of exposed CLT walls of high relative view factors in compartment fires.

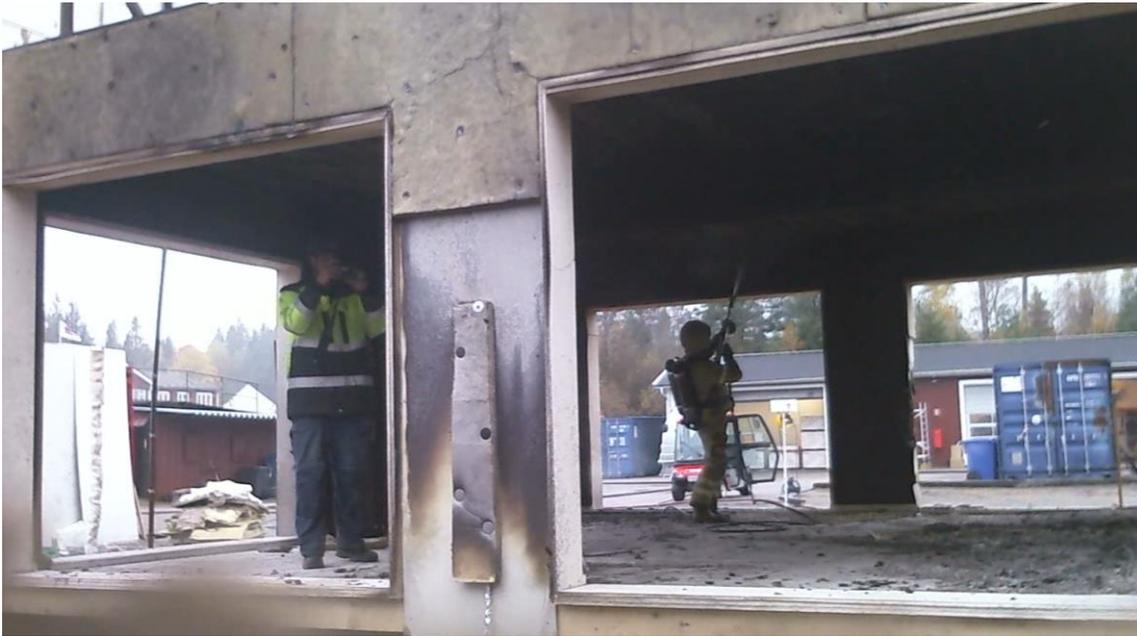
Figure L.5: Cooling down/extinguishing local identified hot spots, directly after Test 4

If the hot spots were only identified in a number of specific locations, the water mist extinguisher was used at these identified spots only (Figure L.5). This approach was taken for the extinguishment after Test 4. It required 16 gallons of water to extinguish any interior smoldering combustion. It took approximately 15 minutes to identify and cool down or extinguish all hot spots. A second check with a thermal camera 15 minutes later, confirmed that all smoldering had stopped.

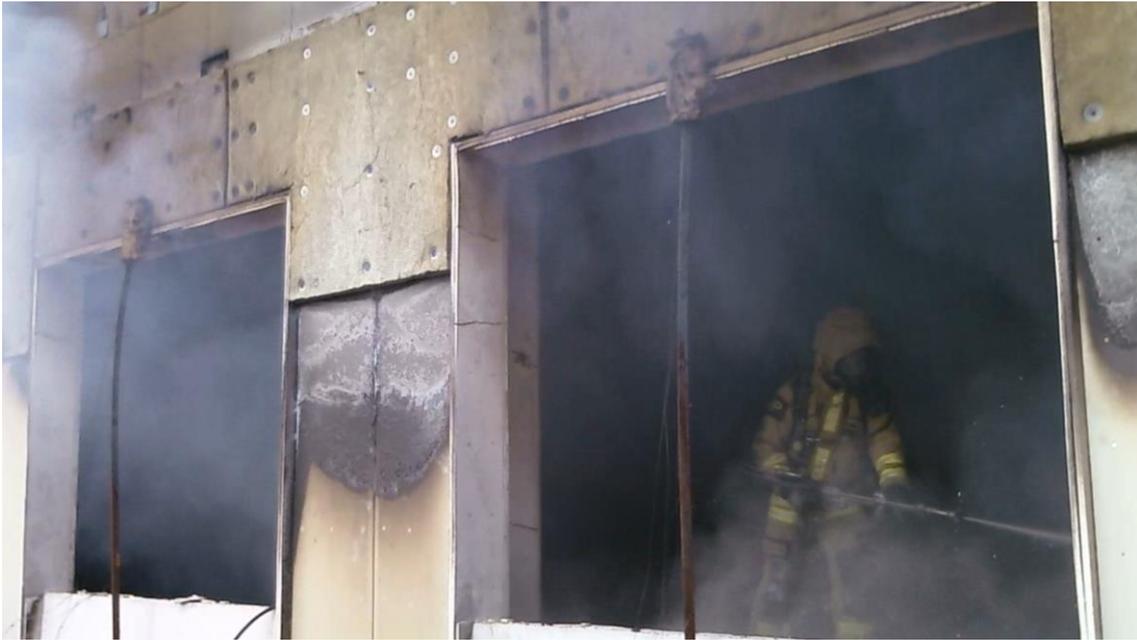
Figure L.6: Systematically cooling all exposed surfaces after directly after Test 2

Where larger surface areas had temperatures over 60 °C, the surface was first cooled down by systematically going past all exposed surfaces with the water mist extinguisher first (Figure L.6). Remaining hot spots were thereafter identified. This was used for tests Test 2 and 5, which had post fire smoldering, mostly in exposed wall surfaces. 90 gallons (340 liters) and 110 gallons (415 liters) were used to extinguish the interior with water mist for Test 2 and 5, respectively. For extinguishment of any remaining combustion in the façade of Test 5 a regular hose was used from the outside. The water from this hose is not included in this quoted volume (Note: Test 5 had cavities in the front wall, which increased the challenge for fire protection).

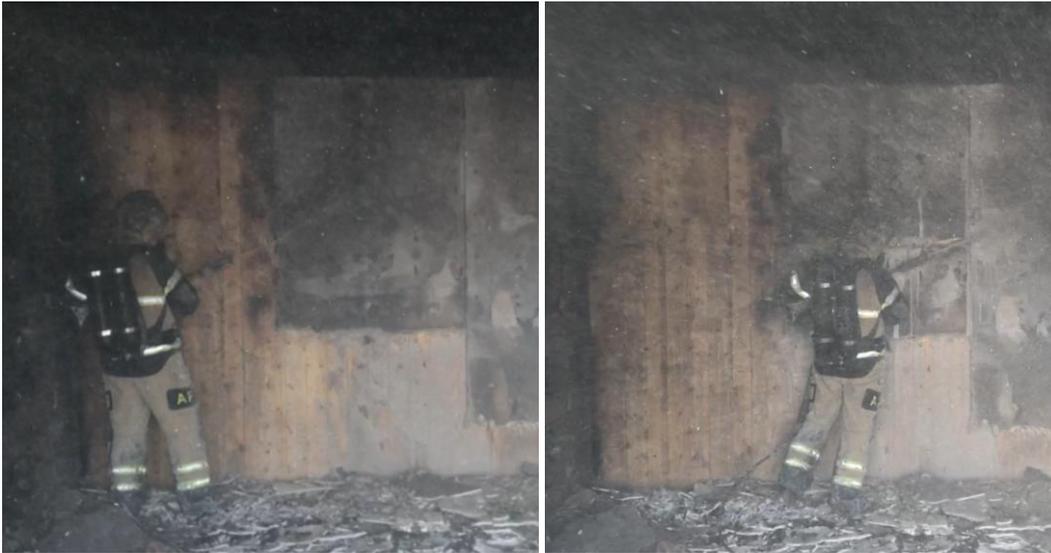
Figure L.7: Cutting the gypsum boards in rectangular parts

- Remove any brittle layers of gypsum board by hand. This should be possible to do with relatively limited effort.
- Layers that are less damaged, be cut in rectangular parts using a water mist extinguisher Figure L.7. To remain visibility, it is advised to perform all actions with the water mist extinguisher in a way that the deflected water misses the firefighter.
- After applying water mist behind the gypsum board layer for a few seconds, the gypsum board can be peeled off relatively easily (Figure L.8)

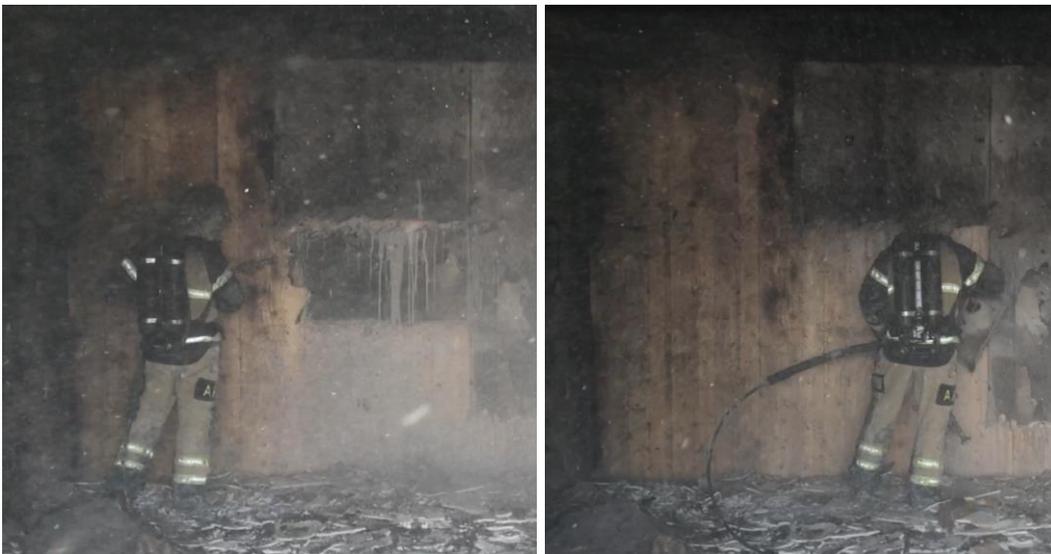
Figure L.8: Applying water mist behind the boards for a few seconds, separating the board from the wall (left), removing the board by hand (right).

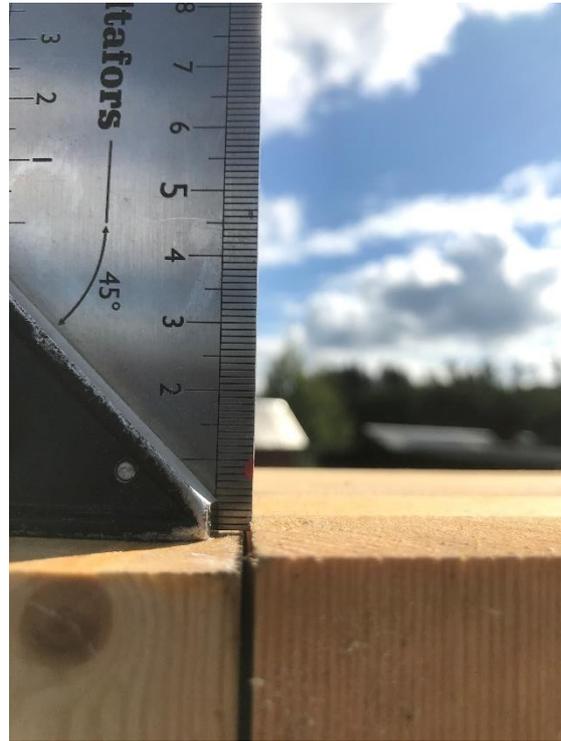
2 - Test 1. 2 mm jump between top of wall members

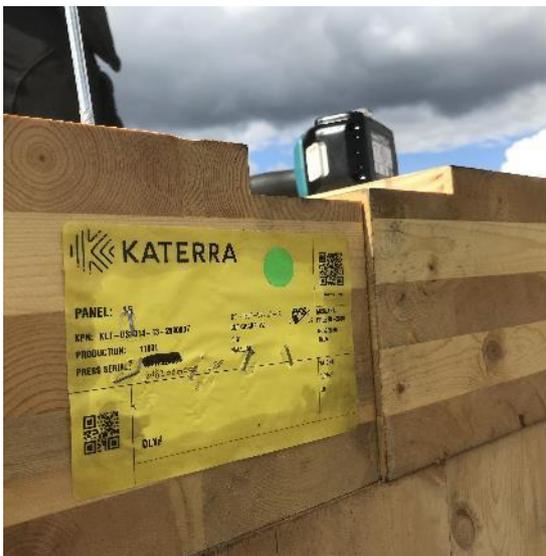
3 - Test 1. Geometrical jump of milled surface

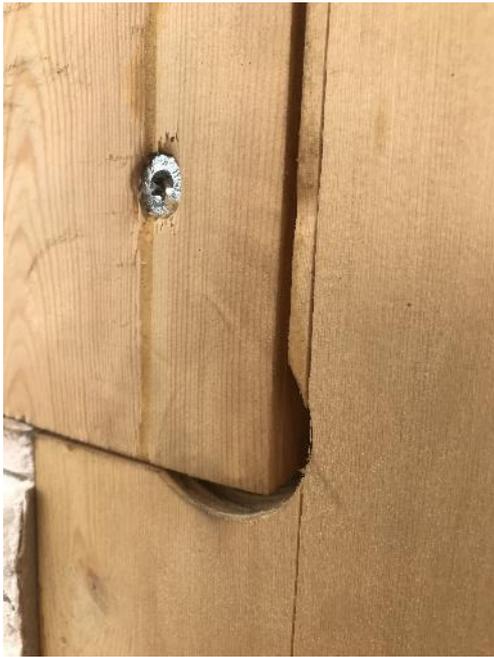
9 - Test 1. Lap joint above corners of openings, without sealant in Test 1

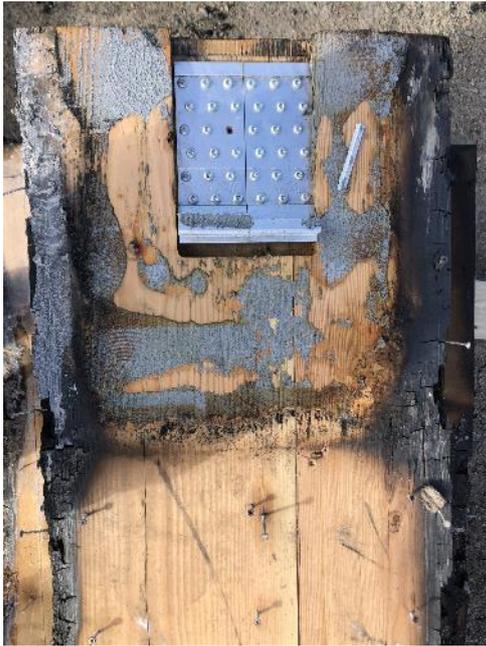
17 - Test 1. Column to beam connection post fire.

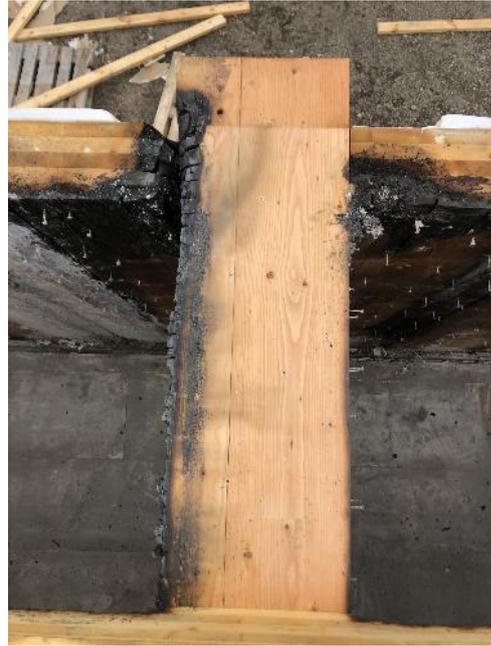
18 - Test 1. Post fire, beam penetrating through rear wall. Charring visible on the left where gap wasn't sufficiently sealed (see Section, 6.15), none visible on the right.

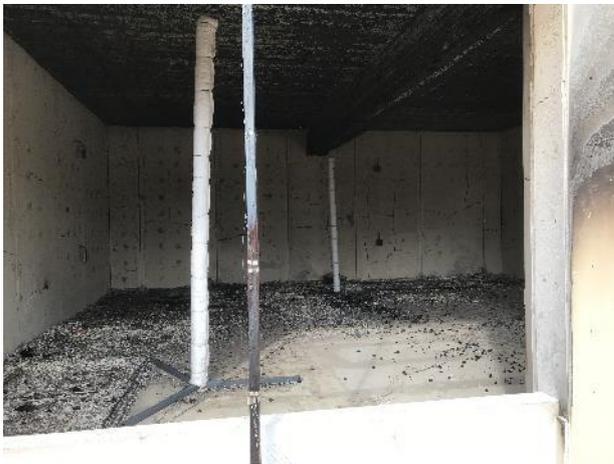
19 - Test 1. Interior post fire (gypsum still attached)

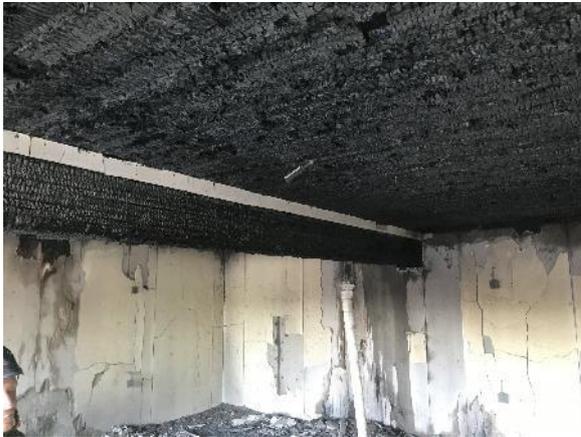
21 - Test 1. Exposed roof and beam post fire.

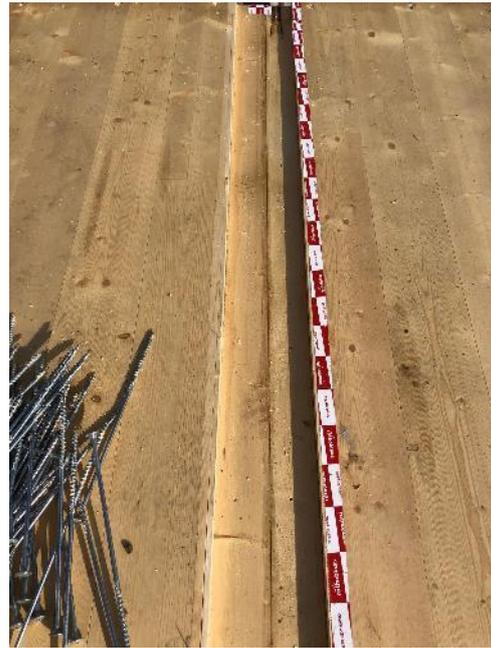
22 - Test 1. Roof joint post fire, no visible charring on unexposed surface at joint.

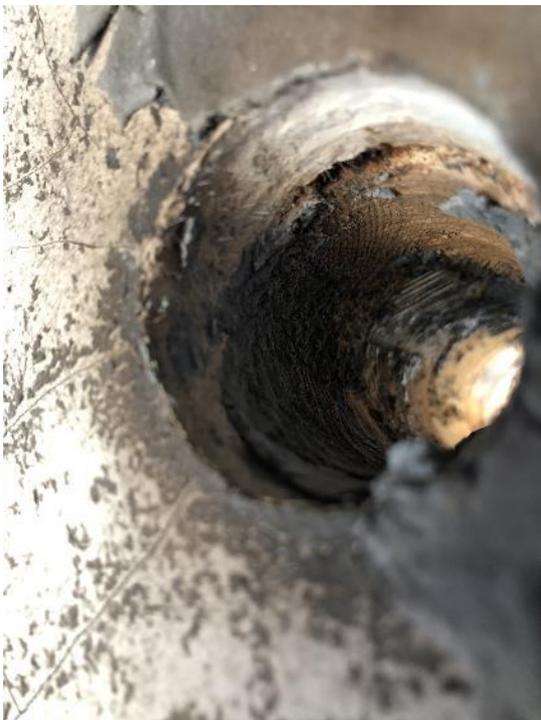
23 - Test 1. Penetration for instrumentation in wall, no visible charring within the hole.

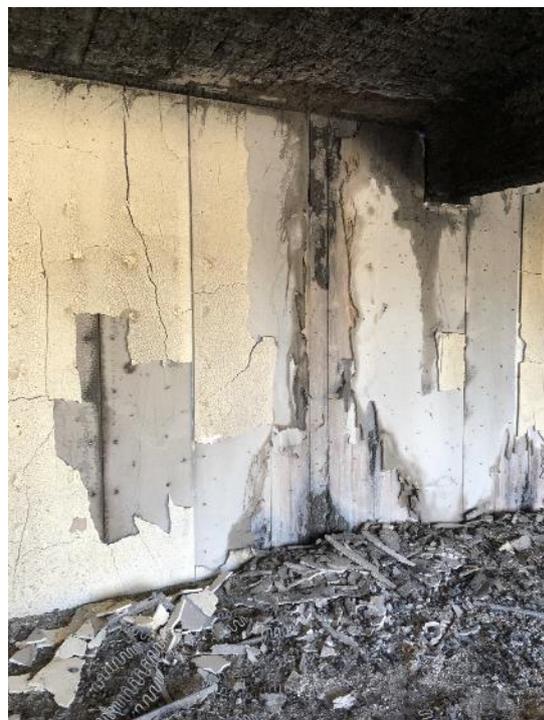
- Smoldering behind gypsum board can require more time to locate with infrared cameras. Sustained smoldering was observed for test 1 Only and not for the other tests. It was immediately identified behind the gypsum at the left side of the back wall, using a thermal camera at the end of the test. A second check with an infrared camera approximately 2.5 h after Test 1 identified all remaining local spots of smoldering combustion that were not seen directly after the test. These spots were more clearly visible after removing the exposed layer of gypsum board (which was brittle and easy to remove). Removing the base layer of gypsum board, led to automatic extinction of the smoldering, and no water was needed. A technique described in K.3 uses the water mist extinguisher to remove the gypsum boards.

24 - Test 1. Gypsum post fire after using a water mist extinguisher to extinguish local smoldering.

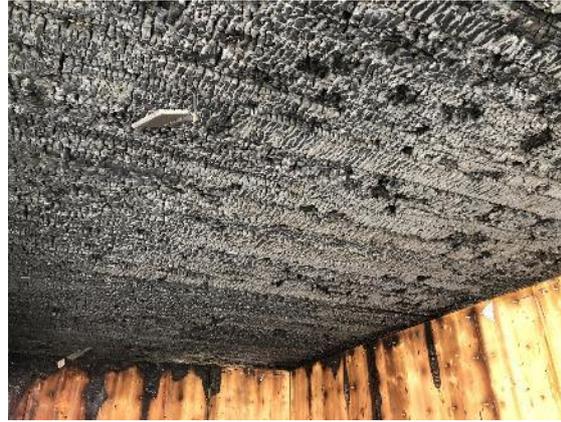
26 - Test 1. Exposed ceiling and unexposed walls (after gypsum removal). Right back corner visible.

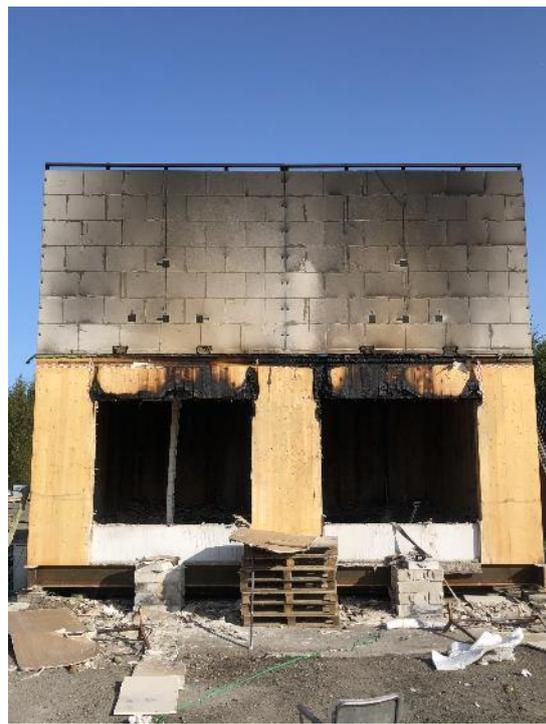
28 - Test 1. Front of the compartment posttest. Some charring directly above the openings. Especially, in the lap-joints which had no sealant applied.

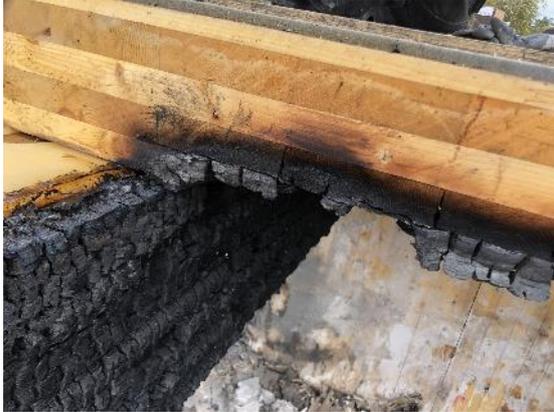
54 – Test 2. Post fire gypsum board condition.

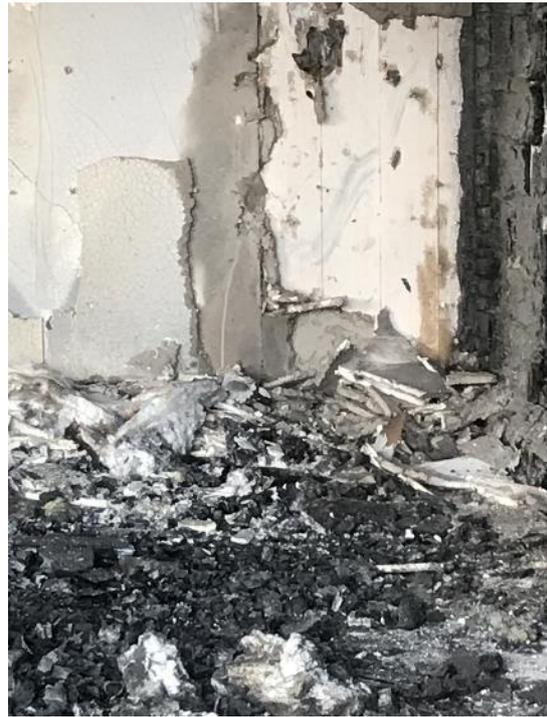
55 – Test 2. Façade after gypsum removal.

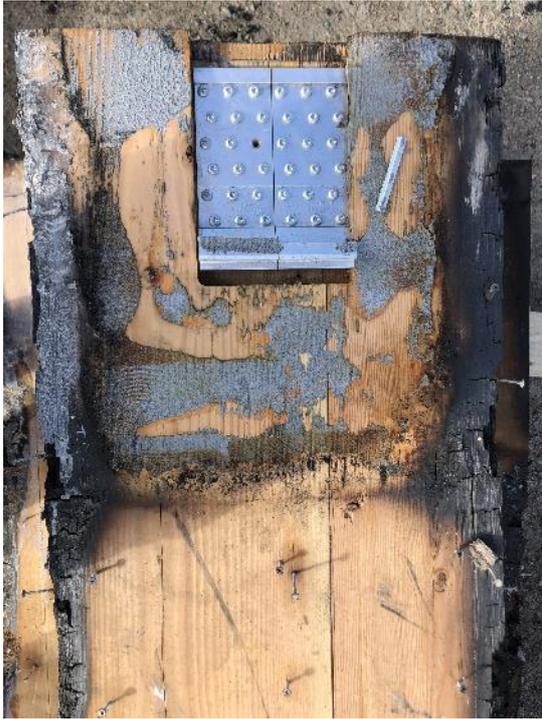
58 - Test 2. Right wall post fire.

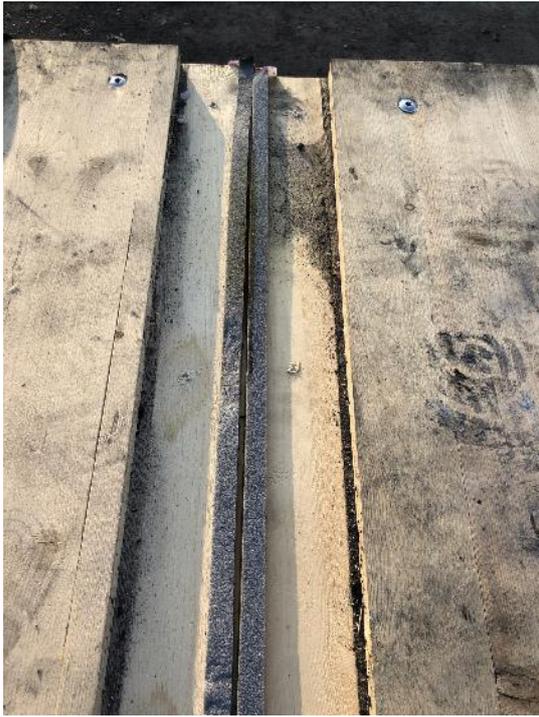
61 - Test 2. Ceiling spline board joint post fire.

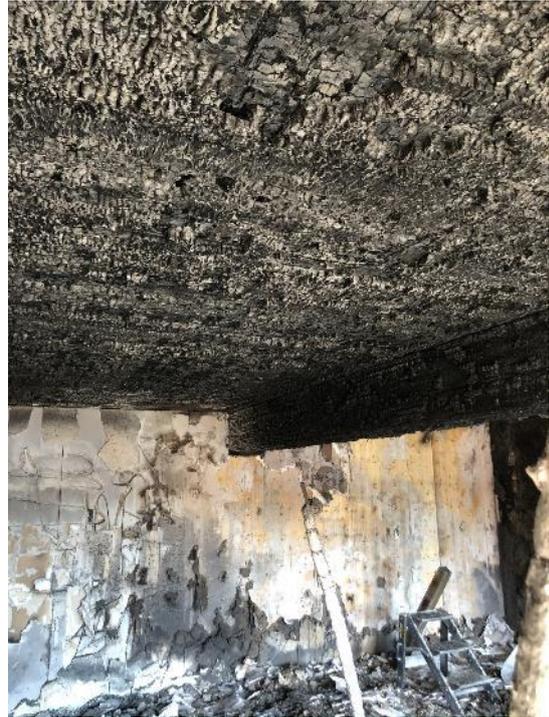
62 - Test 2. Ceiling underside post fire

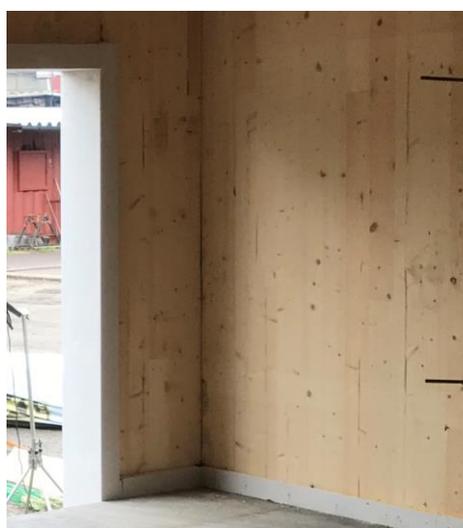
67 - Test 3. Exposed CLT wall in a corner.

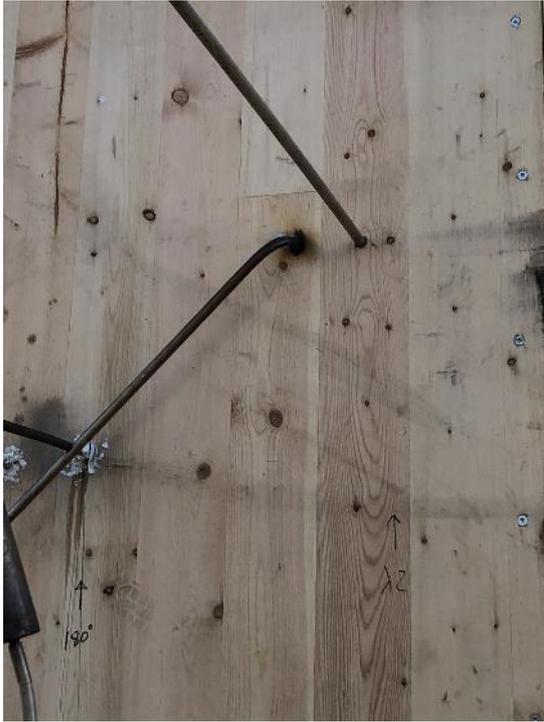
77 - Test 3. Small flame showing from behind gypsum board around opening.

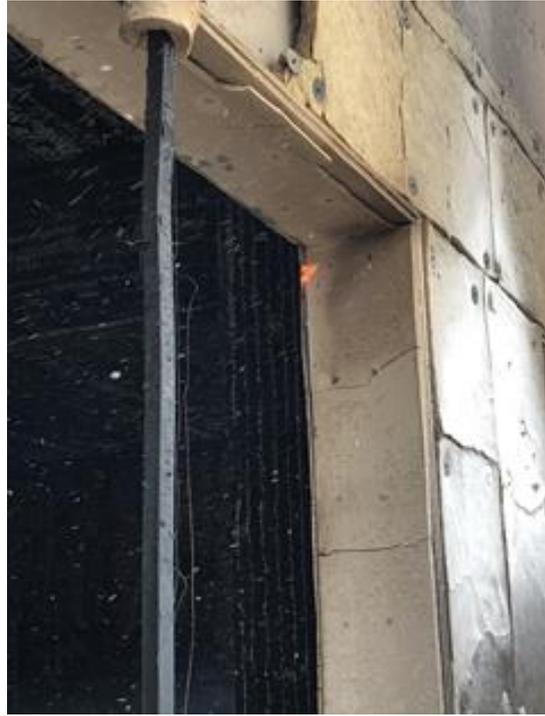
78 - Test 3. Post fire gypsum removal from rear wall.

Based on the exercise of removing gypsum boards with water mist after Test 3, the following steps are recommended:

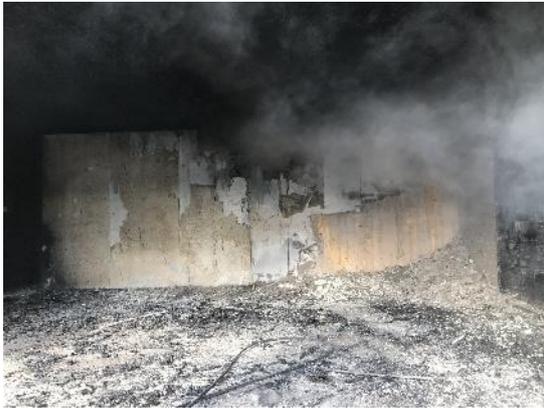
79 - Test 3. gaps visible at wall - ceiling interface post fire.

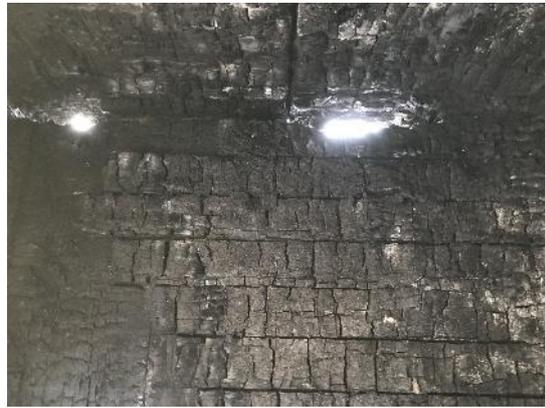
80 - Test 3. example of char depth post fire
