Final Project Report

Fire Safe implementation of visible mass timber in tall buildings – compartment fire testing

RISE Report 2021:40

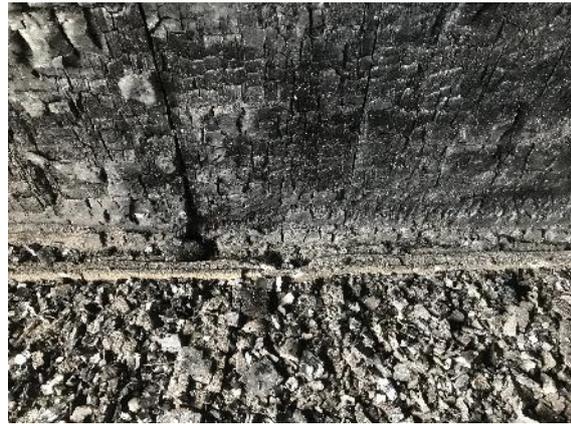
82 - Test 3. Charring of external CLT face above opening visible after protection removed.

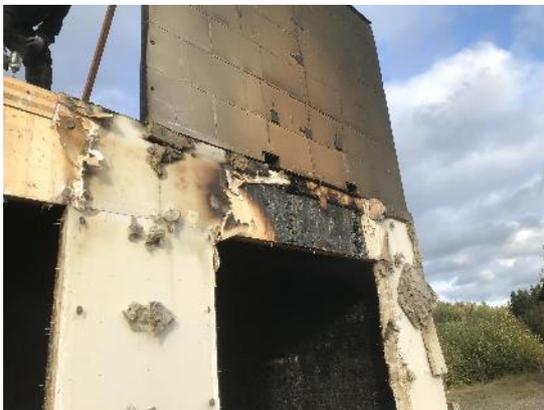
83 - Test 3. Rear wall condition after protection removed.

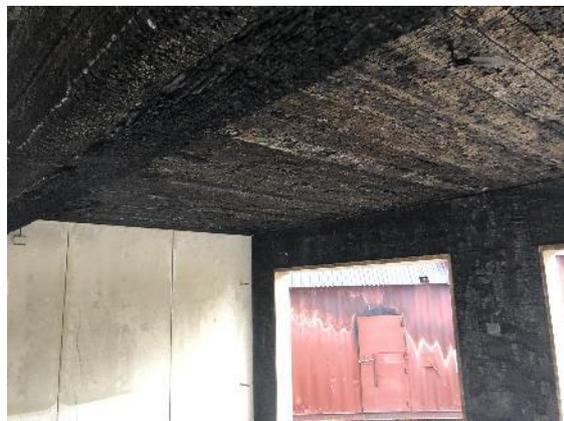
100 - Test 4. Unprotected surfaces after test

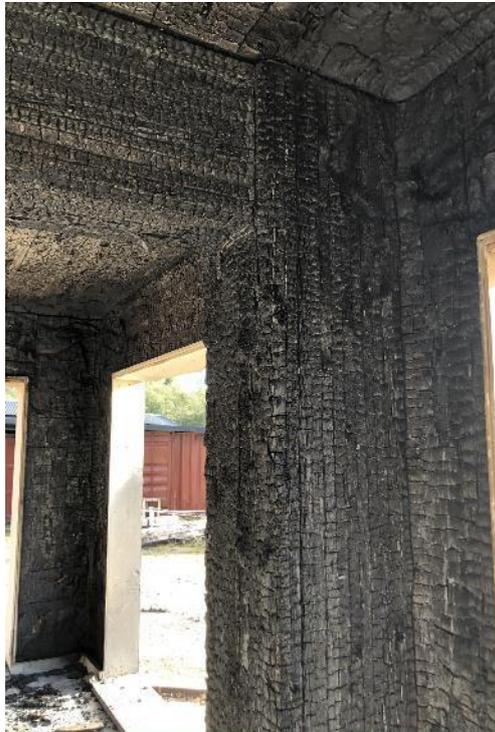
103 - Test 4. Lifting the back wall panel. The uncharred part is the position of the beam and the charring depth in the first lamella is clear.

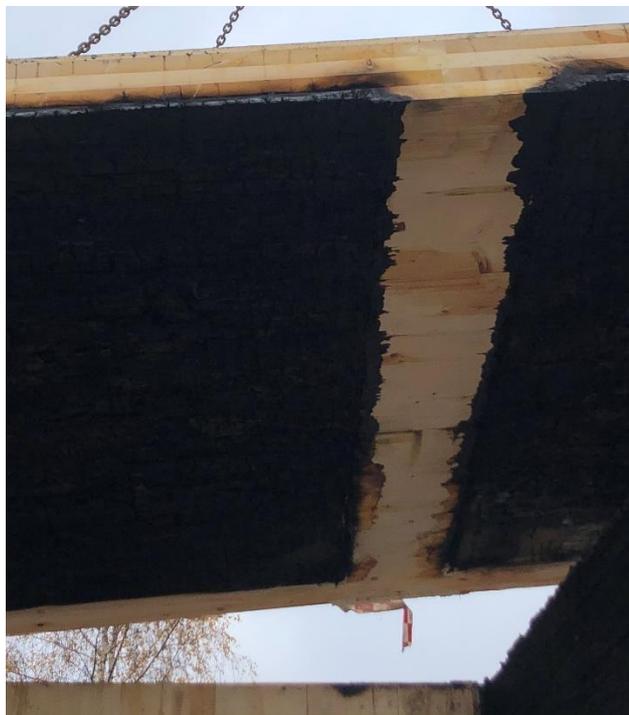
104 - Test 4. Wall section from outside. (same as photo 100 but from the outside and after removal of GB and char due to a local smoldering fire at the position of inserted thermocouples)

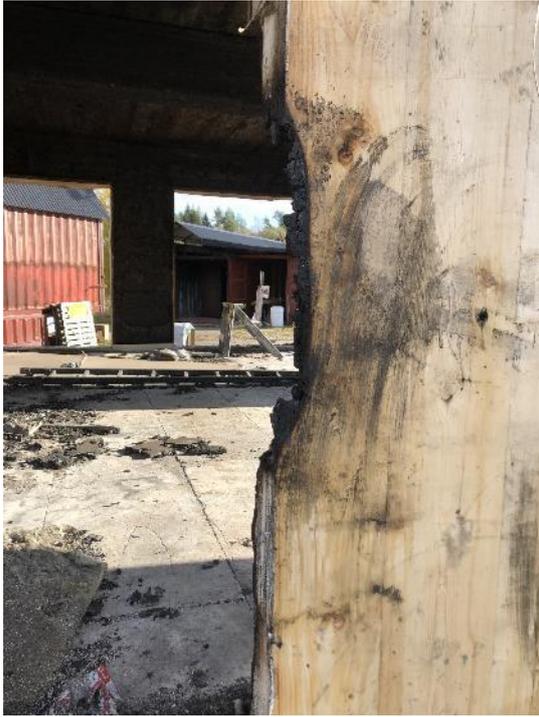
105 - Test 4. Front wall from outside post fire.

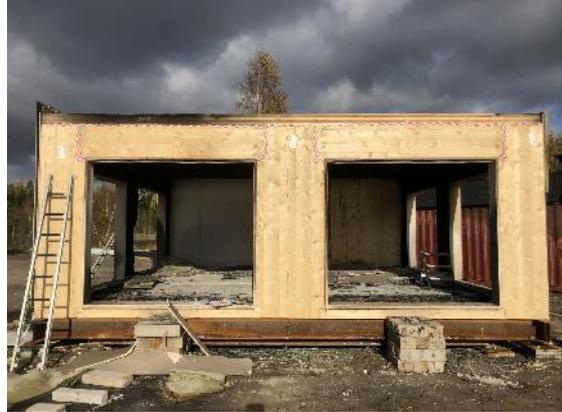
106 - Test 4. Front wall from outside post fire.

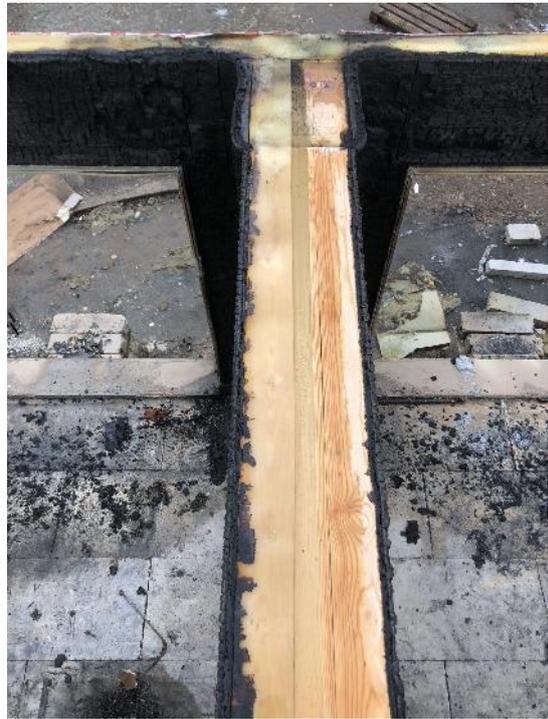
107 - Test 4. Beam from above after the removal of the roof.

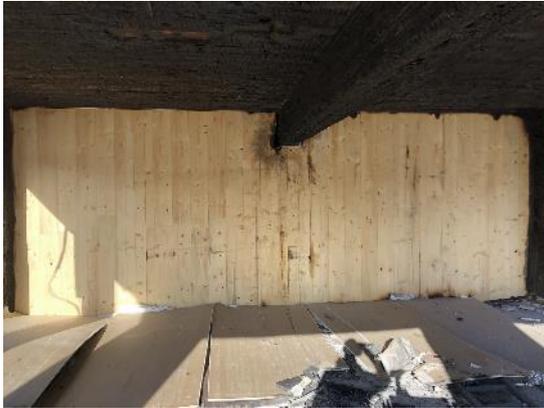
108- Test 4. Rear wall after removal of gypsum.

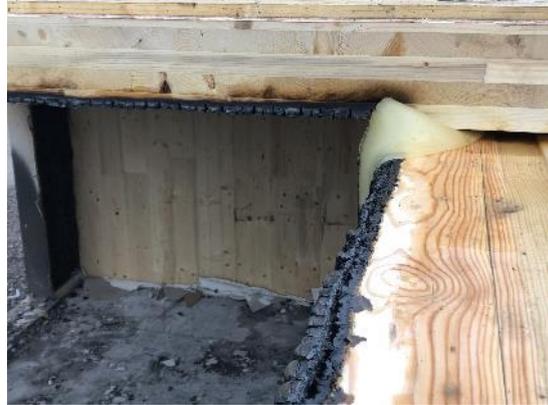
109 - Test 4. Beam after partial removal of the roof showing the resilient profile.

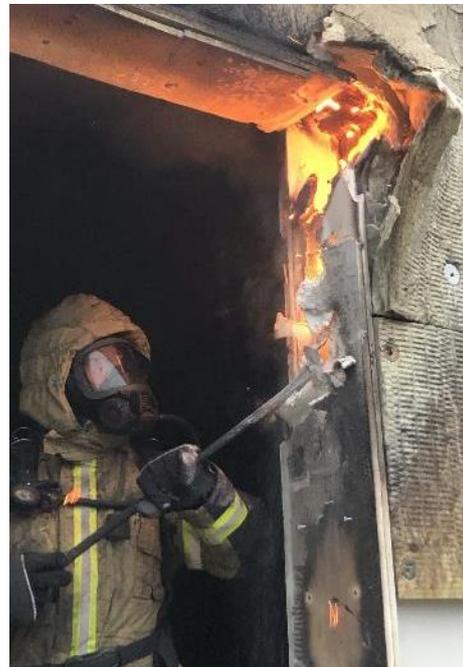
118 - Fire fighter removing gypsum around opening showing penetration of fire into the cavity behind the protection. This cavity was only present in Test 5.

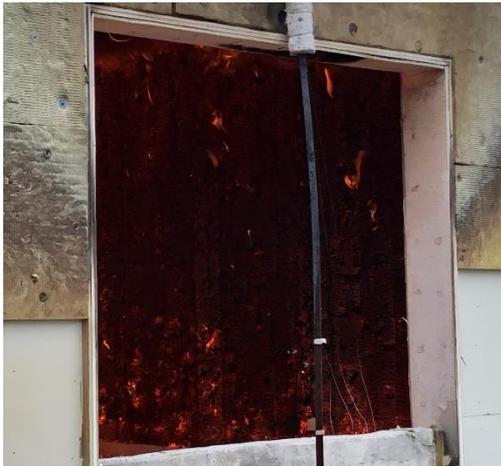
119 - Test 5. Right wall. 50 minutes after ignition.

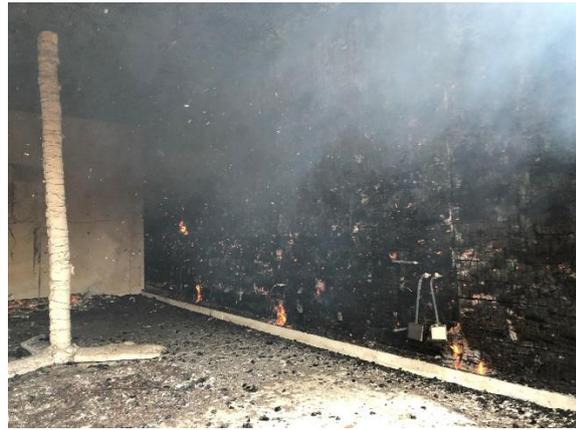
120 - Test 5. Right wall at 2 hours, 47 min after ignition

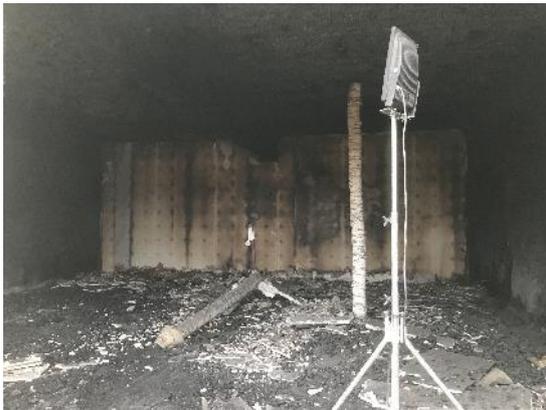
121 - Back wall after gypsum removal

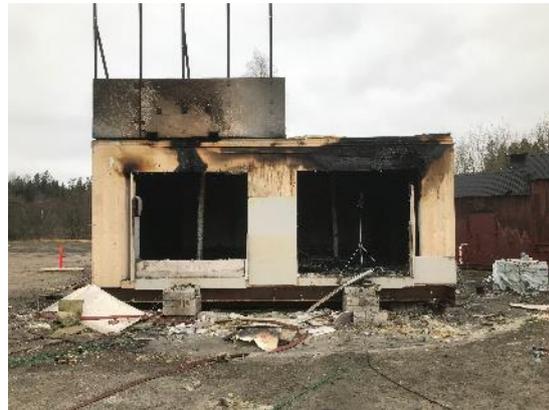
122 - Front of the compartment after protection removed. Areas where fire penetrated the void behind the gypsum boards clearly visible.

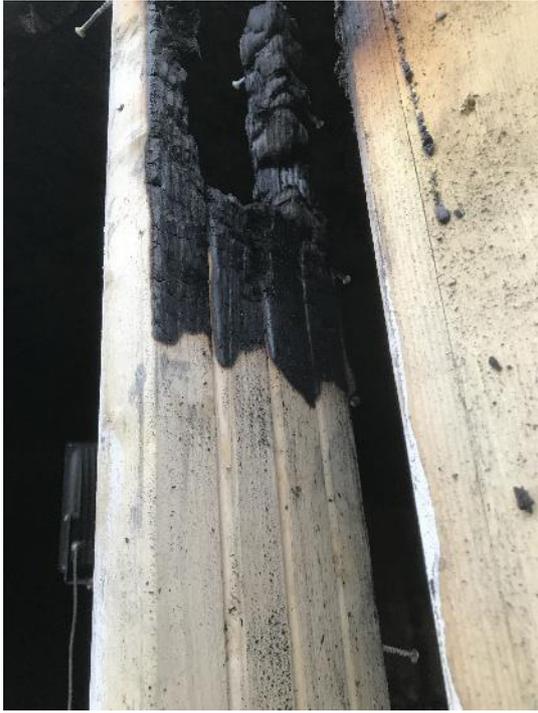
123 - Test 5. Post fire photo of the artificial cavity in the opening of Test 5 to correct the opening size.

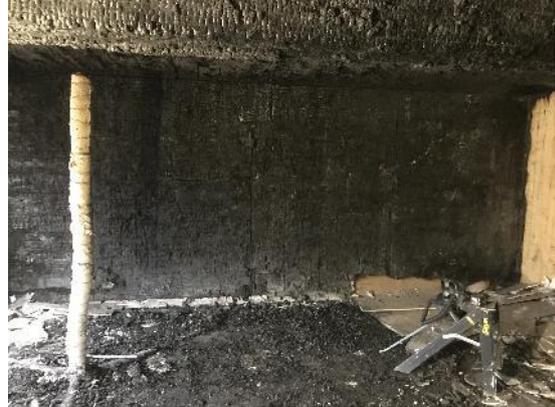
124 - Test 5. Left wall post fire.

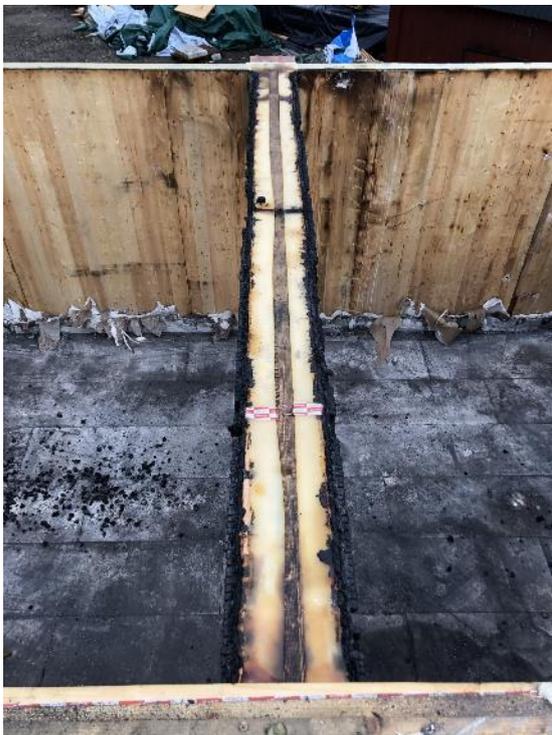
125 - Beam post fire after ceiling removal. Resilient profiles still in place.
